RE: Post Comments to the following Dockets:
- Docket No. 02N-0534: Medical Device User Fee and Modernization Act (MDUFMA) &
- Docket No. 03N-0161: Medical Devices; Reprocessed Single-Use Devices; Termination
of Exemptions from Premarket Notification; Requirement for Submission of Validation
Data

Report on Observations of New and Reprocessed Octopus 3[®] Tissue Stabilizers and Octopus 4[®] Tissue Stabilizers

The objective of this study was to evaluate new sterile and reprocessed sterile Medtronic Octopus 3[®] and Octopus 4[®] Tissue Stabilizers (see attached product PDF files). A report dated May 24, 2004 contained information and data describing the differences observed between new sterile and reprocessed sterile Medtronic Octopus 3[®] and Octopus 4[®] Tissue Stabilizers. In that report a total of four devices were assessed, one new sterile Medtronic Octopus 3[®], one new sterile Medtronic Octopus 4[®], one reprocessed sterile Medtronic Octopus 3[®] (SterilMed) and one reprocessed sterile Medtronic Octopus 4[®] (Alliance). Subsequent to that report, eight additional reprocessed Medtronic Octopus 3[®] and Octopus 4[®] Tissue Stabilizers from the same two reprocessors were examined

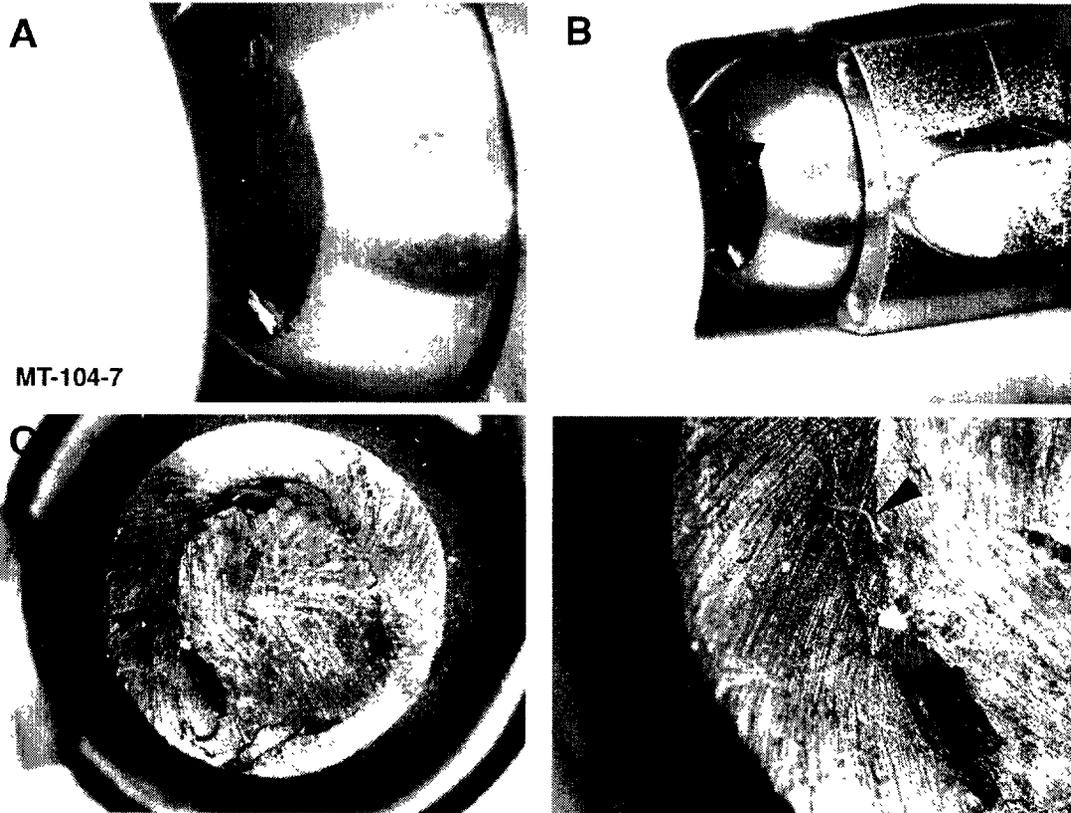
Reprocessed devices study IDs MT-104-3, 7, 8 and 9 (SterilMed) all had discoloration and significant corrosion in the cable attachment area of the ball joint region. All of the units had obvious bioburden and debris including hair or hair-like fibers (arrowheads) in the region of the ball joint. Example images from MT-104-7, 8 and 9 are below (arrowheads indicate hair, note extensive corrosion):

Figure 9. Stereomicroscopy images from **reprocessed device MT-104-7**. Arrowheads indicate hair, note extensive corrosion. Hair identified by cuticular scales and has been stained by the corrosion indicating its presence at the time of corrosion formation.

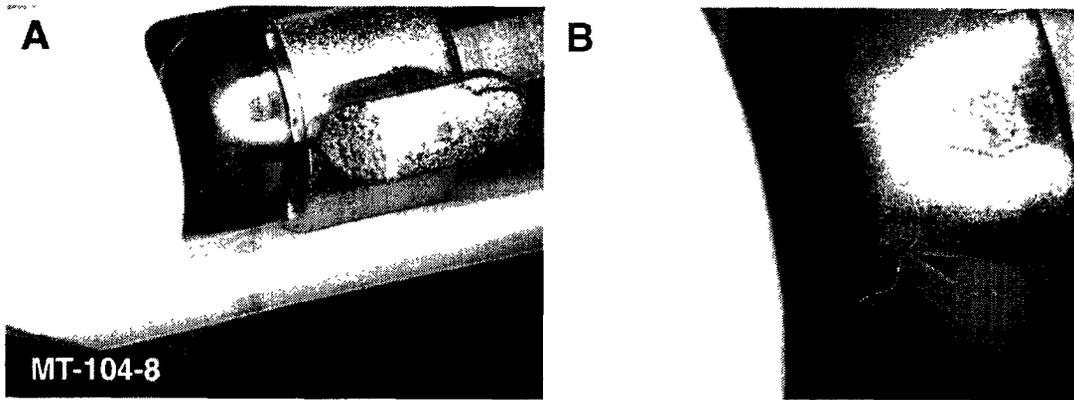
Figure 10. Stereomicroscopy images from reprocessed device MT-104-8. Arrowhead indicates hair or hair-like fiber.

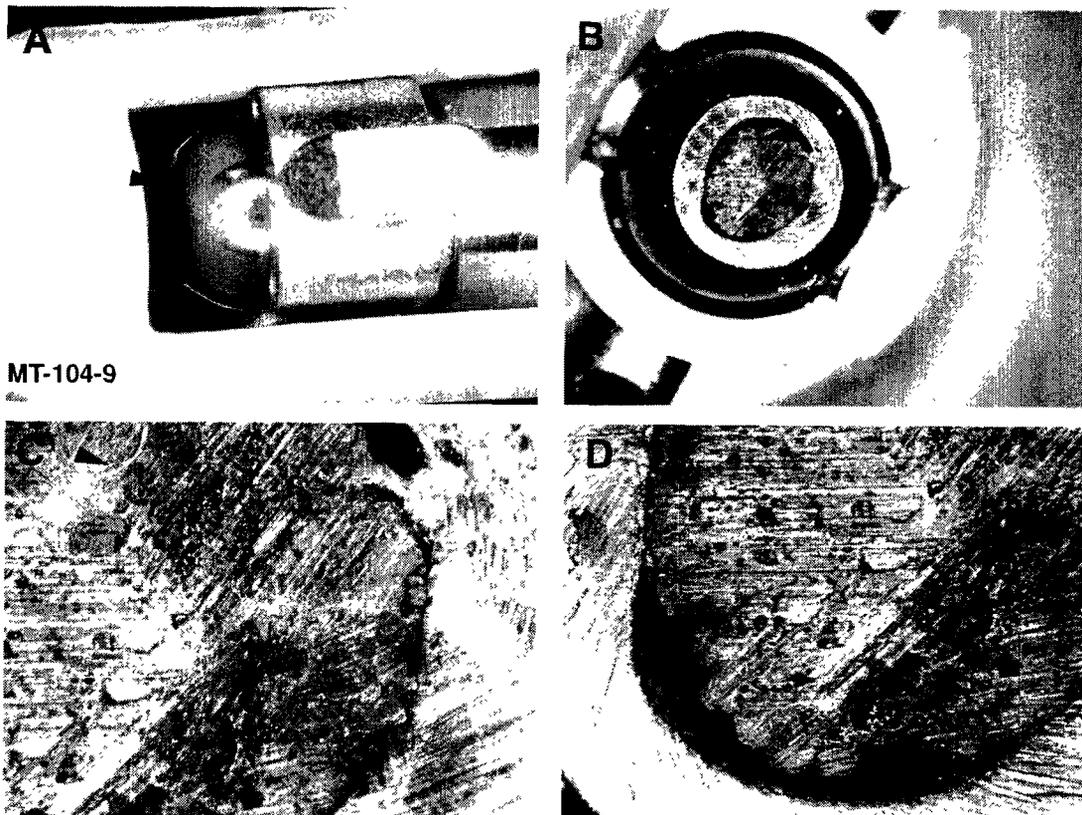
Figure 11. Stereomicroscopy images from reprocessed device MT-104-9. Arrowheads indicate hair, note extensive corrosion.

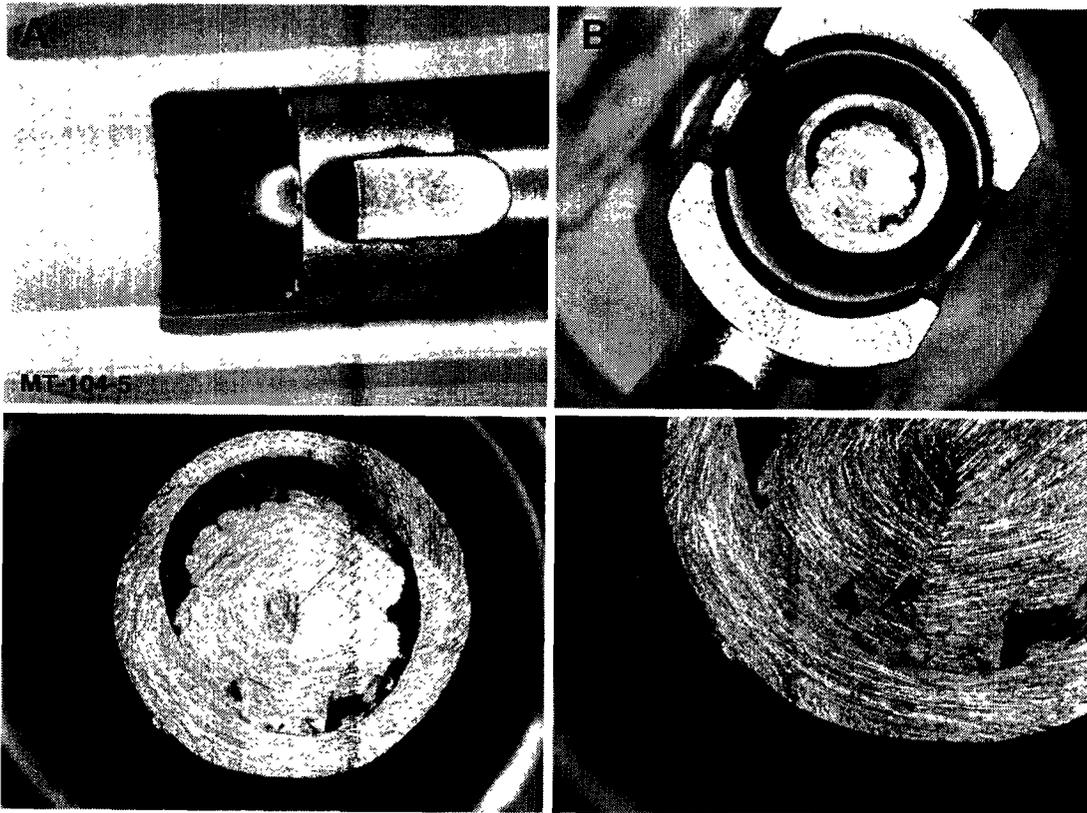
Significantly less corrosion and metal discoloration did appear on reprocessed Octopus[®] devices identified as MT-104-4, 5, 10, 11, 13 and 16 (Alliance) when compared to device IDs MT-104-3, 7, 8 and 9 (SterilMed). Example images from MT-104-5 and 10 are below:

Figure 12. Minor corrosion and metal discoloration (arrowhead) as compared to new on reprocessed Octopus4[®] (MT-104-5).

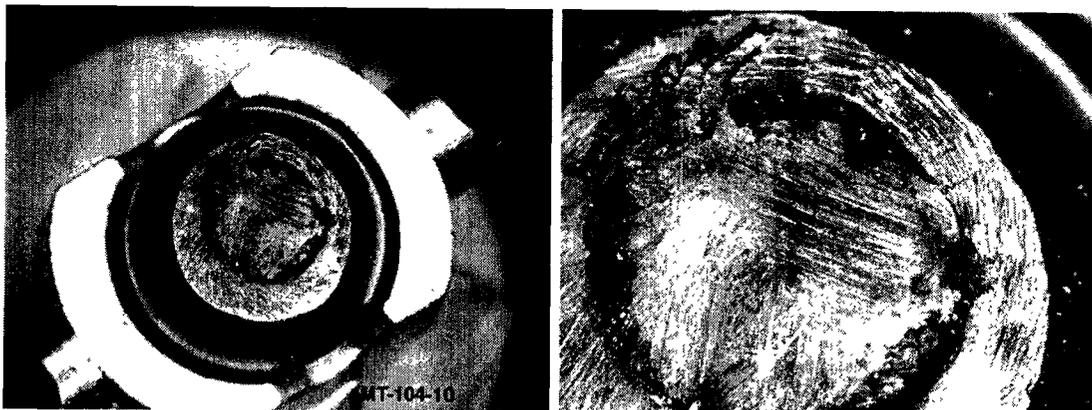
Figure 13. Minor corrosion and metal discoloration as compared to new on reprocessed Octopus4[®] (MT-104-10).

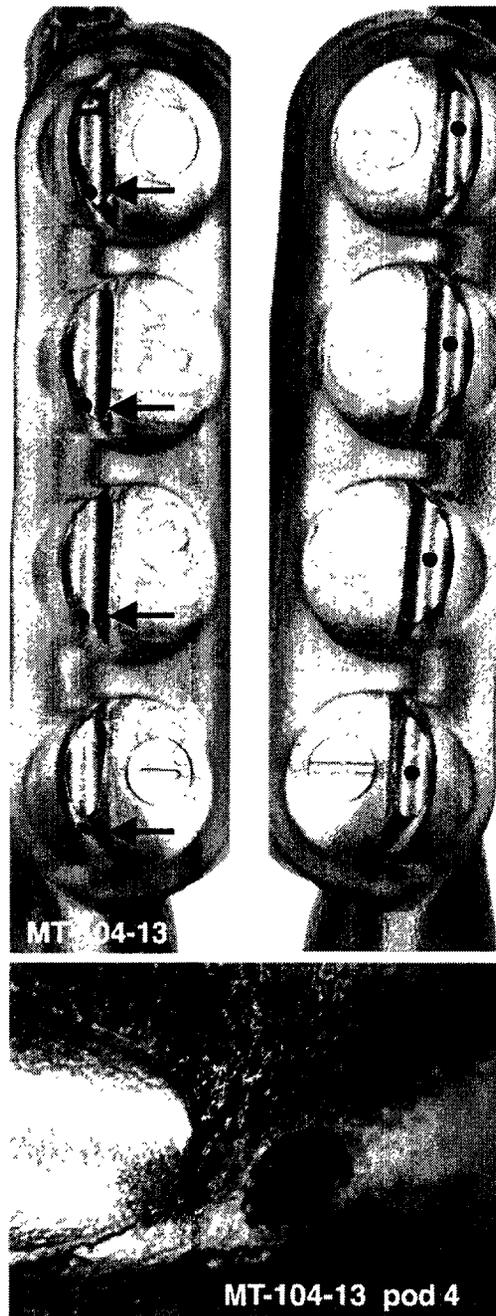
Figure 14. Reprocessed device MT-104-13 with blocked pod openings (arrows).

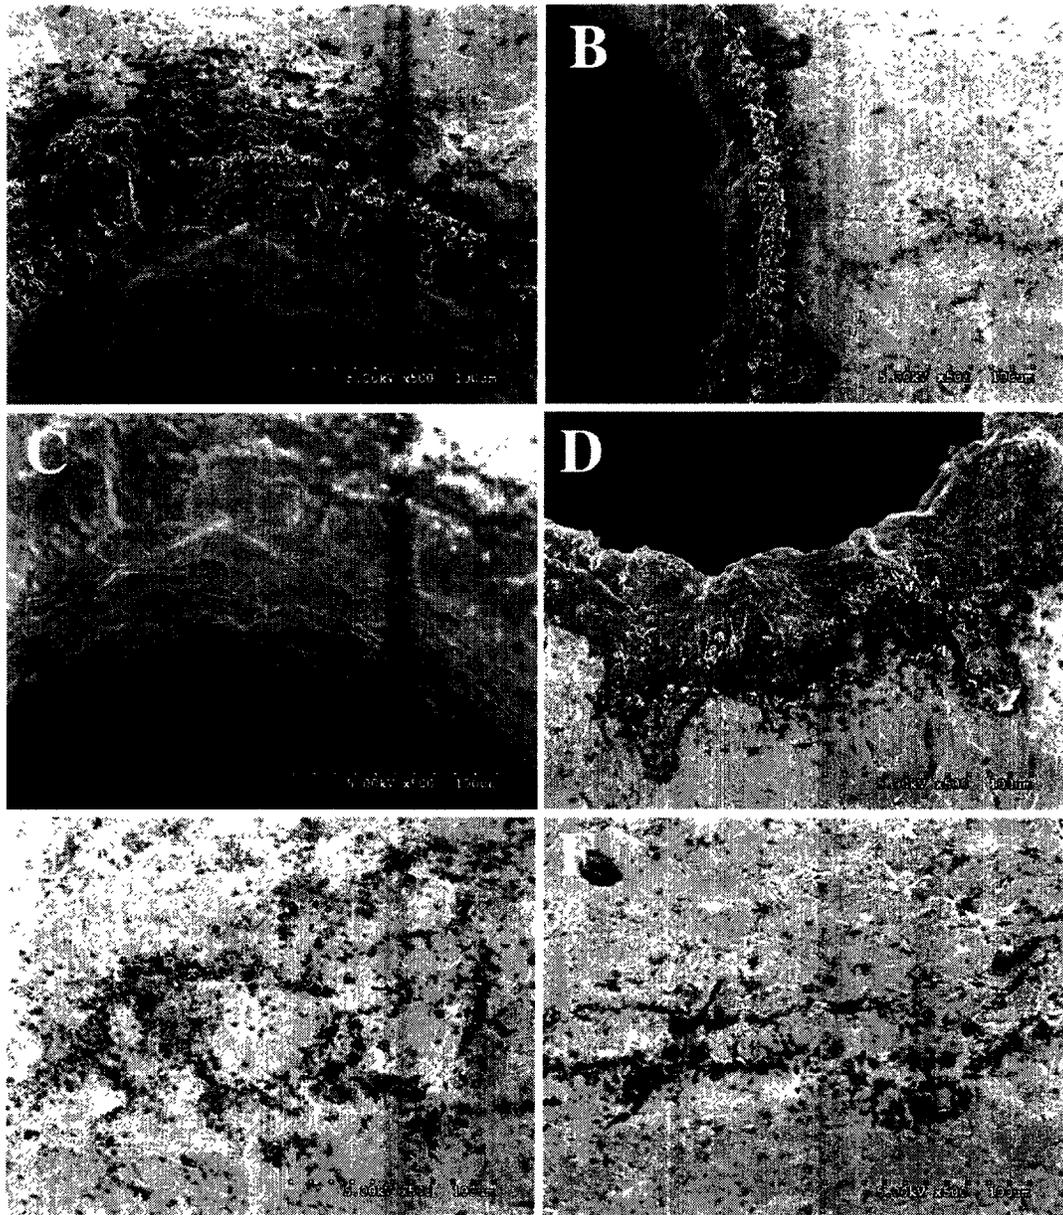
Figure 23. Series of images collected from Hitachi S3500N variable pressure scanning electron microscope of the tubing within pod #8 on the **reprocessed Octopus 3[®] MT-104-3**. The images show irregularities to varying degrees on surface structure of the tubing in all pods. A-D is debris present in the orifices of the tubing. Note bioburden material coating the opening of the tubing orifice and the irregular shape. E and F are images showing debris and contamination on the surface of the metal tubing. Scale bar in each image.

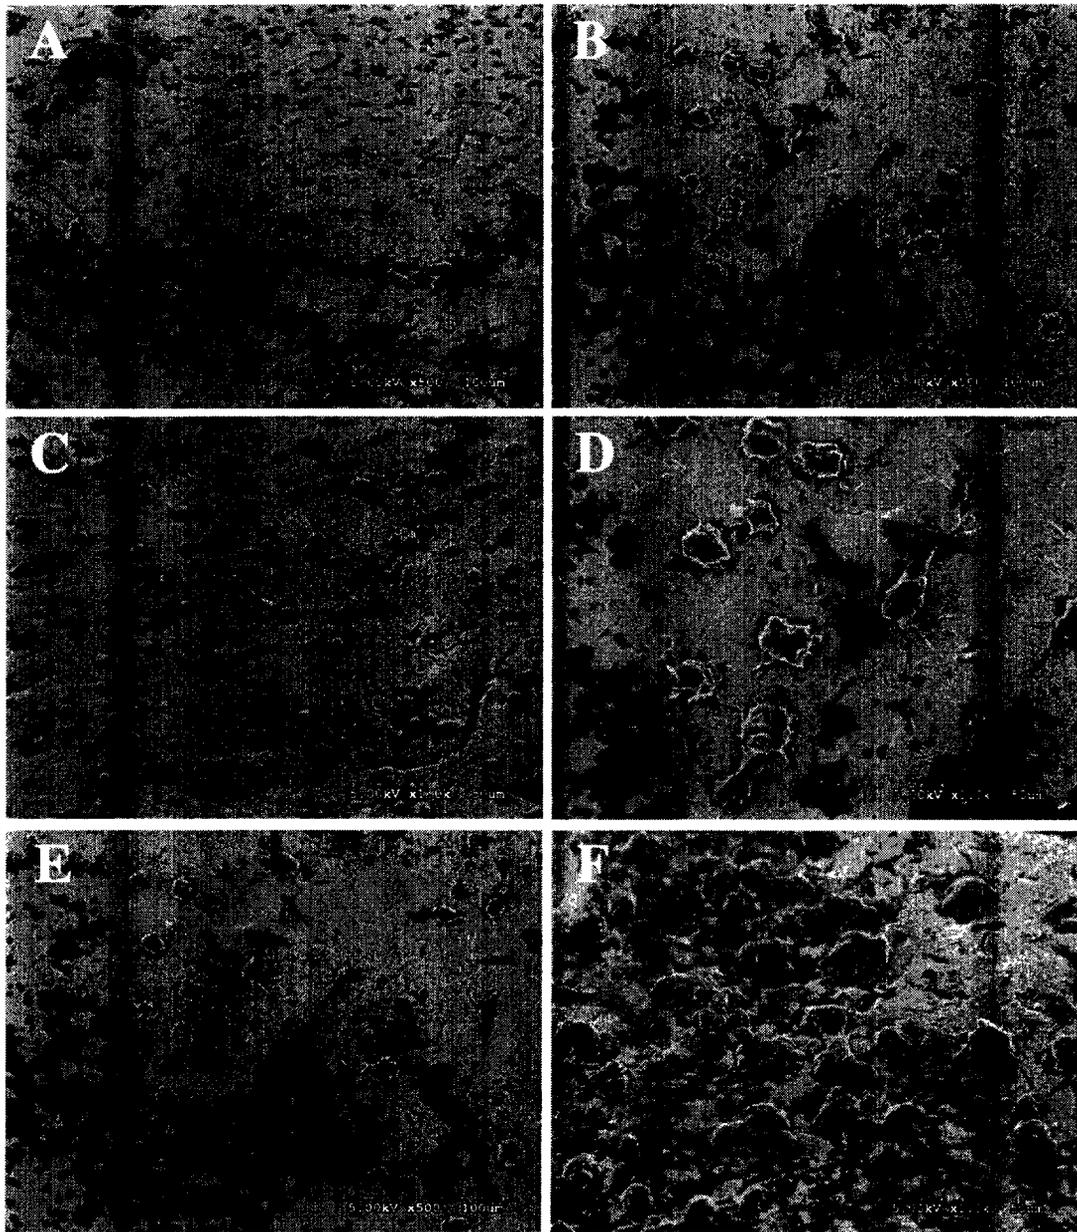
Figure 24. Series of images collected from Hitachi S3500N variable pressure scanning electron microscope of the tubing within pod #5 on the **reprocessed Octopus 3[®] MT-104-3**. The images show various irregularities and contamination on the surface structure of the tubing. All images show foreign debris, bioburden and contamination present on the surface of the tubing when compared to “new”. B, D, E and F are images show what clearly appear to be mammalian cells on the surface of the metal tubing. Scale bar in each image.

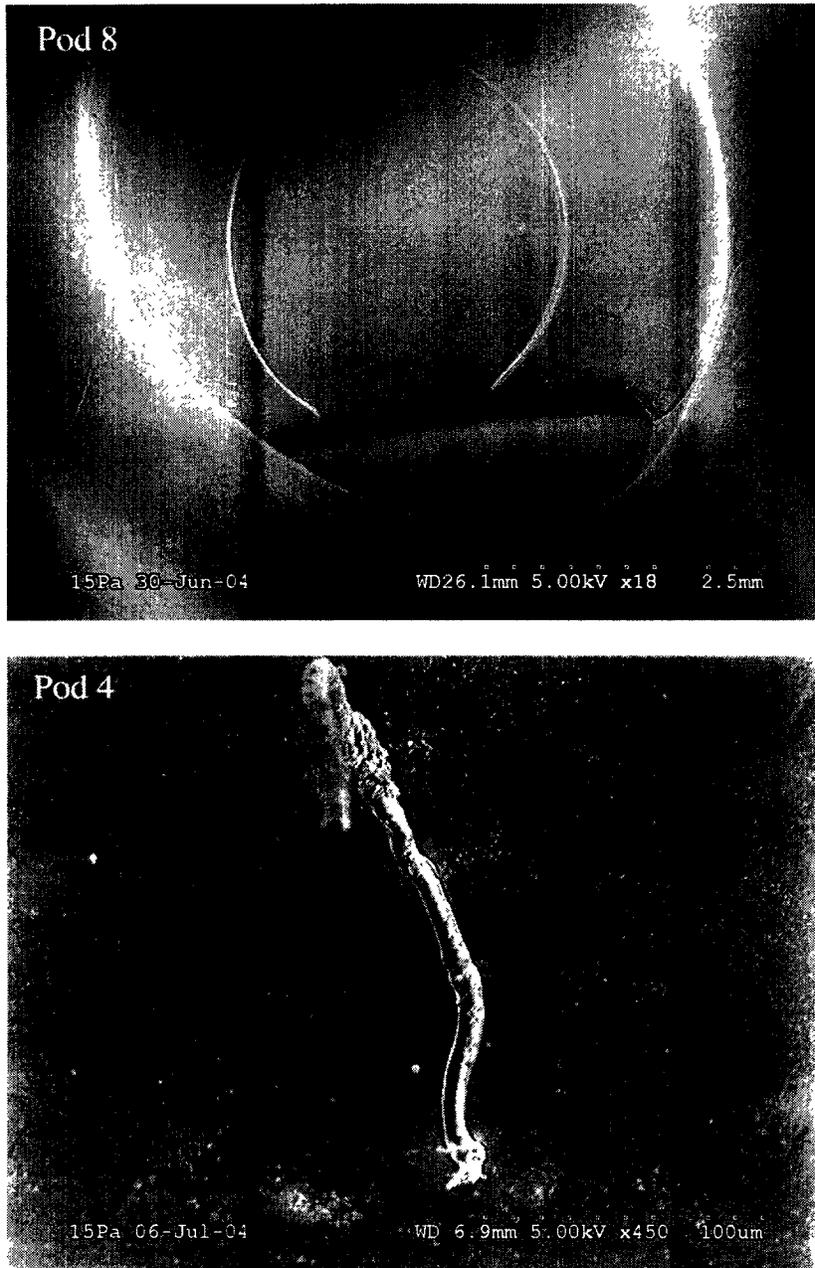
Figure 38. Series of images collected from Hitachi S3500N variable pressure scanning electron microscope of the **reprocessed Octopus 3[®] MT-104-8**. The images show several irregularities on surface structure of the tubing including a gap in the area of the pod surrounding the tubing. There is a fiber and irregularities present in the pod of the tubing. Scale bar in each image.

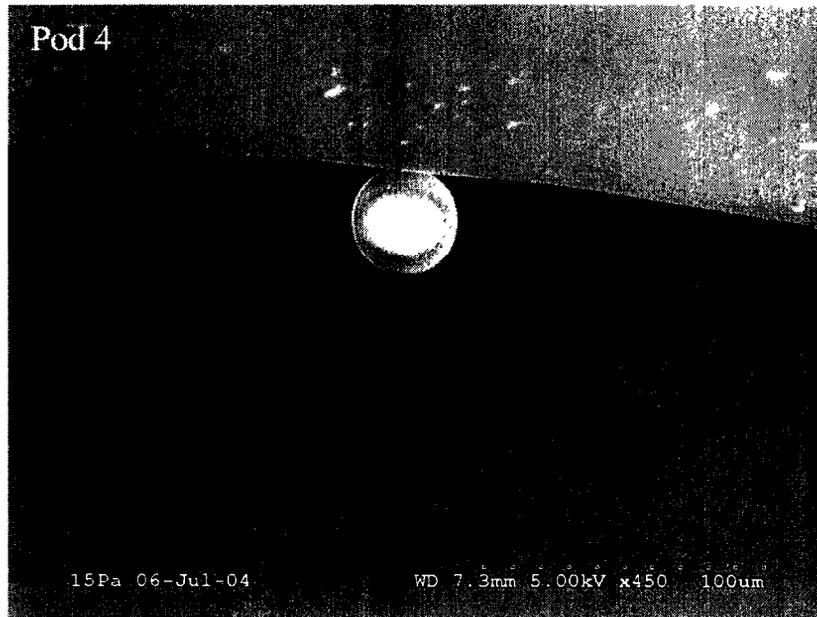
Figure 39. Image collected from Hitachi S3500N variable pressure scanning electron microscope of the **reprocessed Octopus 3[®] MT-104-8**. The image shows spherical shaped particle on the surface of the pod. Numerous 40-60 micron diameter particles were observed on this and other devices. Scale bar in each image.

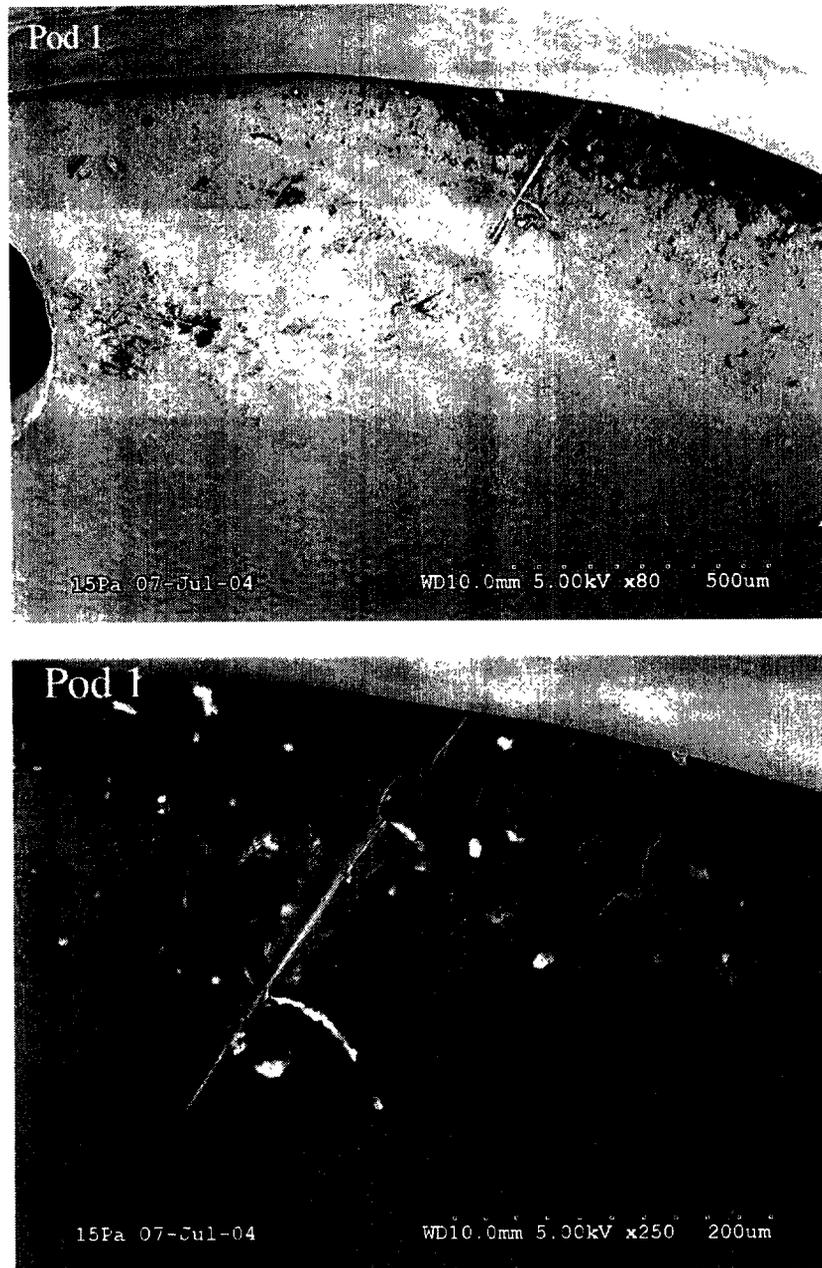
Figure 49. Images collected from Hitachi S3500N variable pressure scanning electron microscope of pod 1 on the **reprocessed Octopus 4® MT-104-10**. The images show various irregularities and contamination on the surface structure of the tubing and the pods. Bioburden debris and contamination is present on the surface of the tubing when compared to “new”. Note fiber. Scale bar in each image.

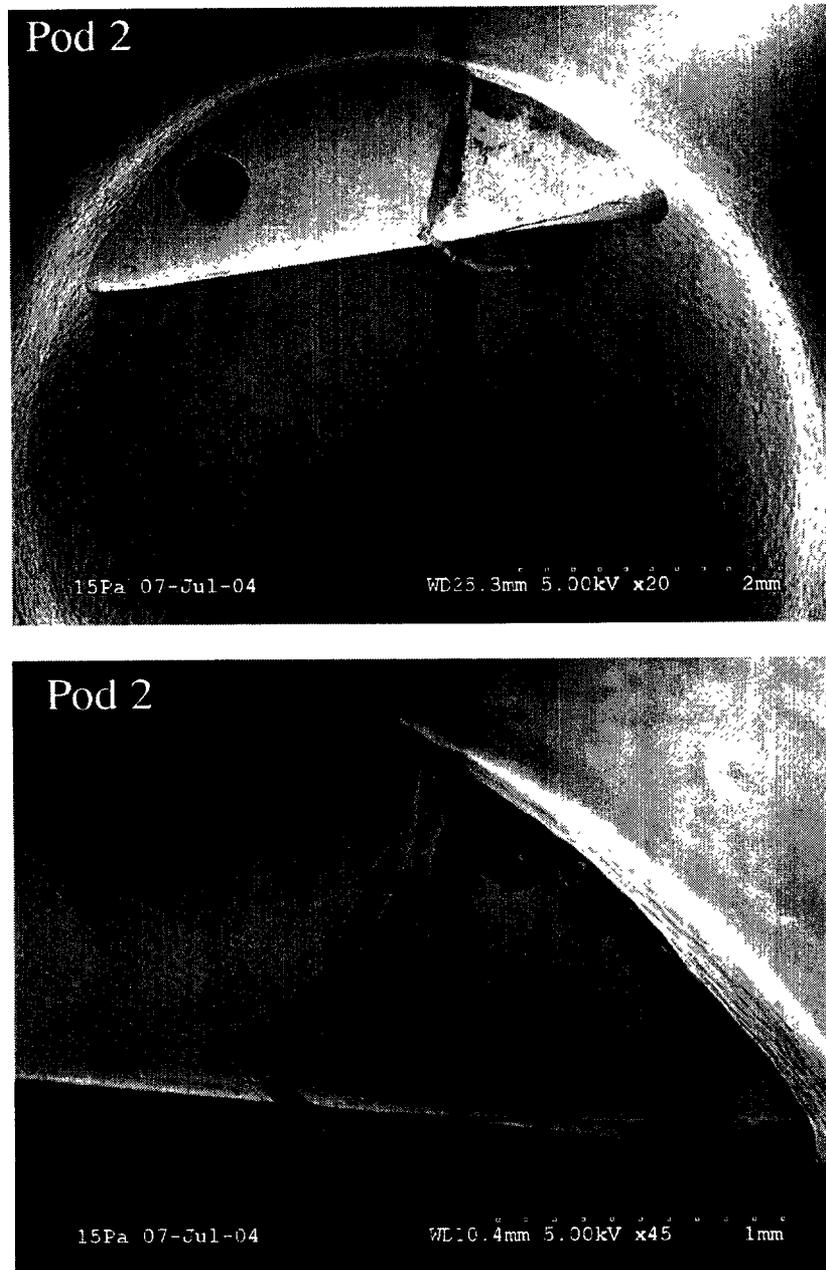
Figure 50. Images collected from Hitachi S3500N variable pressure scanning electron microscope of pod 2 on the **reprocessed Octopus 4[®] MT-104-10**. The images show various irregularities and contamination on the surface structure of the tubing and the pods. Bioburden debris and contamination is present on the surface of the tubing when compared to “new”. Note large fragment of material. Scale bar in each image.

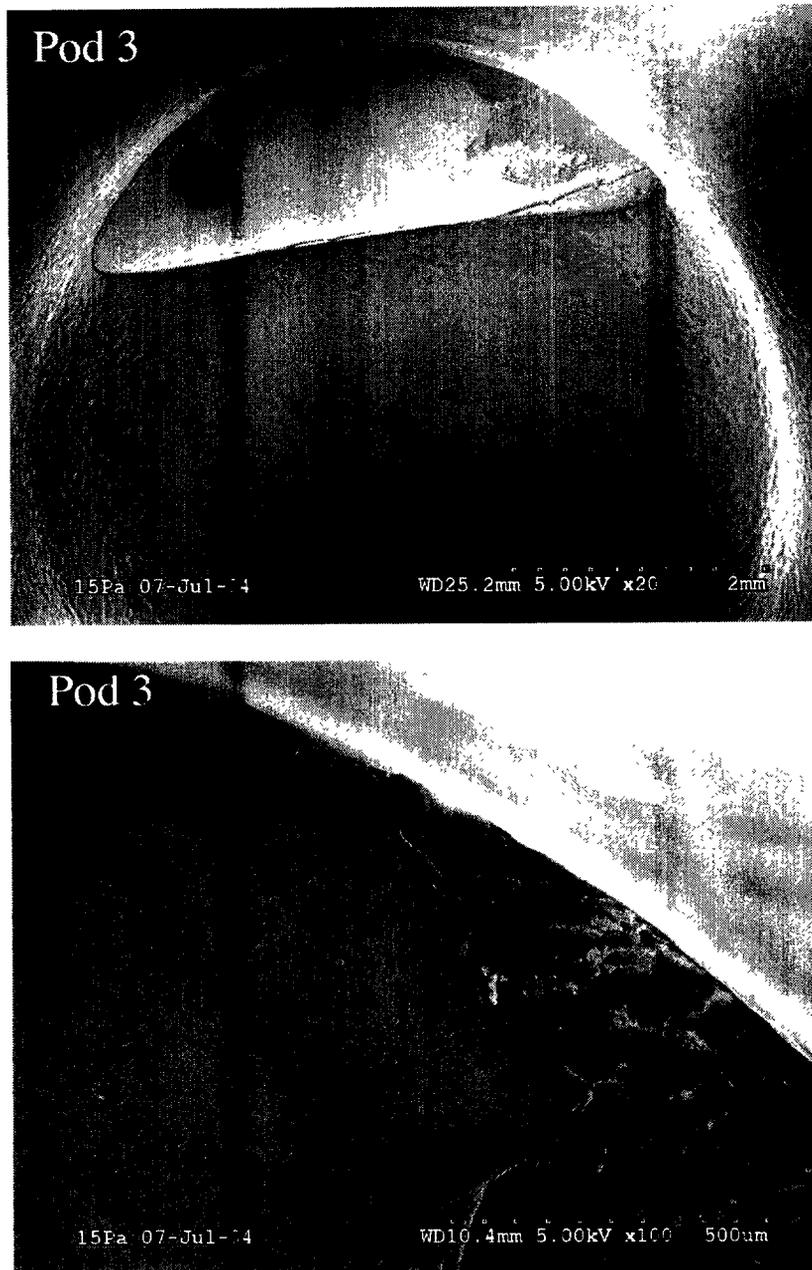
Figure 51. Images collected from Hitachi S3500N variable pressure scanning electron microscope of pod 3 on the **reprocessed Octopus 4® MT-104-10**. The images show various irregularities and contamination on the surface structure of the tubing and the pods. Bioburden debris and contamination is present on the surface of the tubing when compared to “new”. Note “sheet” of foreign material on tubing surface. Scale bar in each image.

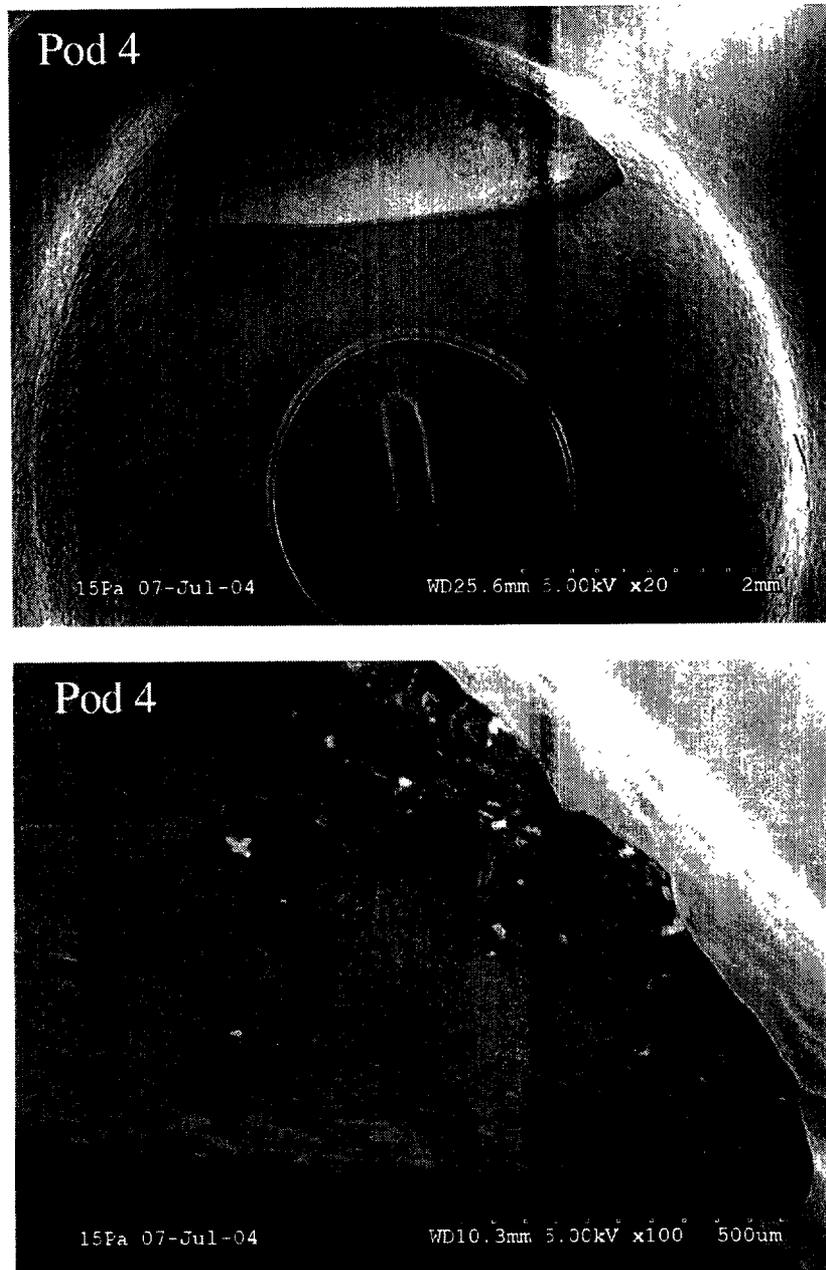
Figure 52. Images collected from Hitachi S3500N variable pressure scanning electron microscope of pod 4 on the **reprocessed Octopus 4® MT-104-10**. The images show various irregularities and contamination on the surface structure of the tubing and the pods. Bioburden debris and contamination is present on the surface of the tubing when compared to “new”. Note sheet of material on tubing, gap between pod and hypotube and the partially blocked opening. Scale bar in each image.

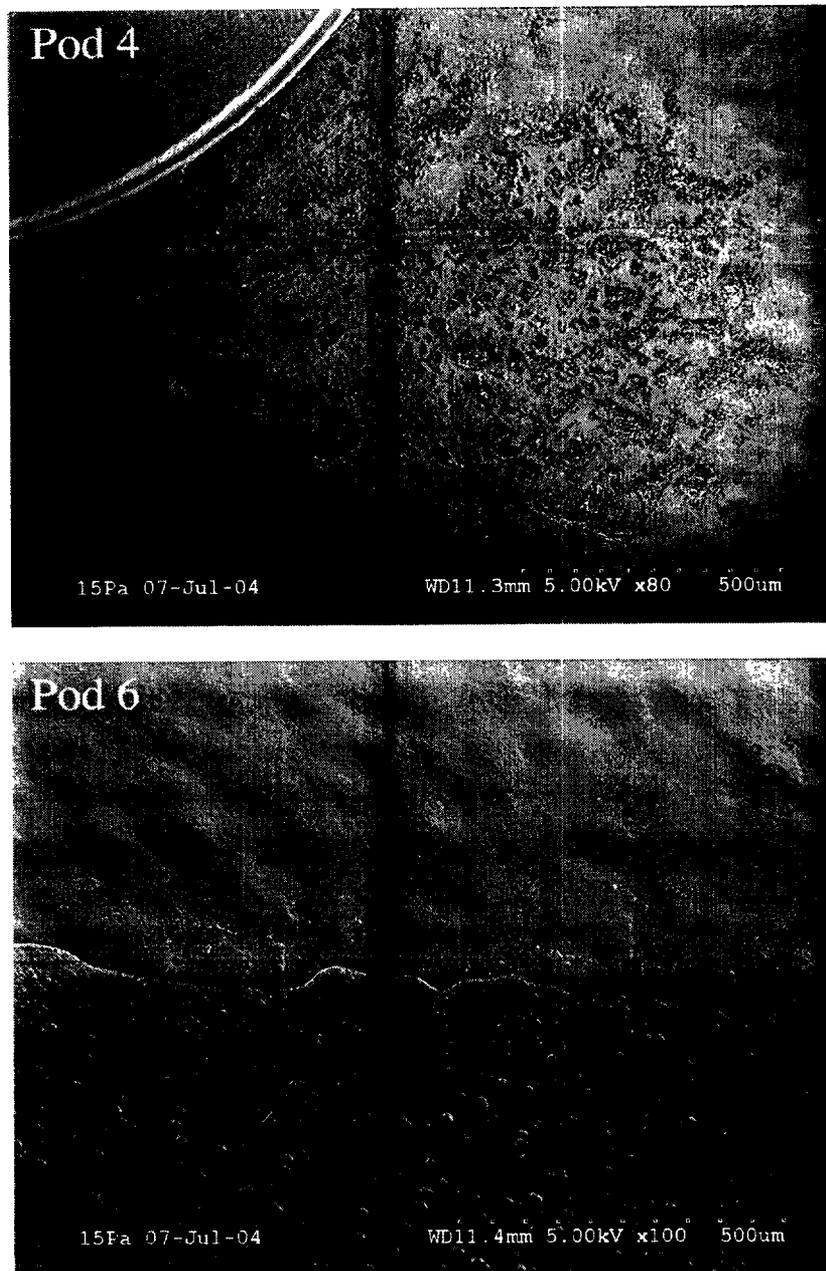
Figure 53. Images collected from Hitachi S3500N variable pressure scanning electron microscope of pods 4 and 6 on the **reprocessed Octopus 4[®] MT-104-10**. The images show contamination on the surface structure of the pods. Scale bar in each image.

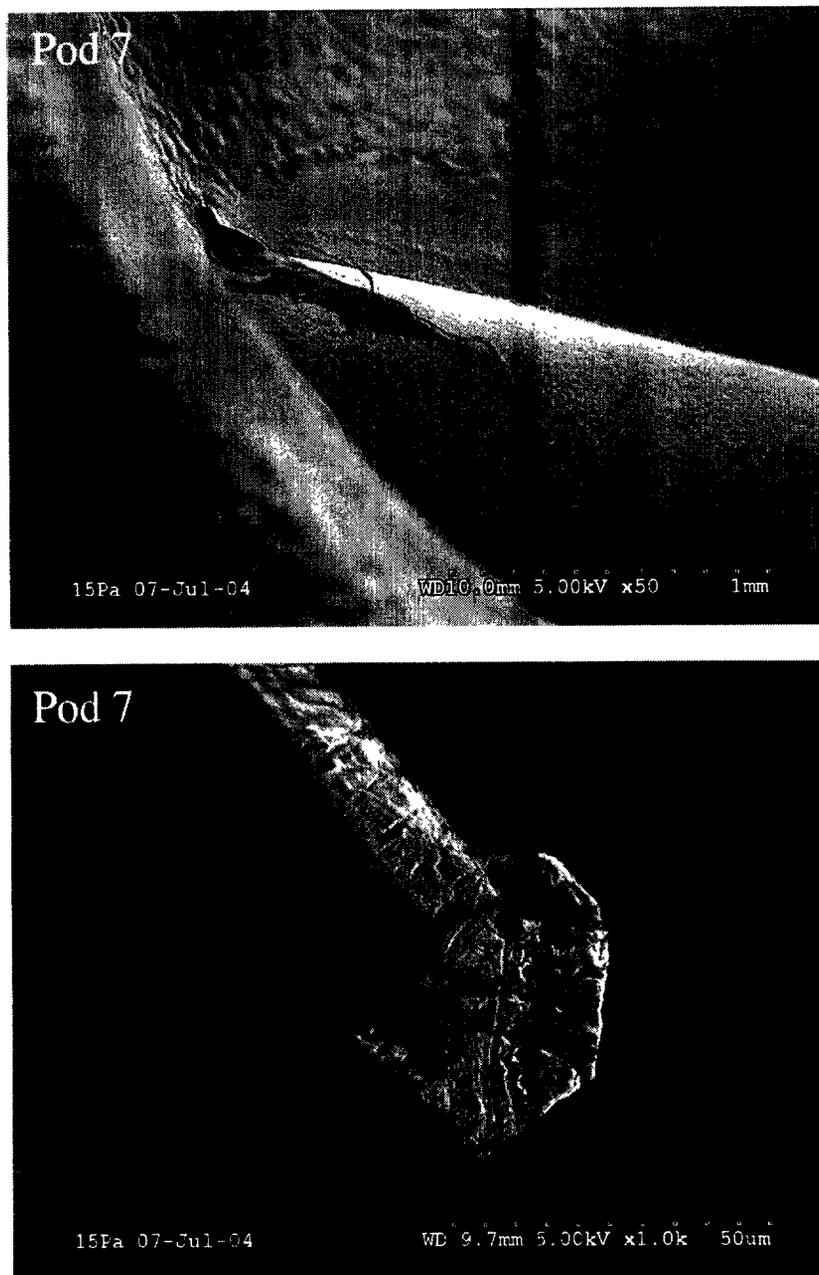
Figure 54. Images collected from Hitachi S3500N variable pressure scanning electron microscope of pod 7 on the **reprocessed Octopus 4® MT-104-10**. The images show various irregularities and contamination on the surface structure of the tubing and the pods. Note hair-like fiber in lower panel. Scale bar in each image.

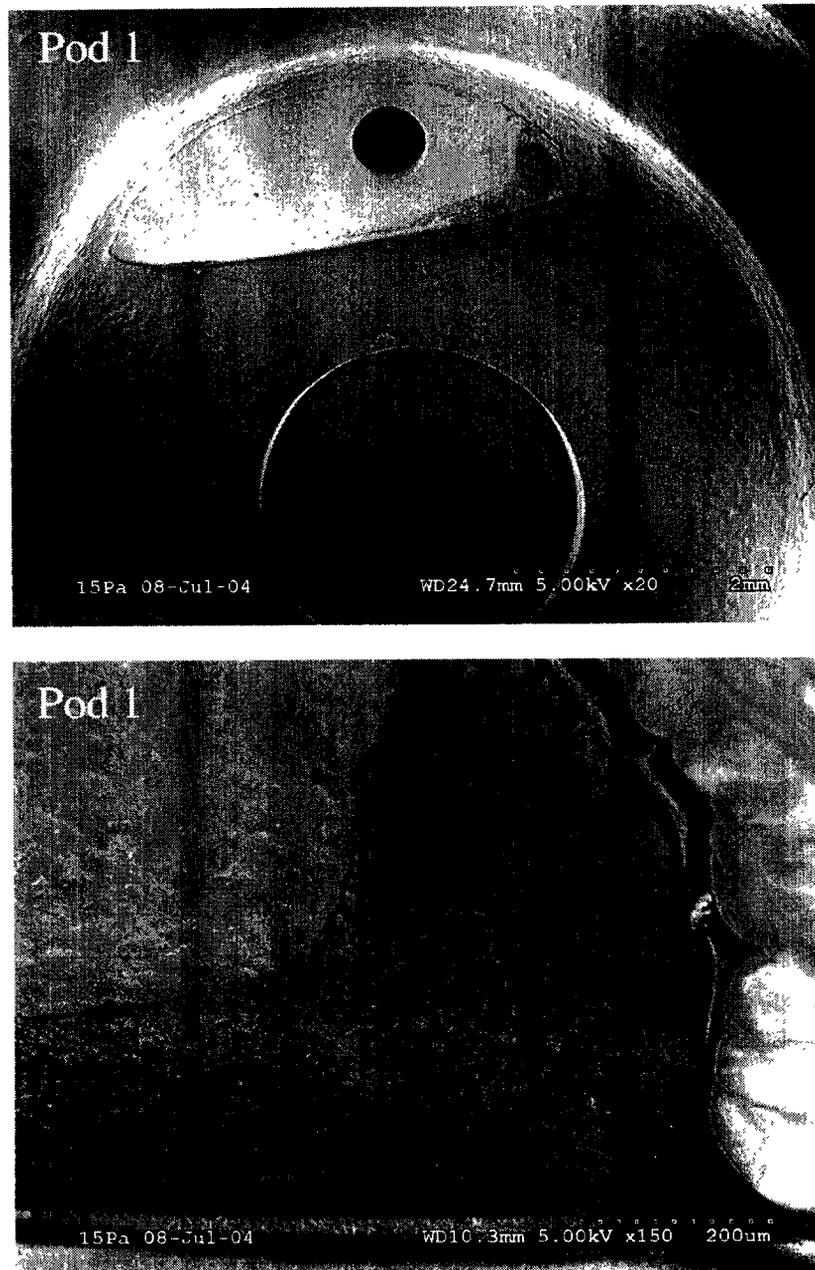
Figure 55. Images collected from Hitachi S3500N variable pressure scanning electron microscope of pod 1 on the **reprocessed Octopus 4® MT-104-11**. The images show various irregularities and contamination on the surface structure of the tubing and the pods. Bioburden debris and contamination is present on the surface of the tubing when compared to “new”. Note “sheet” of foreign material on tubing surface. Scale bar in each image.

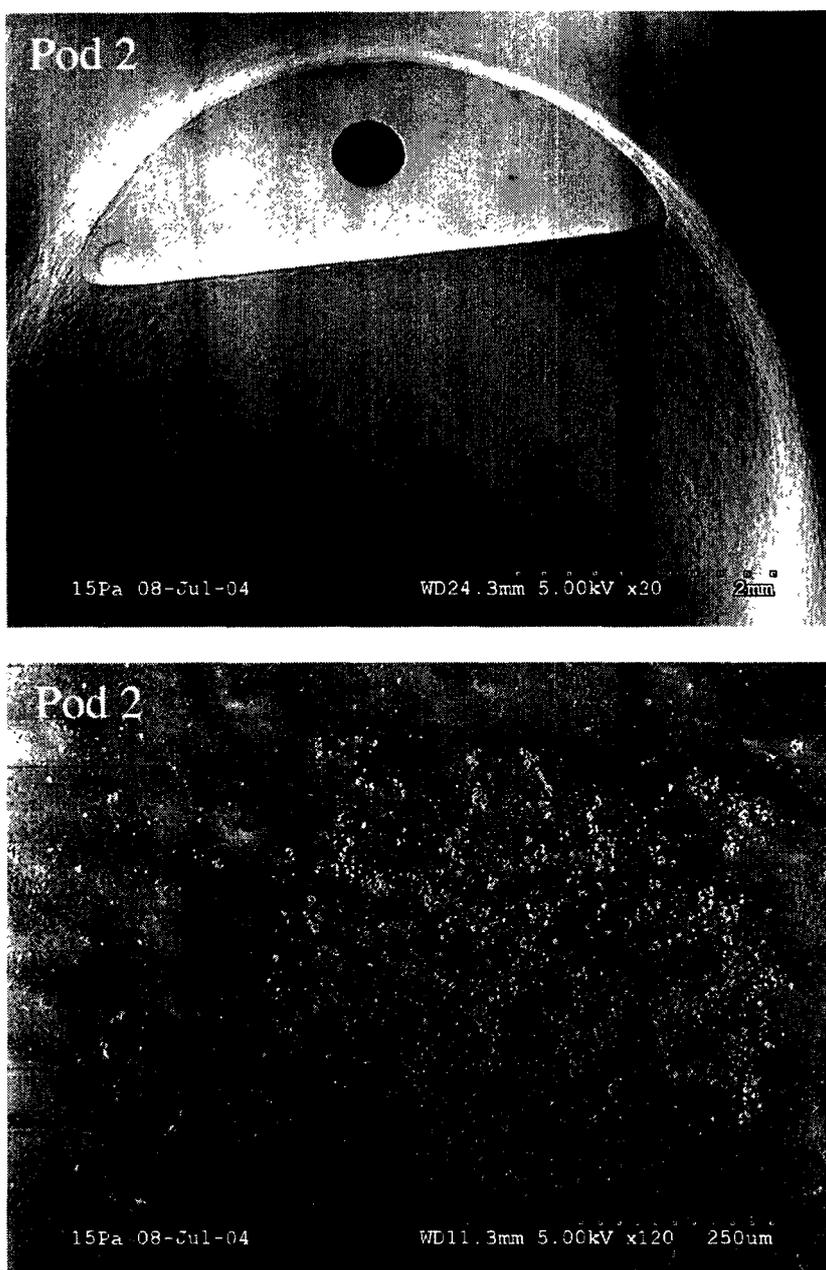
Figure 56. Images collected from Hitachi S3500N variable pressure scanning electron microscope of pod 2 on the **reprocessed Octopus 4[®] MT-104-11**. The images show various irregularities and contamination on the surface structure of the tubing and the pod. Bioburden debris and contamination is present on the surface of the pod when compared to “new”. Scale bar in each image.

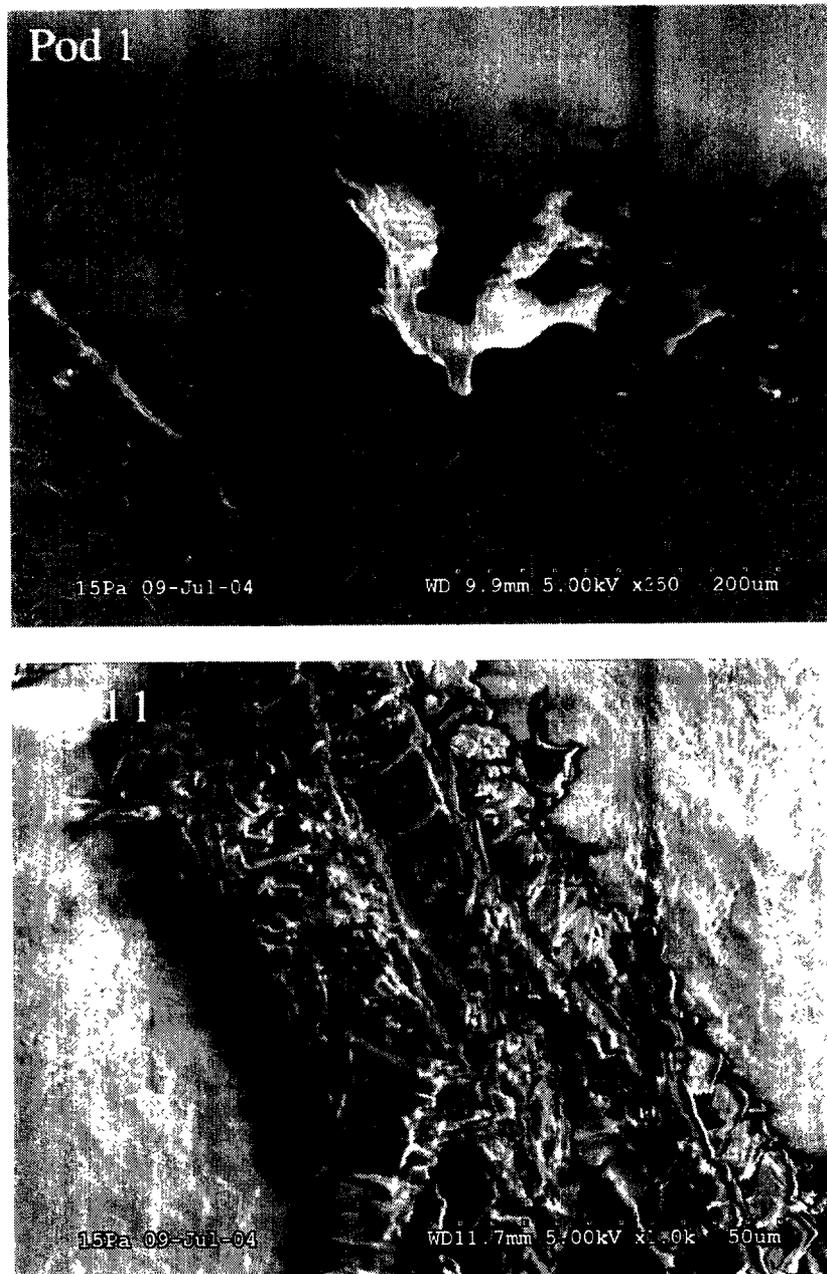
Figure 60. Higher magnification views of debris in pod 1 on the reprocessed Octopus 4[®] MT-104-13. The number in the upper left indicates the pod # (see Figure 5). Scale bar in each image.

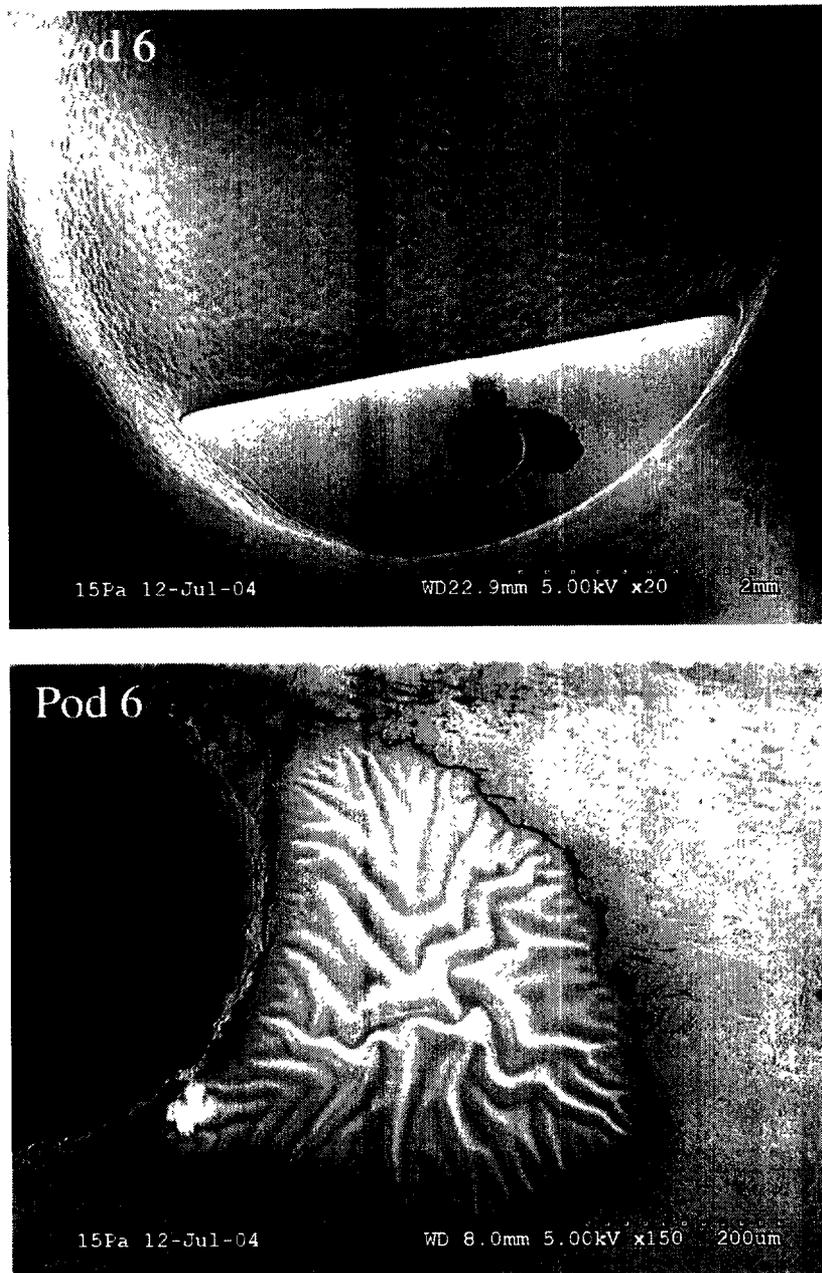
Figure 72. Images collected from Hitachi S3500N variable pressure scanning electron microscope in the areas of pod 6 on the **reprocessed Octopus 4[®] MT-104-16**. Note contamination and dried liquid material near hypotube opening. The number in the upper left indicates the pod # (see Figure 5). Scale bar in each image.

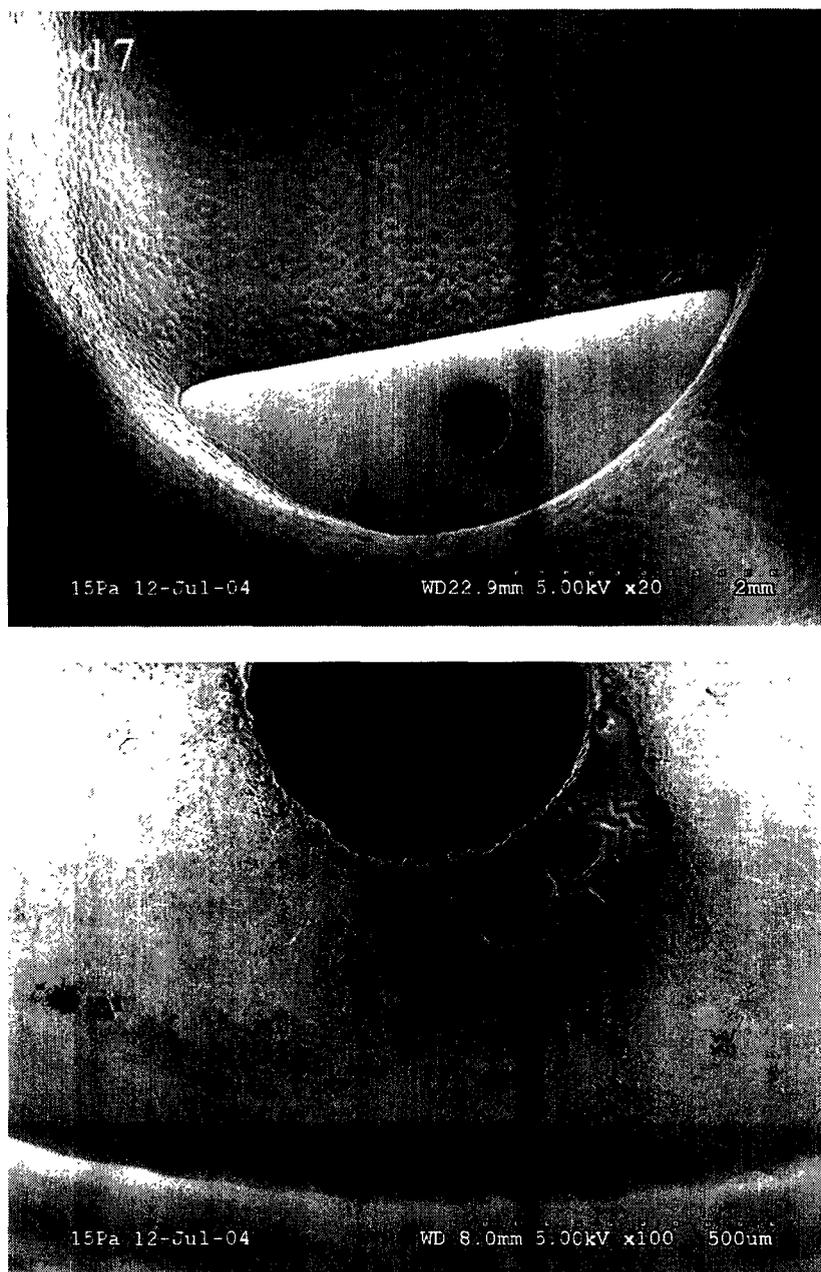
Figure 73. Images collected from Hitachi S3500N variable pressure scanning electron microscope in the areas of pod 7 on the **reprocessed Octopus 4[®] MT-104-16**. Note contamination and dried liquid material near hypotube opening. The number in the upper left indicates the pod # (see Figure 5). Scale bar in each image.
