RE: Post Comments to the following Dockets:
- Docket No. 02N-0534: Medical Device User Fee and Modernization Act (MDUFMA) &
- Docket No. 03N-0161: Medical Devices; Reprocessed Single-Use Devices; Termination
of Exemptions from Premarket Notification; Requirement for Submission of Validation
Data

Report on Observations of New and Reprocessed Octopus 3[®] Tissue Stabilizers and Octopus 4[®] Tissue Stabilizers

The objective of this study was to evaluate new sterile and reprocessed sterile Medtronic Octopus 3[®] and Octopus 4[®] Tissue Stabilizers (see attached product PDF files). A report dated May 24, 2004 contained information and data describing the differences observed between new sterile and reprocessed sterile Medtronic Octopus 3[®] and Octopus 4[®] Tissue Stabilizers. In that report a total of four devices were assessed, one new sterile Medtronic Octopus 3[®], one new sterile Medtronic Octopus 4[®], one reprocessed sterile Medtronic Octopus 3[®] (SterilMed) and one reprocessed sterile Medtronic Octopus 4[®] (Alliance). Subsequent to that report, eight additional reprocessed Medtronic Octopus 3[®] and Octopus 4[®] Tissue Stabilizers from the same two reprocessors were examined

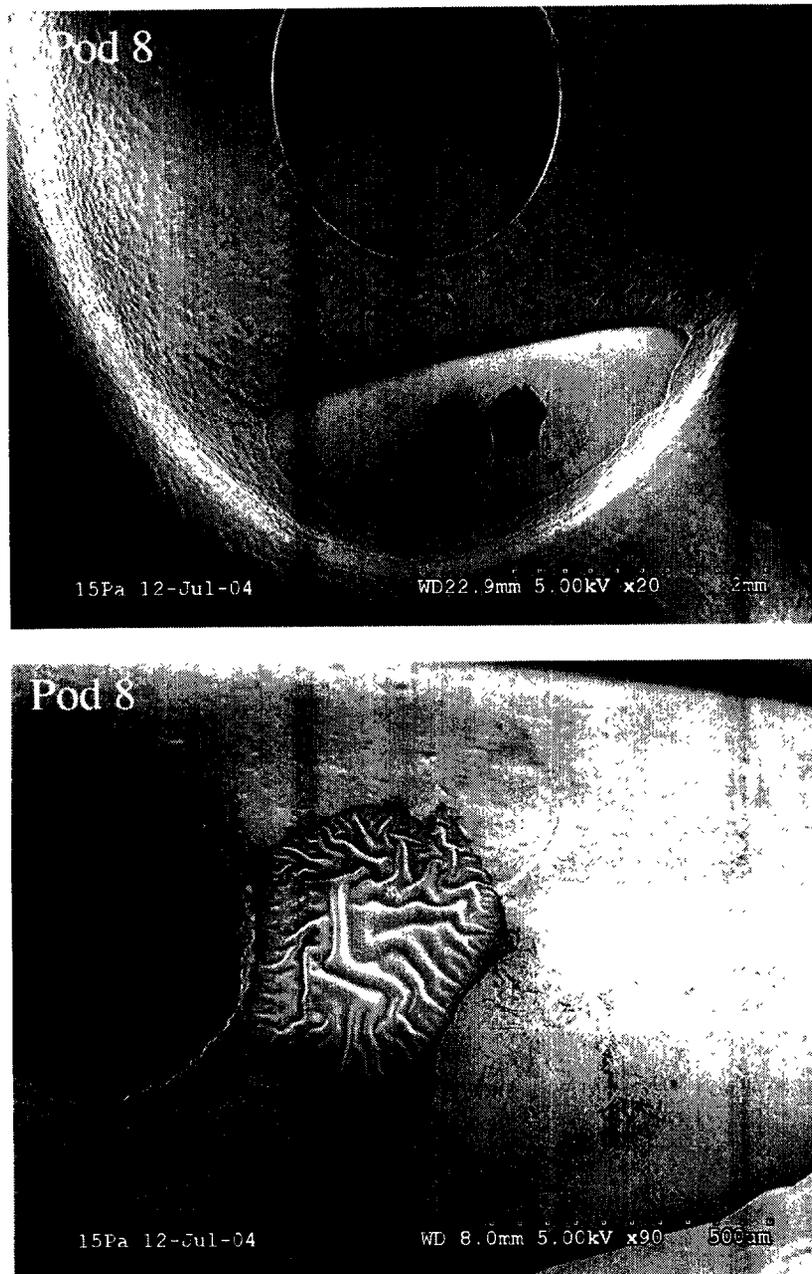
Figure 74. Images collected from Hitachi S3500N variable pressure scanning electron microscope in the areas of pod 8 on the **reprocessed Octopus 4[®] MT-104-16**. Note contamination and dried liquid material near hypotube opening. The number in the upper left indicates the pod # (see Figure 5). Scale bar in each image.

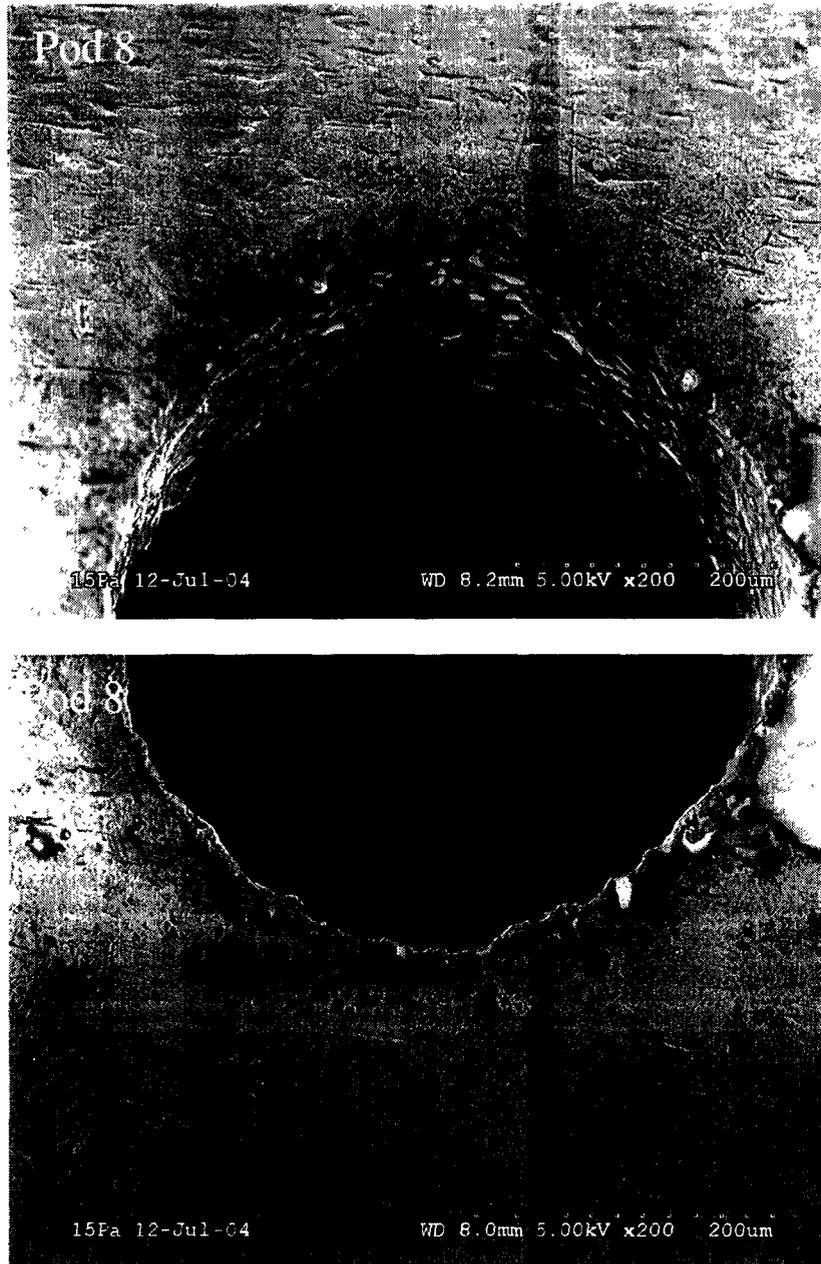
Figure 75. Images collected from Hitachi S3500N variable pressure scanning electron microscope in the areas of pod 8 on the **reprocessed Octopus 4® MT-104-16**. Note contamination and dried liquid material near hypotube opening. There is also debris in the opening of the hypotube. The number in the upper left indicates the pod # (see Figure 5). Scale bar in each image.
