June 2018

Volume 18, Issue 6

HIGHLIGHTED REPORTS

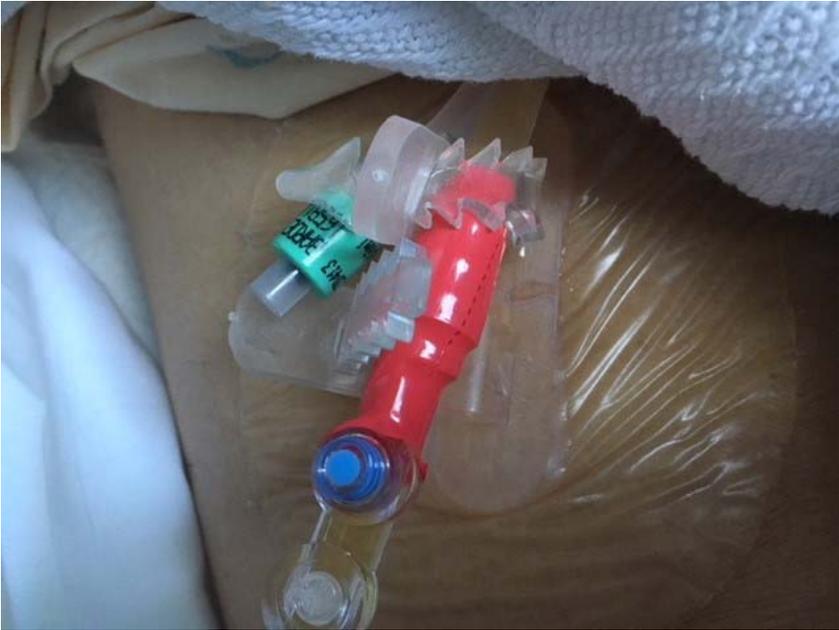
Device	Manufacturer	Problem
<p>Accessories, Catheter</p> <p>Brand: Cath Grip/uni Grip Lot #: D04403 Cat #: 51300NS</p>	<p>Bioderm, Inc.</p>	<p>Catheter securement device new out of the package is ripping at the seam around the tabs.</p> <p>Please see picture below:</p>

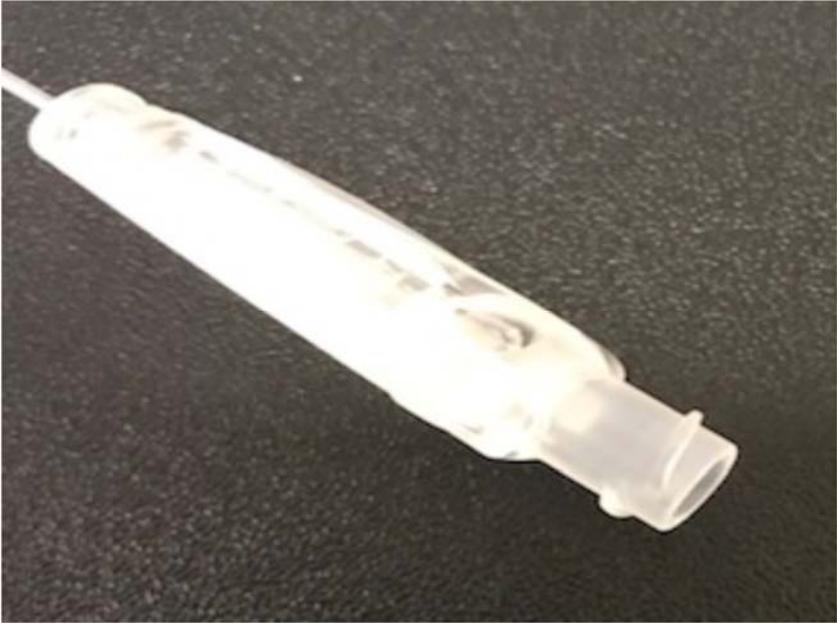
Device	Manufacturer	Problem
<p>Epidural Anesthesia Kit</p> <p>Brand: Design Options Model#: 552122 Lot #: 0061589452 Cat #: 552122 Other #: Periflex Catheter Connector-Clamp style plastic connector</p>	<p>B. BRAUN MEDICAL INC.</p>	<p>The patient was admitted to labor and delivery. A B. Braun Epidural catheter was placed on at approximately 12:15. During the night, the epidural catheter started to leak at the distal end of the catheter site, and the IV pump was alarming. The IV tubing was properly connected to the plastic catheter connector hub, but there was leaking from the connector clip piece housing the catheter. Upon inspection, the MD noted that the catheter had migrated approximately 1 mm from the plastic clip portion of the connector which secures the catheter in place. The doctor opened the clip and re-advanced the catheter to the distal end of the plastic catheter clip, bolused the patient and rechecked all catheter connections. Approximately two hours later, a stat C-section was required. The doctor attempted to re-bolus the patient through the epidural. Again, the catheter was leaking. The doctor re-advanced the catheter through the plastic injection port, and it was still leaking. The decision was made to convert the patient to general anesthesia.</p> <p>We have also experienced this issue with the Model: 552122, Lot: 0061589452; Model: 552127, Lot: 0061547773.</p> <p>In looking over the catheter connector we noted the following:</p> <ol style="list-style-type: none"> 1. It looks like there is only ½ turn required on the thread that the epidural medication infusion tubing attaches to. I believe there are usually 2-3 threads on the hub where the tubing connects. This could lead to easier detachment of the tubing at the hub site. 2. It is visually difficult to tell whether distal tip the catheter is fully engaged within the connector before clamping. 3. The clamp locking mechanism is not very secure and is easily opened. 4. It is unclear whether the pressure of the infusion into the catheter may push it out of the connector lock and cause leaks. 5. Ideally there should be a second locking mechanism on the catheter. 6. The connector plastic may be too pliable, which may allow flexing of the grasp mechanism on the catheter allowing leaking, infusion hub separation or accidental opening from the clamp hinge. <p>Please see picture below:</p>

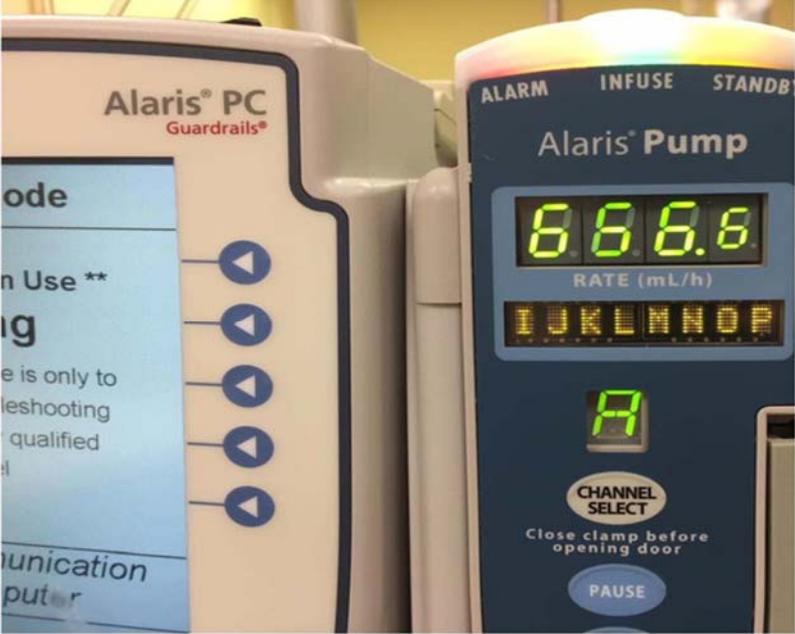
Device	Manufacturer	Problem
<p>Pump, Infusion</p> <p>Brand: Alaris Model#: 8100</p>	<p>CAREFUSION 303, INC.</p>	<p>The issue has been ongoing for a couple years but recently there has been an increase in the dim LED segments on the rate display of the Alaris 8100 Infusion pump module display boards. There is potential for harm due to the fact that the boards can be misread and numbers can be misinterpreted as another number. Photos attached. It seems most common with units that have a manufacturer time around 7/2014 and 8/2014 in our inventory. Many affected display boards were marked "Rev: 07". Between Oct 2015 and March 2018 100 displays have had the issue and needed replacing. The hospital has been replacing the boards but it comes at a significant cost and amount of time. Becton Dickinson was notified of the problem and their response is attached where the problem is acknowledged but a clear plan on how to correct this issue is not provided.</p> <p>Please see picture below:</p>

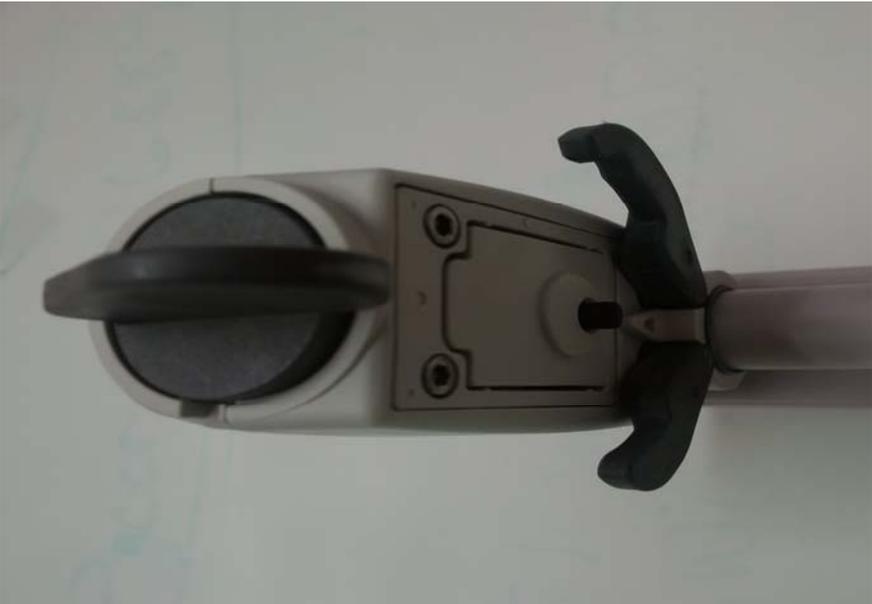
<p>Carefusion 303, INC.</p>	<p>During a syringe pump fentanyl infusion to an infant, the pump alarmed that the dose was complete though it was noted to have 0.3 ml of dose remaining. Examination of the syringe module revealed that the clasp mechanism that closes around the top of the plunger was not closing properly. Infusion was completed on a different pump.</p> <p>Please see picture below:</p>
