June 2017

Volume 17, Issue 6

## HIGHLIGHTED REPORTS

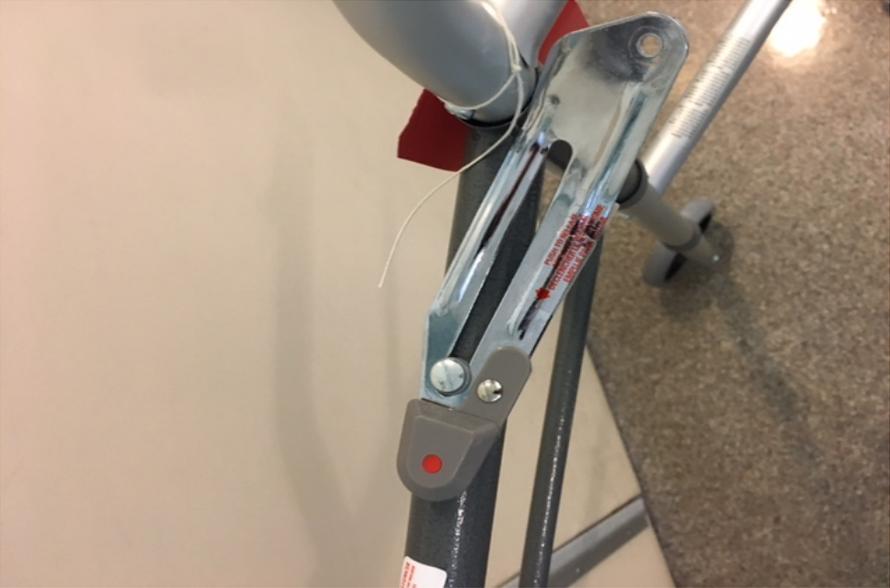
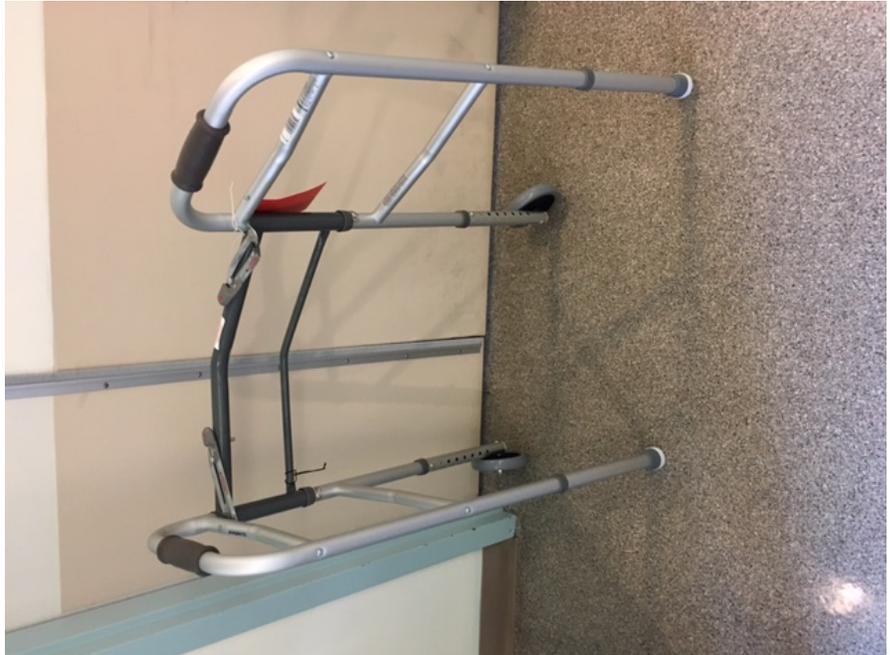
Device	Manufacturer	Problem
<p><b>Walker</b></p> <p>Brand: Guardian Signature</p>	<p>Medline Industries, Inc.</p>	<p>The patient was found on the floor calling for help. While holding on to her walker, the patient reached for something on the window sill. The patient reported that the walker broke causing her to fall. Please see pictures below:</p>
