September 2017

Volume 17, Issue 9

HIGHLIGHTED REPORTS

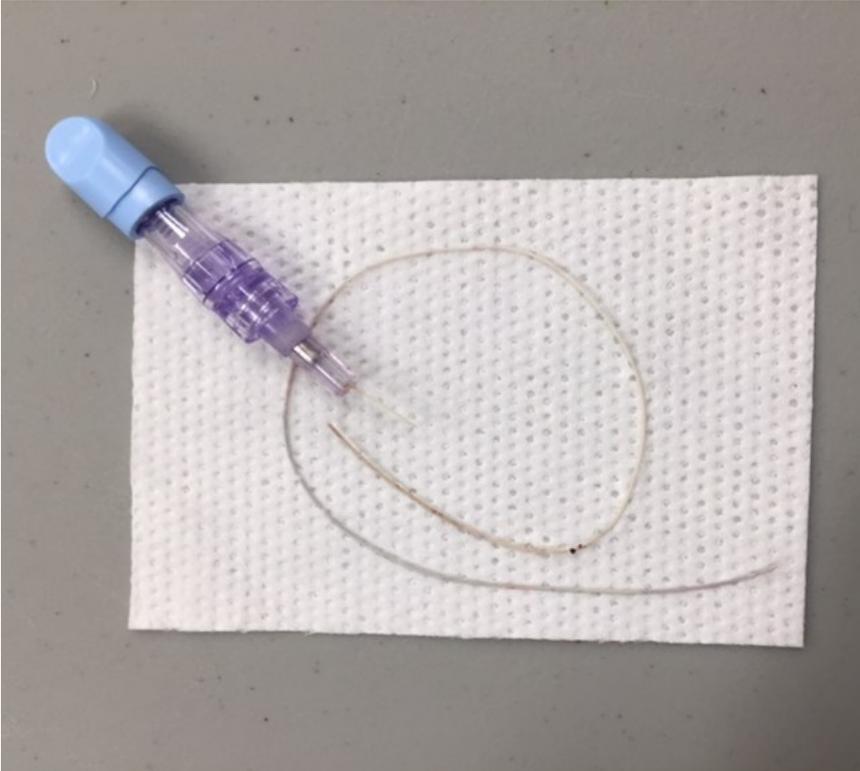
<p>Catheter, Intra-vascular, Therapeutic, Long-term Greater Than 30 Days</p> <p>Brand: L-cath™ S/I Picc S/I</p> <p>Model#: 26GA (1.9F) x 30cm</p> <p>Lot #: 11162385</p> <p>Cat #: 384539</p>	<p>Argon Medical Devices, Inc.</p>	<p>Nurse was discontinuing a PICC line that was no longer needed. She carefully removed the tape, cotton balls and opposites, one layer at a time. When she pulled back the cotton balls, she saw the PICC line sitting on top, with it open and dripping IV fluid. It was quickly clamped it off, and nurse proceeded to remove the PICC per protocol. The line had somehow become severed or ripped right up from the hub about 1 cm. The rest of line was intact. Temporary harm requiring intervention but no lasting issues with patient.</p> <p>Please see picture below:</p>

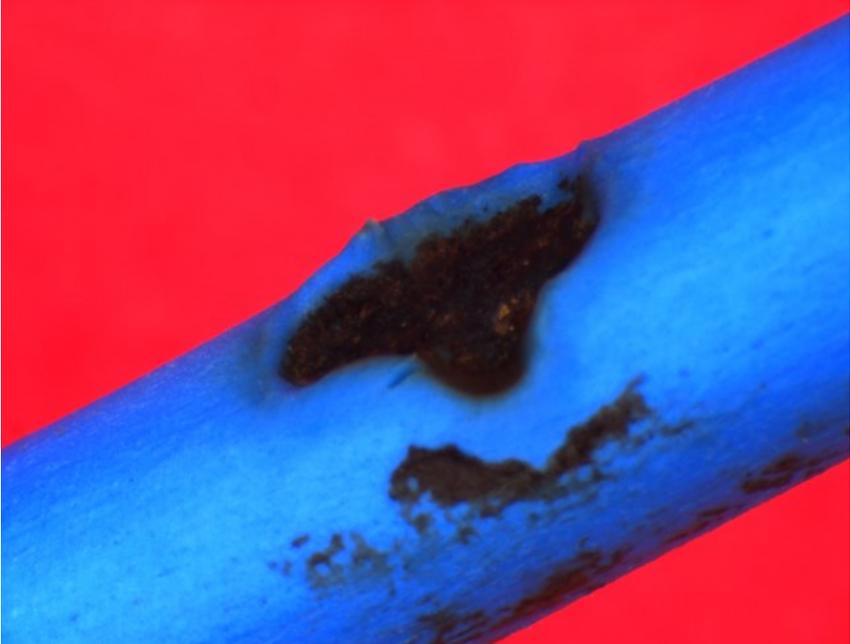
Device	Manufacturer	Problem
<p>Electrosurgical, Cutting & Coagulation & Accessories</p> <p>Brand: Edge</p> <p>Model#: E1465</p> <p>Lot #: 70300264X</p> <p>Cat #: E1465</p>	<p>Covidien LP</p>	<p>During breast augmentation procedure, surgeon noticed outer edge of left nipple where incision was, burned prior to inserting the breast implant. The insulation on the outside of the insulated needle tip cautery was found to have two small areas where the insulation was not there. A new needle tip and a hand held cautery were opened. All items were retrieved and will be returned to the manufacturer. Surgeon repaired the burned area and completed the procedure as planned with no serious injury to the patient. Clinical Engineering viewed the needle tip under a light microscope. Images are available of the torn insulation. Hospital will be returning the product to manufacturer for failure analysis.</p> <p>Please see picture below:</p>

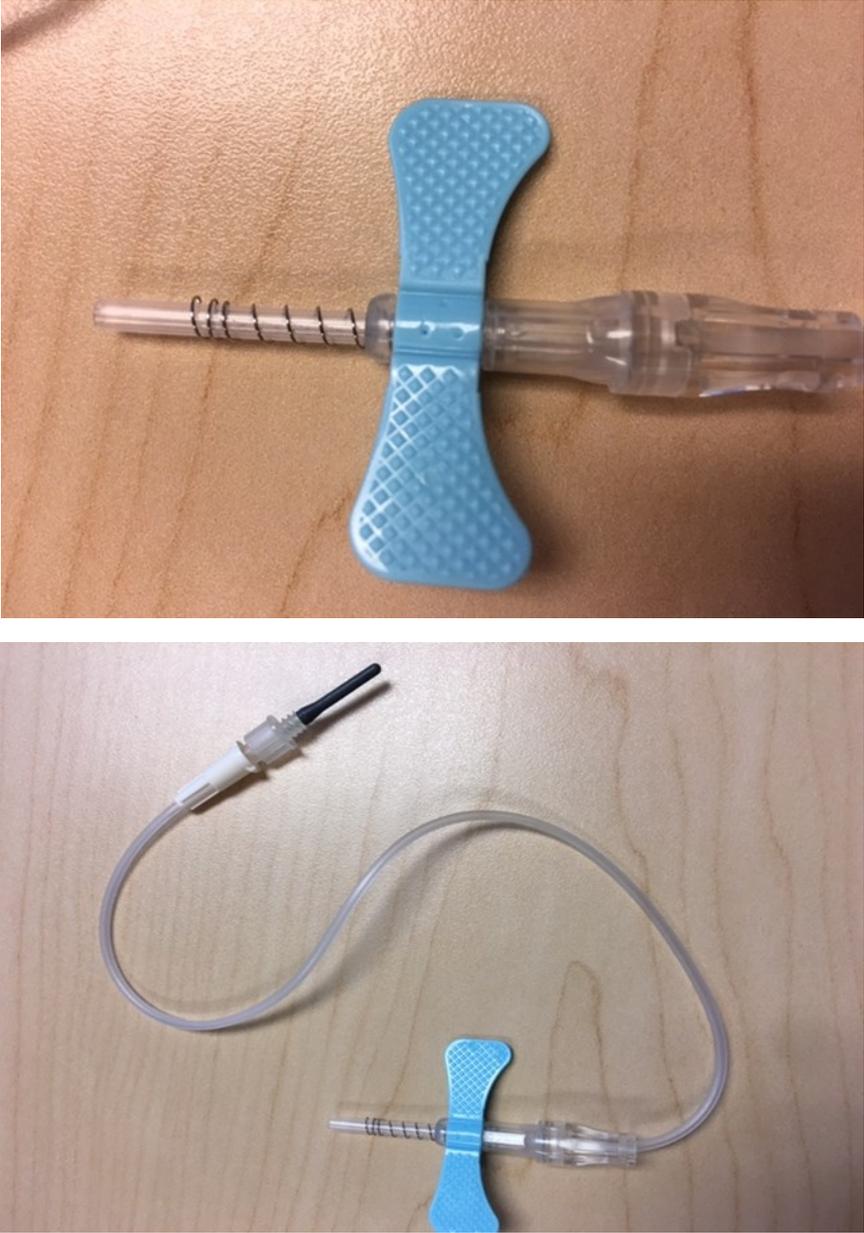
Device	Manufacturer	Problem
<p>Device 5: Pack, Hot Or Cold, Water Circulating</p> <p>Brand: Polar Care Cube Lot #: 272180610 Cat #: 10701 Other #: L57</p>	<p>Breg, Inc.</p>	<p>Patient E. Polar Care Cube is leaking at the end of the hose where it attaches to the pad that goes on the patient's knee. It was replaced with a new one and the defective one sent to risk management</p>
<p>Set, Admin- istration, Intra- vascular</p> <p>Brand: BD Vacutainer UI- tratouch Push Button Blood Collection Set</p> <p>Lot #: 7156633 Cat #: 367364</p>	<p>BECTON, DICK- INSON AND COMPANY</p>	<p>Unused device was packaged with spring outside of the needle guard.</p> <p>Please see pictures below:</p>
