November 2017

Volume 17, Issue 11

HIGHLIGHTED REPORTS

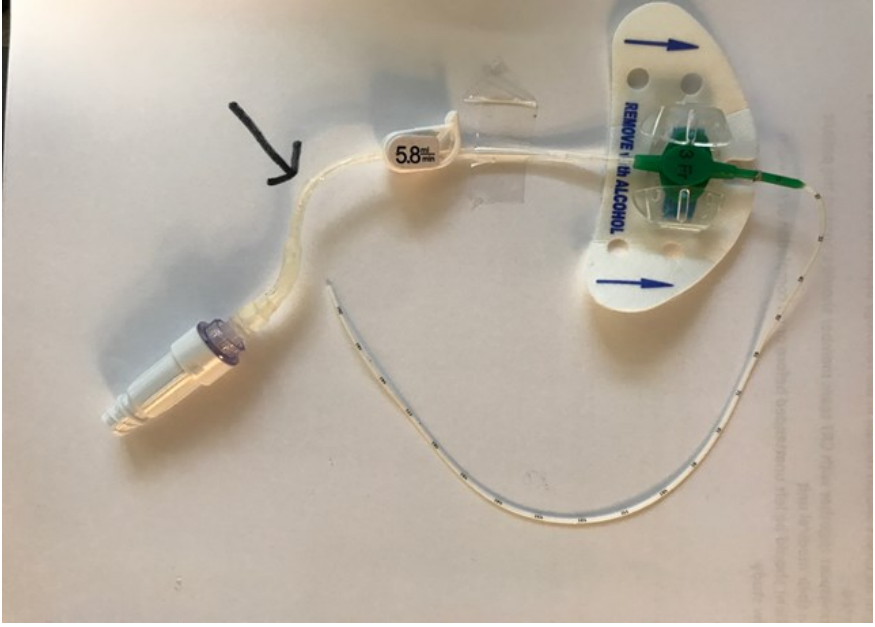
Device	Manufacturer	Problem
<p>Device 1: Injector And Syringe, Angi- ographic</p> <p>Brand: Stellant Ct Injector Sys- tem</p> <p>Device 2: Midline Periph- eral Catheter</p> <p>Brand: Bard Midline Catheter</p>	<p>Bayer Medical Care Inc.</p>	<p>Patient had a midline catheter upon her arrival for her CT Scan. The midline catheter connected to the injector split when the contrast was being injected. The midline was removed and the sending facility was contacted to report the incident.</p> <p>Please see picture below:</p>

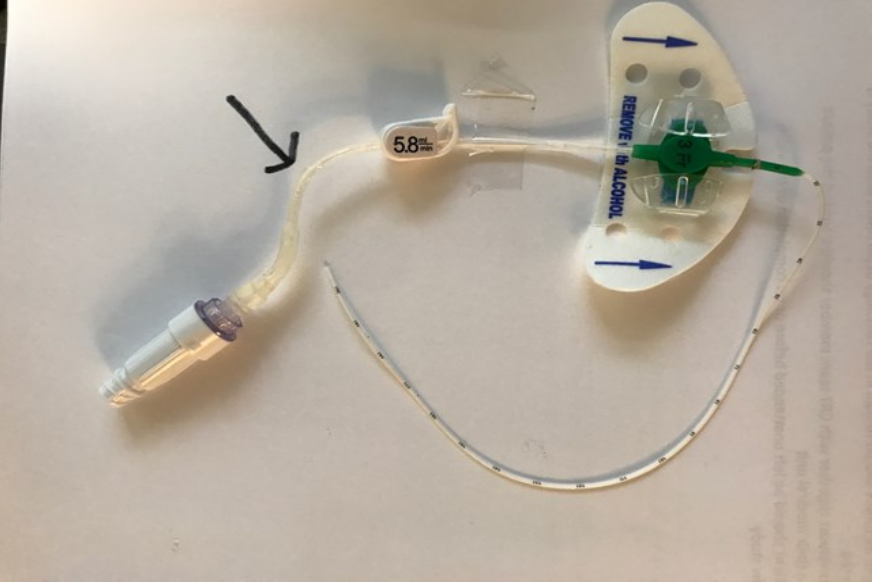
Device	Manufacturer	Problem
<p>Device 1: Injector And Syringe, Angiographic</p> <p>Brand: Stellant Ct Injector System</p> <p>Device 2: Midline Peripheral Catheter</p> <p>Brand: Bard Midline Catheter</p>	<p>Bayer Medical Care Inc.</p> <p>Bard Access Systems, Inc.</p>	<p>Patient had a midline catheter upon her arrival for her CT Scan. The midline catheter connected to the injector split when the contrast was being injected. The midline was removed and the sending facility was contacted to report the incident.</p> <p>Please see picture below:</p>

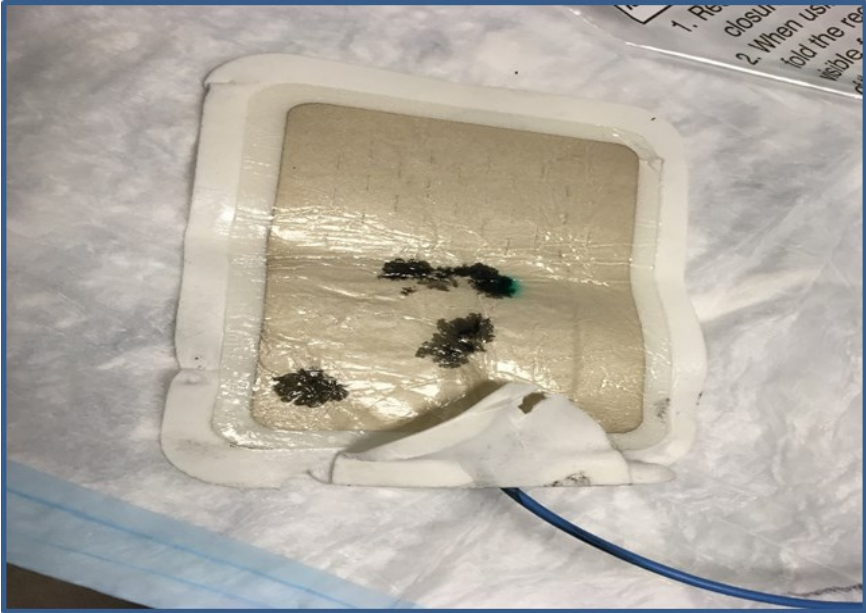
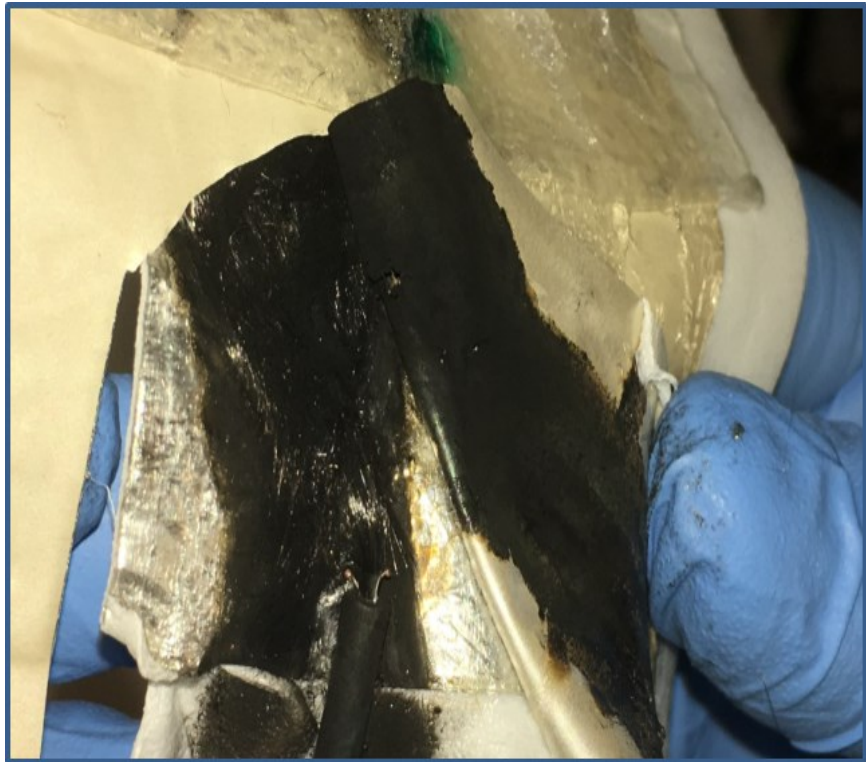
Device	Manufacturer	Problem
<p>Pacemaker, Cardiac, External Transcutaneous (Non-invasive)</p> <p>Brand: Lifelinks (Adult) Model#: P-211-Z1 Cat #: P-211-Z1 Other #: TZ transparent Defibrillator pads (TZ Medical Defib Pads (P-211-Z1))</p>	<p>TZ Medical, Inc.</p>	<p>During defibrillation of patient, staff states there was a "pop" noise and smoke from the defibrillator pads. Patient was successfully defibrillated at 200J using the TZ Medical Defib Pads (P-211-Z1) attached to the high output defibrillator in the OR. Soot was seen at the left lateral side of the patient and defibrillator pad. Pads were immediately removed from patient and replaced with a new set. No burns were apparent on patient skin noted, device and pads taken out of service for further evaluation.</p> <p>Please see pictures below:</p>
