February 2018

Volume 18, Issue 2

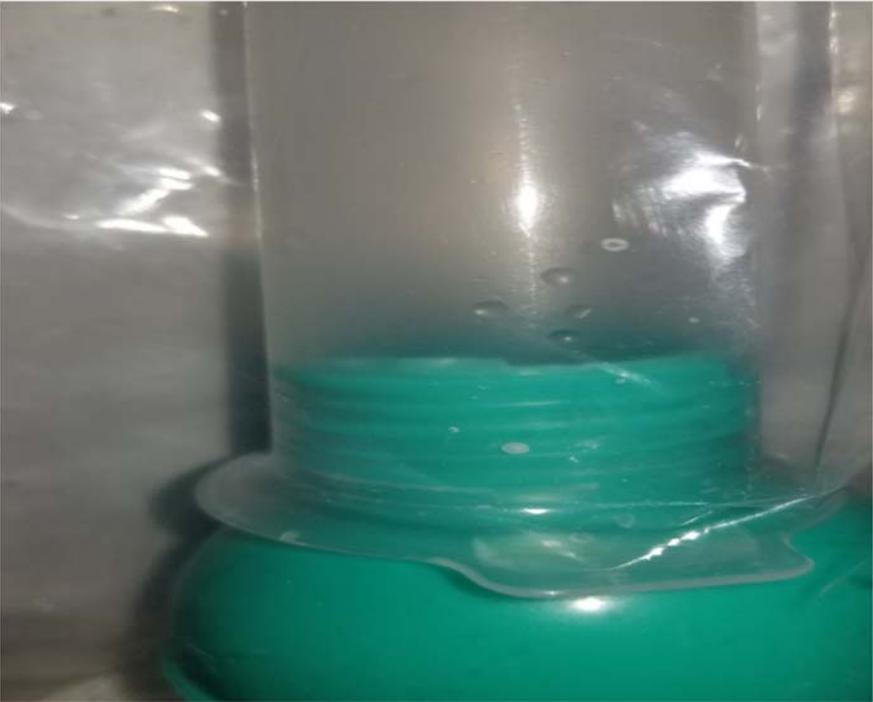
Device	Manufacturer	Problem
<p>Syringe, Irrigation</p> <p>Brand: Bard® Bulb Irrigation Syringe</p> <p>Cat #: 0035280</p>	<p>C. R. Bard, Inc.</p>	<p>EP Physician was creating a skin pocket for the insertion a pace-maker. Part of that process is to use a 50cc bulb-type syringe to irrigate the newly created pocket. As he was completing the final inspection of the pocket, the EP Physician noticed a 2 to 2.5 cm long very thin sliver of green plastic or rubber sitting in the bottom of the skin pocket. It appears to be from the bottom edge of the green bulb which sits inside the syringe portion of the bulb-syringe device. When I look through the clear plastic of the syringe portion, I can see that the neck edge of the green bulb it not smooth. Part of the bulb still has a rough edge remaining and attached.</p> <p>It's very apparent that the selvage edge at the neck of the bulb was where the green sliver broke off and the sliver was propelled into the skin pocket during the irrigation process. To my eye, the sliver which broke off seems to be a by product of the manufacturing process. There was no harm to the patient and the sliver was quickly removed. I have both the bulb syringe and the green plastic/rubber sliver which was retrieved in my office. I have already contacted the company rep so they can send me the box to return the items to the company.</p> <p>Please see pictures below:</p>
