March 2018

Volume 18, Issue 3

HIGHLIGHTED REPORTS

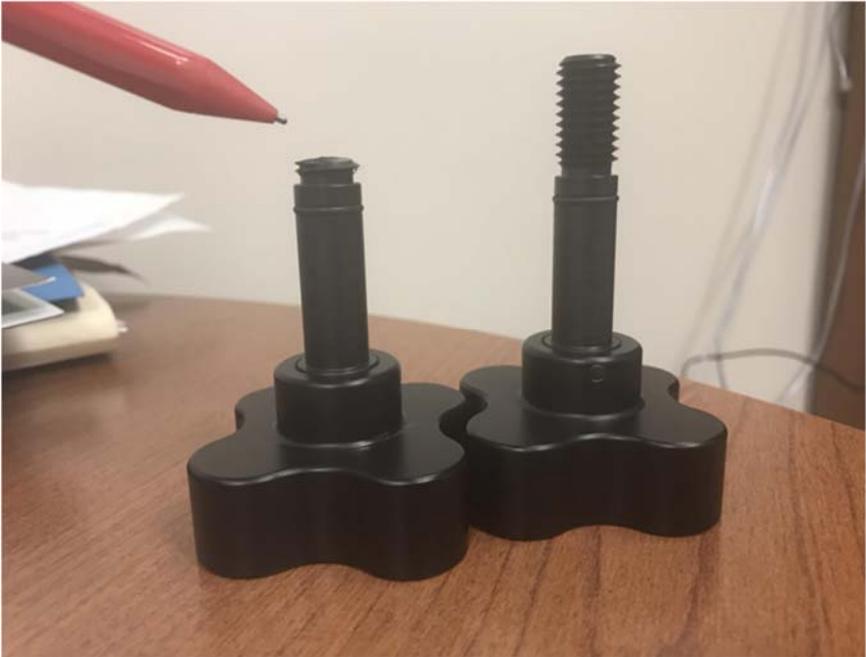
Device	Manufacturer	Problem
<p>Device 1: Holder, Head, Neurosurgical (Skull Clamp)</p> <p>Brand: Mayfield Infinity Xr2</p> <p>Cat #: A2114</p> <p>Device 2: Knob Assembly, Base Unit</p> <p>Brand: Mayfield Infinity Xr2</p> <p>Cat #: 437A2409</p> <p>Device 3: Base Unit, Accessories, Operating-room, Table</p> <p>Brand: Mayfield Infinity Xr2</p> <p>Cat #: A2079</p> <p>Device 4: Swivel Adapter, Base Unit</p> <p>Brand: Mayfield Infinity Xr2</p> <p>Cat #: 437A2400</p>	<p>Integra Lifesciences Corporation</p> <p>Integra Lifesciences Corporation</p> <p>Integra Lifesciences Corporation</p> <p>Integra Lifesciences Corporation</p>	<p>The Infinity XR2 Radiolucent base unit (A2079) is attached to the OR table and then the skull clamp (A2114) is attached to the patient and then using the knob (437A2409) , the skull clamp is attached to the base. After tightening the knob (Standard Knob Assembly 437A2409) that holds the swivel to the skull clamp, the knob broke, forcing the patient's head which was in the skull clamp to become de-attached from the base. The patient's head was caught by the surgeon, so no injuries to the patient. This is a recurring event with the first occurring last summer, this report reflects the second event and there has been one more occurrence.</p> <p>Please see picture below:</p>

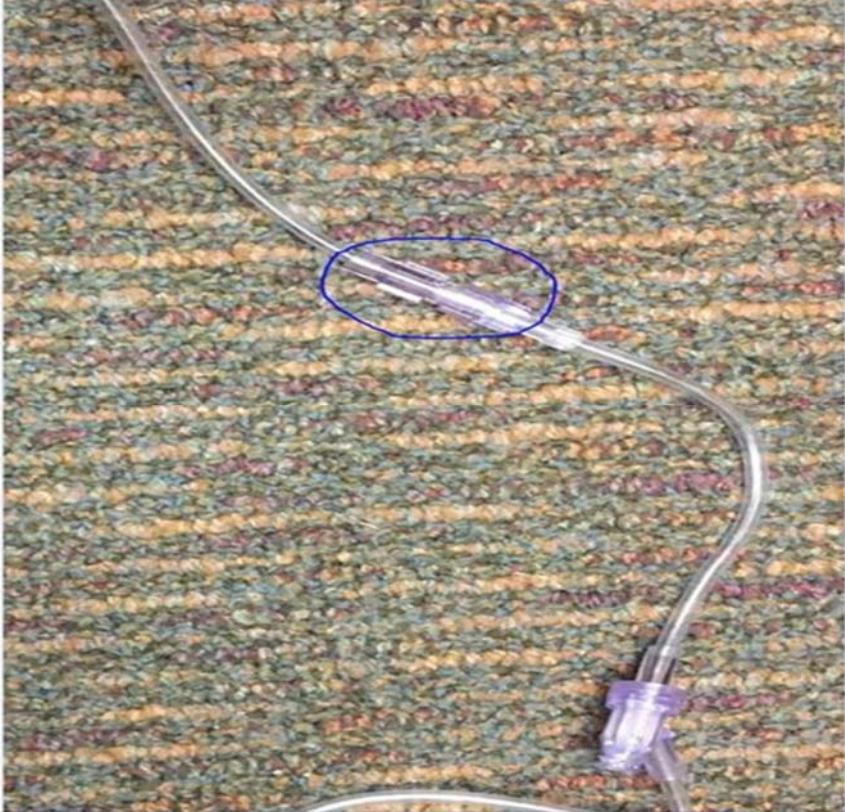
Device	Manufacturer	Problem
<p>Set, Administration, Intravascular</p> <p>Cat #: 470005</p> <p>Other #: Product Code US1505</p>		<p>While giving a break to the nurse in the room, it was brought to my attention by MD that the IV tubing has been coming apart spontaneously. The orderly in the room verified that this had been happening a lot lately. I asked if it was the patients from the Same Day unit and they both told me yes. The MD showed me the IV tubing and I could see it had broken apart at the point of the connection between the regular IV tubing and the extension. I told MD he had done an excellent job of "Stop and Resolve" and that I would follow up with the Same Day unit. I talked to the Same Day charge nurse about it and she told me it was the new tubing they have been using. She said the tubing comes with the extension already connected in the package and that is not something any of the Same Day staff assemble.</p> <p>She told me how it had come apart on her while inserting an IV and she told me it had come apart for another nurse on a patient he had in PACU. She showed me the tubing and then the two of us went to talk to the manager. We told her we had been having problems with the new IV tubing set and showed her the new connection. I told her I would write a report on it. The manager asked the RN to pass this on to the Same Day educators for skills day, which is coming up. The staff will be trained to double check the extension connection and tighten it. I told her I would let our educators know about it as well. The product is: Braun IV Administration Set15 drops/ml, REF#470005, product code- US1505 124in (315 cm).</p> <p>Please see picture below:</p>

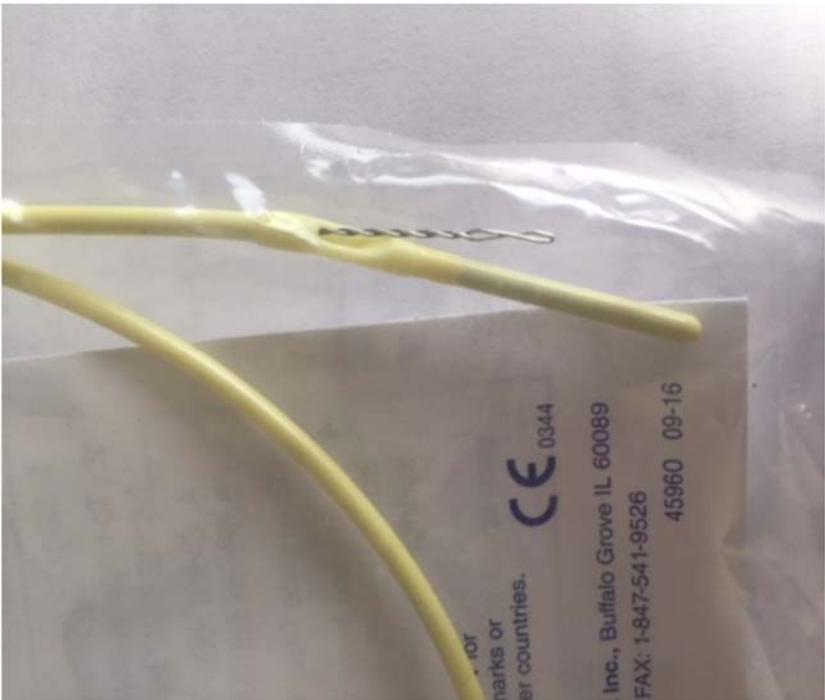
<p>Tubes, Gastrointestinal (And Accessories)</p> <p>Brand: Corflo Ultra</p> <p>Model#: 20-8366</p> <p>Lot #: 78923</p> <p>Cat #: 20-8366</p>	<p>Corpak MedSystems, Inc. (subsidiary of Halyard Health)</p>	<p>On inspection of 6F feeding tube prior to insertion, it was noted that the metal stylet was sticking out of one of the ports at the bottom of the feeding tube.</p> <p>Please see picture below:</p>

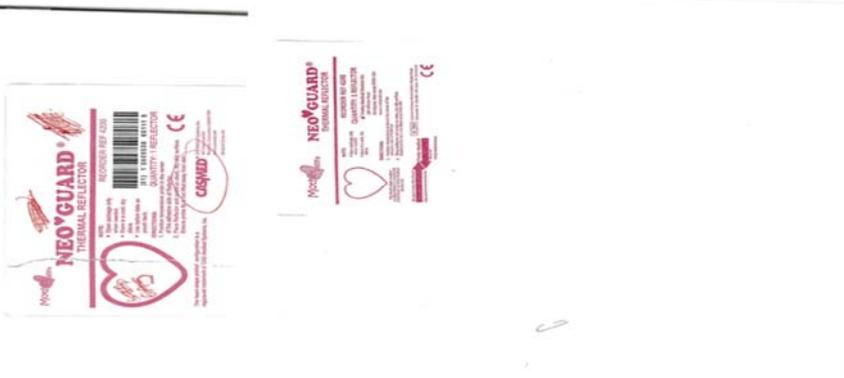
<p>Trinity Medical Devices, Inc.</p>	<p>NeoGuard Thermal Reflector provided by CAS Medical Systems was being used in the NICU without problems. The inventory was dropping and a reorder was issued to CAS Medical Systems. The facility was notified of a backorder. Once the backorder was filled the product arrived and was placed into use. The staff noted that the product that filled the backorder was harder to peel, more sticky and harder to remove from the patient. In addition the humidity in the isolette melted the thermal cover and the product was hard to remove from the patient.</p> <p>There was no harm to the patient. On closer inspection, the packaging of the replenished product while the same graphics, color, and name of the product in small print, it was noted the product now to be provided by Trinity Medical with a tagline in small print on the packaging: "same product, new owner". The product was removed from use in all areas and additional products are under trial use for selection of a new product.</p> <p>Please see picture below:</p>
