As of April 2, 2018

HIGHLIGHTED REPORTS

The reports that follow represent a cross section of device-related events submitted by MedSun Reporters during March 2018. The reports are displayed within clinical specialty areas based on analysis of the information submitted. The reports are presented as submitted by MedSun Representatives and in some instances have been summarized and/or edited for clarity.

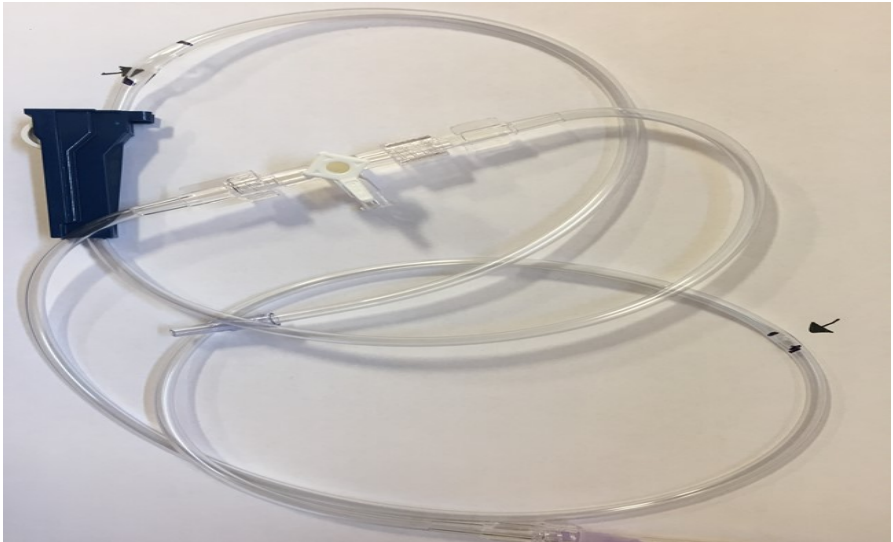
<p>General Surgery Tray</p> <p>Brand: Thoracentesis Tray</p> <p>Lot #: Tray:T1258413 Tubing:H1213855 Other #: Thoracentesis Tray lot T1258413</p>	<p>MERIT MEDICAL SYSTEMS, INC</p>	<p>This is one of several reoccurring kinked tubing incidents. While setting up for a thoracentesis procedure approximately a week ago at 10am, the custom fluid Management tubing demonstrated a kink. A new thoracentesis tray was opened. The tube from the newly opened tray was used as a substitute. Lot number for thoracentesis tray (T1258413). Lot number for custom fluid Management kit (H1213855). This tubing lot number differs from previously submitted reports. Please see picture below:</p>

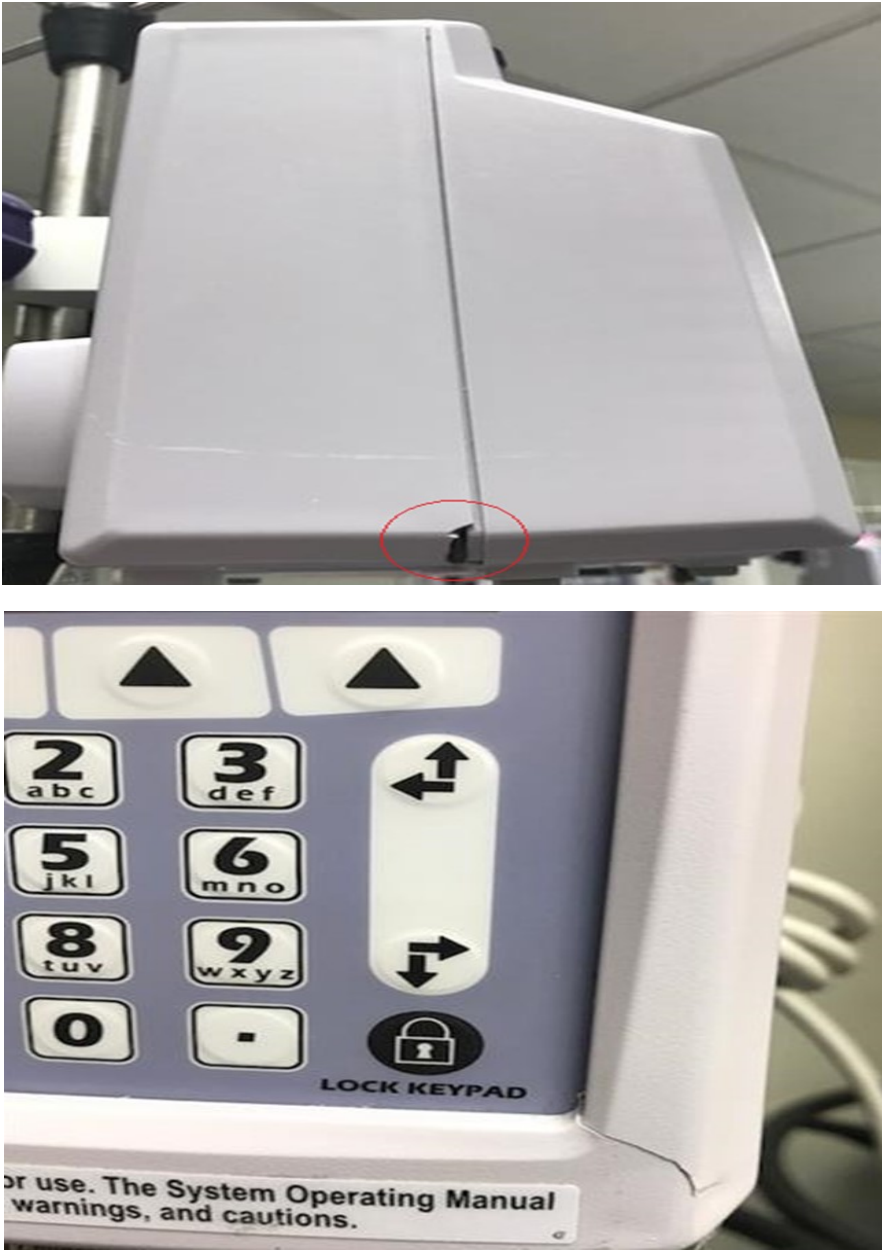
Device	Manufacturer	Problem
<p>Pump, Infusion</p> <p>Brand: Plum 360</p> <p>Model#: 30010</p> <p>Cat #: 30010</p>	<p>Hospira, Inc.</p>	<p>ICU Medical (Hospira's) Plum 360 units are deteriorating to the point of causing breakage on the stress joint points between the front and back casings. Hospira has been notified and we are replacing the broken cases. After investigation, it was determined by ICU Medical that our current cleaning agent is the one causing the deterioration of the plastic. We use CaviCide and it is currently been replaced by an approved ICU Medical cleaning agent.</p> <p>We wanted to report this as the damage on the casings utilizing CaviCide is extensive. By our experience, actual damage will start physically showing after @ 12 to 18 months after continuous cleaning and disinfection. A broken casing creates sharp edges that could cause an injury to the patient or device operator.</p> <p>Please see pictures below:</p>

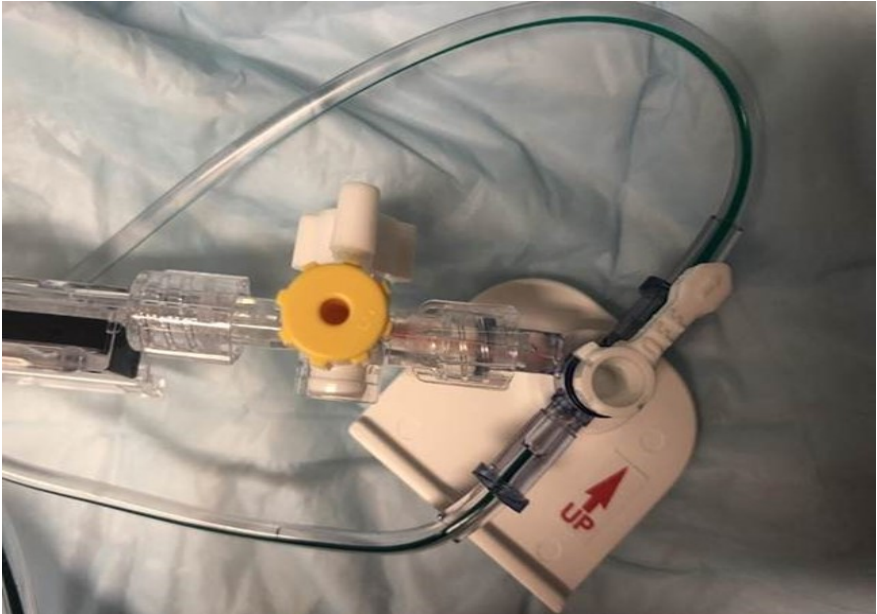
Device	Manufacturer	Problem
<p>Shunt, Central Nervous System and Components</p> <p>Brand: Limitorr Volume Limiting External Csf Drainage And Monitoring System</p> <p>Model#: INS9020SP1 Lot #: 1172935 Cat #: INS9020SP1</p>	<p>Integra Lifesciences Corporation</p>	<p>LimiTorr EVD/LSAD drain setup found to be broken at connection site, no obvious cause noted at the time. NS resident doctor notified to change EVD setup. Survey of staff found this had happened a few times before. Pictures were taken of broken device and lot number was noted.</p> <p>Please see picture below:</p>

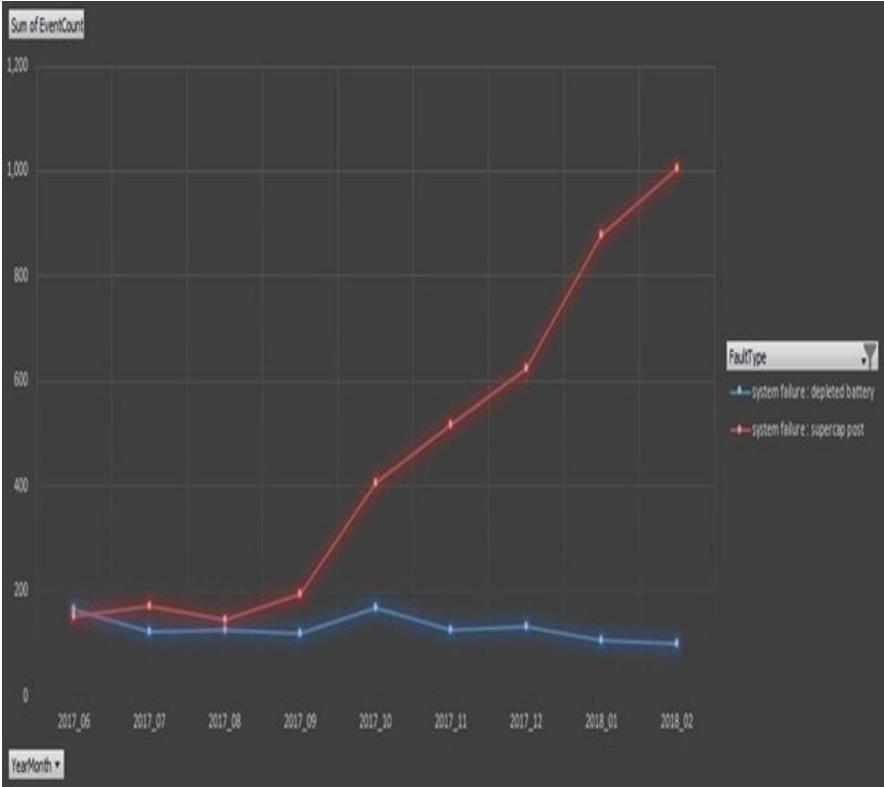
Device	Manufacturer	Problem																														
<p>Syringe Infusion Pump</p> <p>Brand: Med-fusion 4000</p> <p>Model#: 4000</p>	<p>Smiths Medical, Inc.</p>	<p>A large number of Medfusion pumps in our fleet have been showing the fault 'System Failure: Supercap Post'. The hospital has tried a few different ways of supporting the assets including battery and board replacements. Smith's medical has been notified but no progress has been made. The issue has been escalating since October of last year and the reports out of the Pharmguard server show the the number of unique serial numbers to have a 'System Failure: Supercap Post' fault has increased from 157 in September last year to 271 in February of this year. The number of 'System Failure: Supercap Post' events has increased from 383 to 1,193 in six months. This is out of a fleet of 707 Medfusion 4000 pumps. The surge in failures causes frustration for the staff because of the shortage of pumps. This has resulted in delays to care and submission of incident reports by staff.</p> <p>We have also analyzed the 'system failure: depleted battery' Events for the pumps which has actually declined over the same period suggesting that these supercap failures are a separate issue than the battery being run too long. When cycling the power of the same pump will sometimes come back normally and other times show the fault. The inconsistency makes it difficult to determine the root cause of the problem. See attached image of surge in 'System Failure: Supercap Post' faults.</p> <p>Please see picture below:</p>

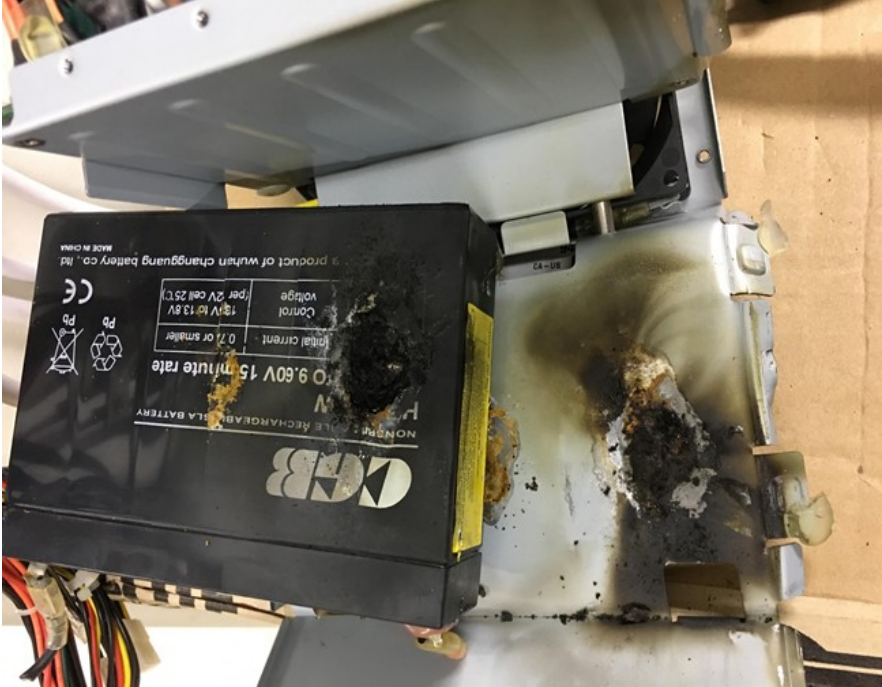
Device	Manufacturer	Problem
<p>System, X-ray, Fluoroscopic, Image-intensified</p> <p>Brand: Insight 2</p> <p>Model#: Insight 2</p> <p>Other #: XRY0358</p>	<p>Hologic Inc.</p>	<p>Biomed was called to the repair a c-arm at a remote clinic. We identified that the power supply was faulty. After investigating what on the power supply failed, we opened up the metal case of the power supply. (by force as this is not a case meant to be opened.)</p> <p>We found the battery had caught fire. (picture attached to this report) We called the vendor and asked if this battery was meant to be replaced. They stated it was not part of a pm. It served as a backup in case of power loss, much like a UPS. Our unit was approx. 5 years old.</p> <p>Please see picture below:</p>
