April 2019

Volume 19, Issue 4

HIGHLIGHTED REPORTS

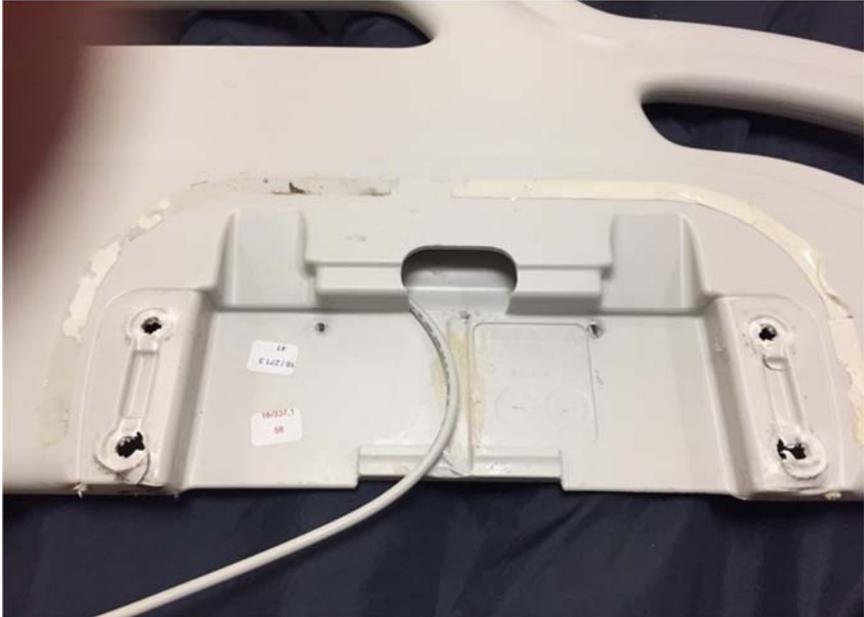
Device	Manufacturer	Problem
<p>Bariatric Bed, Ac-powered Adjustable Hospital</p> <p>Brand: Citadel Plus</p> <p>Model#: FX811B8B4AM ABB</p> <p>Cat #: FX811B8B4AM ABB</p>	<p>ArjoHuntleigh</p>	<p>Patient transferred from ICU to MedSurg room on a bariatric bed during the night. At 01:20 RN heard Bed alarm going off in one of the rooms. RN ran into the room and found the patient on his side facing the window with the lower left side rail completely separated from the bed. No visible injury noted but patient complained of side pain until he was placed in bed. RN deployed a patient lift to place patient back in same bed and RN provided sitter until replacement bed arrived. Patient transferred to replacement bed and failed bed was sequestered for follow up and reporting to Risk Mgt and Biomedical Engineering. Inspection of bed by Biomedical noted complete separation of side rail panel from mounting and locking frame. The mounting assembly still had 4 each mounting screws which were still attached to the side rail attachment rivets. Biomedical's MAUDE database search noted recent events involving loose and detached side rails with this model bed. Biomedical suspected that patient may have tried to kick side rail free in effort to exit bed, but determined cause may be different based on recent reported failures reviewed in the MAUDE database. Bed transferred to the Manufacturer for return and analysis. Biomedical to monitor and report any additional side rail failures and inform the rental agency not to move or position bed by the use of raised side rails.</p> <p>Please see pictures below:</p>

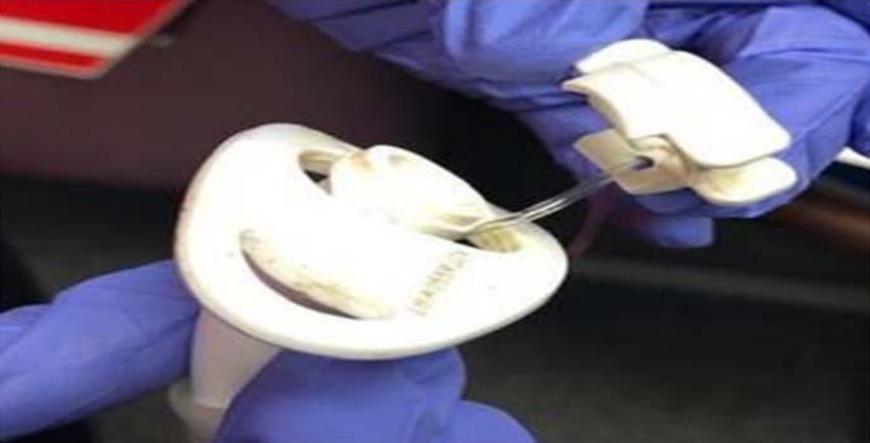
<p>Tube, Tracheostomy (W/wo Connector)</p> <p>Brand: Shiley</p> <p>Model#: 8PERC</p> <p>Lot #: 18A0559JZX</p> <p>Cat #: 8PERC</p>	<p>Covidien LP</p>	<p>Patient with tracheostomy placed. Eight days later, the registered nurse noted that a piece of the patient's tracheostomy tube was broken off of the main tracheostomy front plate. It was described as the end of the tracheostomy tube where the inner cannula locks into the tracheostomy - this end piece separated from the tracheostomy tube. The patient had been up in the chair and recently was moved back to bed without incident. There were no reports of the patient pulling at the device or other difficulties with the device. There was not apparent injury. The patient continued to pull appropriate volumes on the ventilator.</p> <p>Please see picture below:</p>

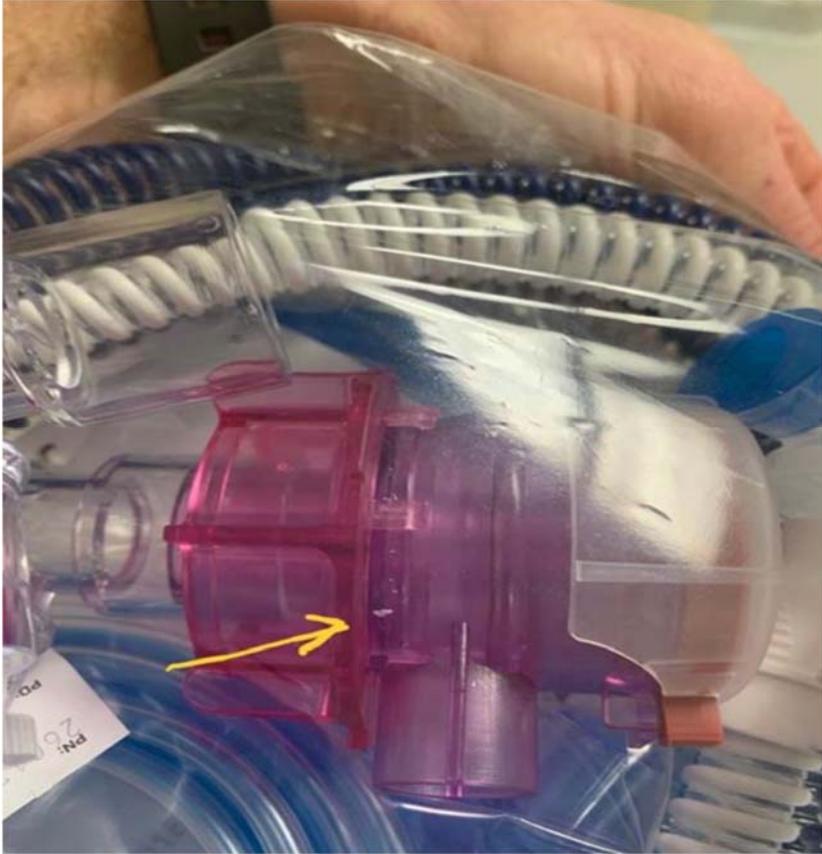
Device	Manufacturer	Problem
<p>Ventilator, Continuous, Exhalation Valve</p> <p>Model#: 260170/01</p> <p>Lot #: 201005970</p>	<p>Hamilton Medical, Inc.</p>	<p>Background: Earlier this month, it was identified that two lot numbers of Hamilton neonatal circuits had white debris surrounding and within the locking collar on the valve. These lots were pulled from service, Hamilton notified, and Life Flight notified of need to remove locking collar on the neonatal expiratory valve to clean it prior to use if white debris was seen upon visual inspection. Alternatively, we could replace the original valve with an individually-wrapped expiratory valve.</p> <p>About a week ago, the pediatric/neonatal team was dispatched to pick up a intubated patient by Life Flight and placed on conventional ventilation using the Hamilton ventilator, neonatal circuit, and expiratory valve (unknown lot number).</p> <p>Prior to use, the Hamilton neonatal circuit/valve passed tests. No alarms initially, but after departing facility, started to get occasional "disconnection on ventilator side" alarms. All connections double checked and they were all feeling well-seated. Return tidal volumes all within normal limits. The patient's transcutaneous monitoring (TCM) responded to titrations well. When not being jiggled, the Hamilton would not alarm. Roughly ten minutes out from airport, the alarm became more frequent. Still with good return tidal volume, good saturations, and TCM. Once in ambulance and in route to hospital the alarm was non-stop. The patient's PEEP titrated up to keep saturations greater than 90% and to assist in re-expanding previously-known collapsed right upper lung and bilateral areas of atelectasis with good result in TCM. One "Loss of PEEP" alarm seen at this time as well and one episode of loss of tidal volume associated with patient bearing down, which quickly returned to normal exhaled tidal volumes. A PEEP of 10 and sixty percent oxygen upon arrival to hospital. Receiving PICU team notified of technical ventilator concerns during sign out.</p> <p>Clinical Engineering contacted upon completion of flight to look at Hamilton, circuit, and valve. It was discovered that the circuit and valve had the white debris inside the locking collar as seen in previous lot numbers. Visual inspection of valve had been completed prior to placing the circuit on the ventilator and no debris was seen. Staff member also reported that it was easy to turn when she placed it in the Hamilton. When examined by Clinical Engineering, it would no longer turn at all. Clinical Engineering cleaned it out and it was easier to turn, but still did not move as freely as the peds/adult valves do, but did seat into valve lock. Circuit and valve left with night team. It was reported in the morning that "circuit ran for 30 minutes". It never failed the tightness tests or gave any alarms when running on the test lung with different settings.</p> <p>A locking collar that progressed from not having visible debris and being easily placed in valve lock to having visible white debris and no longer turning at all, combined with alarms that initially did not appear, then progressively became worse speaks to hidden debris. Clinical Engineering demonstrated how to remove back portion of valve to clean off and then replace.....</p>

Device	Manufacturer	Problem
		<p>Concern for known patient harm: possible that these alarms meant that our patient was not receiving the intended PEEP, which was likely true according to Clinical Engineering. Prior to going home, I returned to the PICU to deliver chart, evaluate patient, and ventilator settings. Patient had been weaned to PEEP of 8, but was now pressure-limiting with peak inspiratory pressures in the 31-32 range and saturations intermittently in the high 70's. It is possible that low saturations towards the end of the trip were probably a combination of the ventilator problems and the patient's inherent disease process.</p> <p>Concern for potential patient harm: if the white debris is in the expiratory valve; could it be in other parts of the circuit? i.e on the inspiratory side where it could potentially be forced into patients' lungs?</p> <p>Concern for potential patient harm: cleaning method of using non-sterile water to clean a ventilator circuit could present a risk of contamination to the patient. Lots involved: 201005970, 2022669(valve only), 201009251 and 201003740(full circuit). Seven sets have been identified. Six found prior to use and one on the above patient. Per site reporter, the rep has been very responsive. She overnighted a different product in that can be used. We will be returning the sets that weren't used on patients for further investigation. The rep also reported that a couple of other facilities have reported this issue.</p> <p>Please see picture below:</p>
