August 2019

Volume 19, Issue 8

HIGHLIGHTED REPORTS

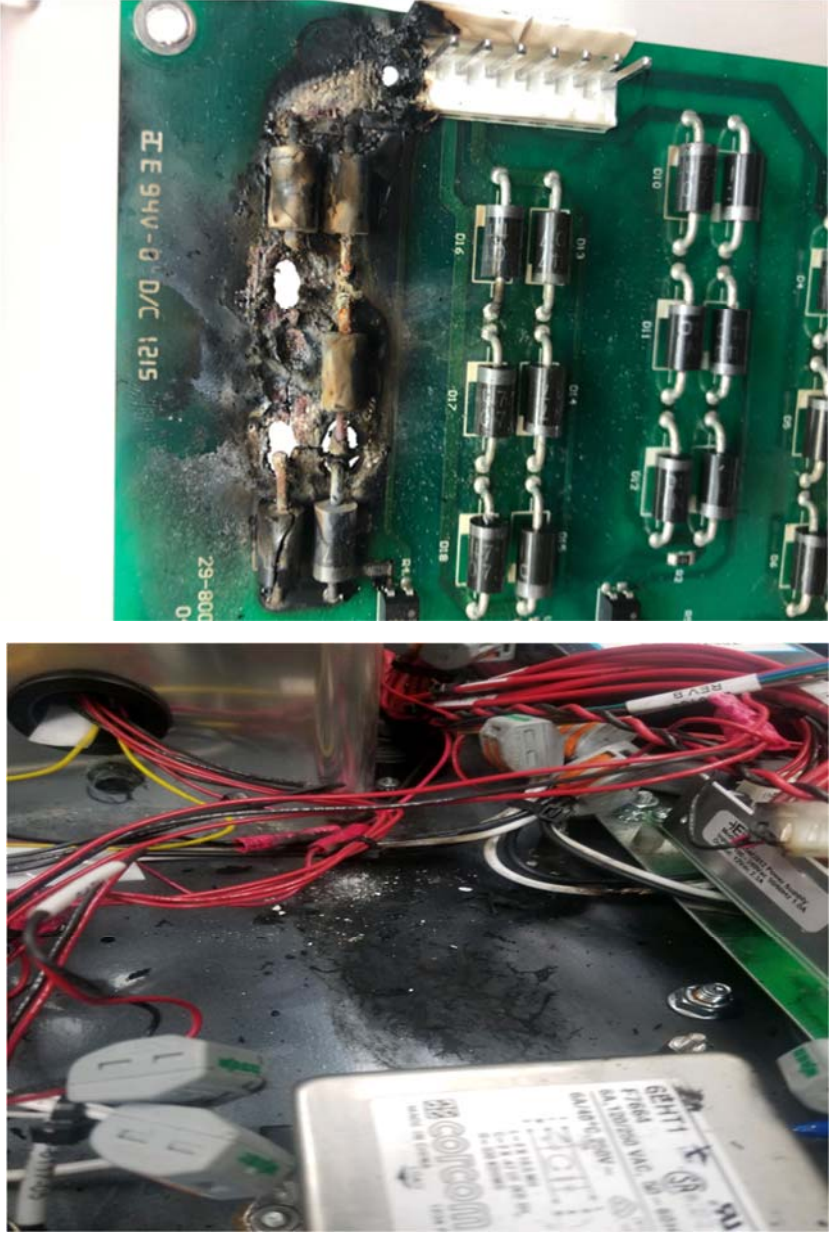
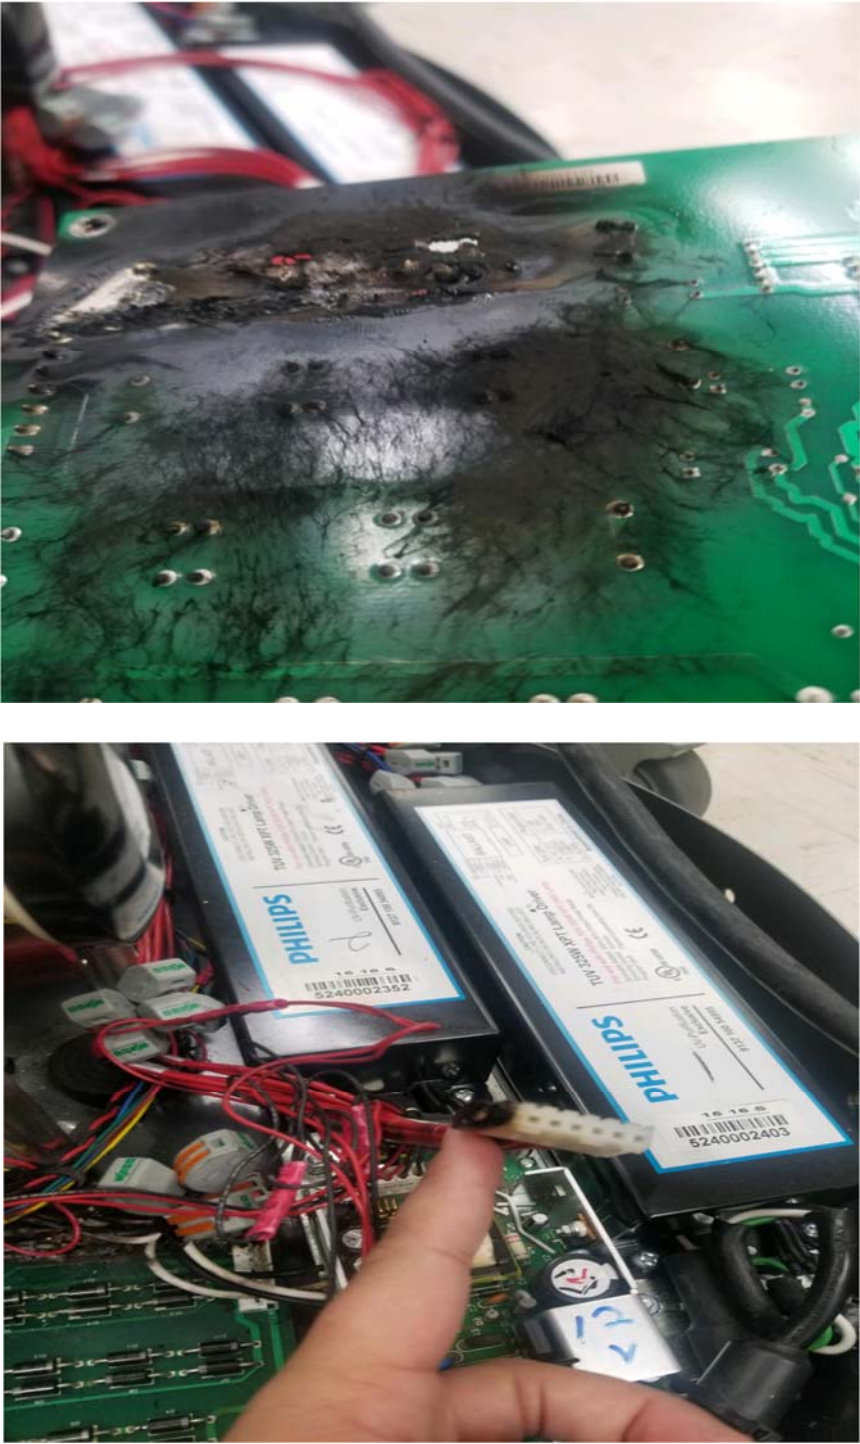
Device	Manufacturer	Problem
UV Disinfection Tower Model#: 29-5100	Clorox Healthcare	<p> Clinical Engineering received a call indicating that a circuit breaker kept tripping when the UV tower was plugged in. While inspecting the device, it was noted that one of the circuit boards appeared to have been on fire. Significant burn damage was noted on the circuit board and associated connector. Also noted 1)the electronics for this device are all located in the base and there does not appear to be a fluid barrier on this device 2) every other relay on the printed circuit board appears to have excessive residue on the insides of the relays (this is true of the relays on all devices that were inspected.) </p> <p> This event happened in the OR, which of course is an oxygen enriched environment, making this event especially concerning. Per hospital, the vendor came on site and inspected all devices. </p> <p> Please see pictures below: </p>

<p>The top photograph shows a close-up of a green printed circuit board (PCB) that has been severely damaged. A large, irregular area of the board is covered in a thick, black, charred residue, likely from a fire or electrical short. The surrounding green PCB material is visible, along with several circular holes and traces. A red ribbon cable is partially visible in the upper left corner.</p> <p>The bottom photograph shows the internal components of a device, including two Philips power supplies. The power supplies are black with white labels. The left power supply has a label with the Philips logo and the text "PHILIPS" and "5240002352". The right power supply has a label with the Philips logo and the text "PHILIPS" and "5240002403". A hand is holding a white ribbon cable connector, which is plugged into a port on the right power supply. Various other components, including capacitors and wires, are visible in the background.</p>
