January 2020

Volume 20, Issue 1

HIGHLIGHTED REPORTS

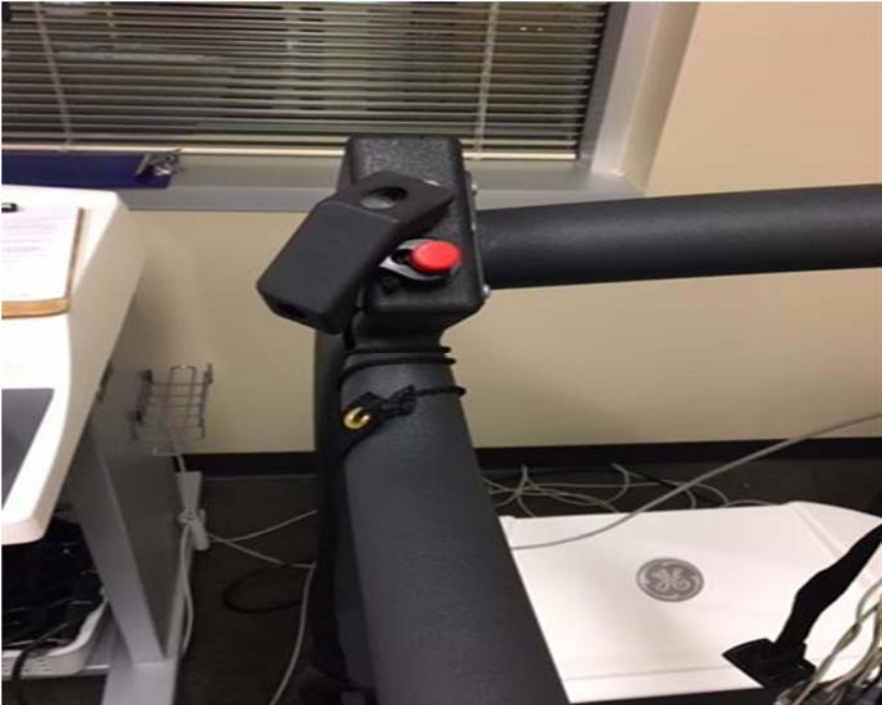
Device	Manufacturer	Problem
<p>Treadmill, Powered</p> <p>Brand: Ge T2100 Treadmill</p> <p>Model#: T2100 Cat #: T2100-ST2</p>	<p>GE MEDICAL SYSTEMS INFORMATION TECHNOLOGIES, INC.</p>	<p>Patient was having exercise stress test. After 12:02 minutes the stop button was accidentally deployed on patient's Left grab bar as RN was taking BP while patient was walking on TM (Tread Mill). The Left grab bar has an automatic stop button in addition to a pull cord from underneath the bar. This caused treadmill to suddenly stop which did not cause patient harm. This caused the treatment portion of the test to be reordered and restarted.</p> <p>This design appears to be a poor design when staff approach patient from the patient's Left side. Clinical Engineering staff attached a plastic button cover with Velcro to prevent the automatic stop button from accidentally being pushed while nurses are attending to the patient.</p> <p>Please see picture below:</p>
