**June 2020**

**Volume 20, Issue 6**

**In This Issue:**

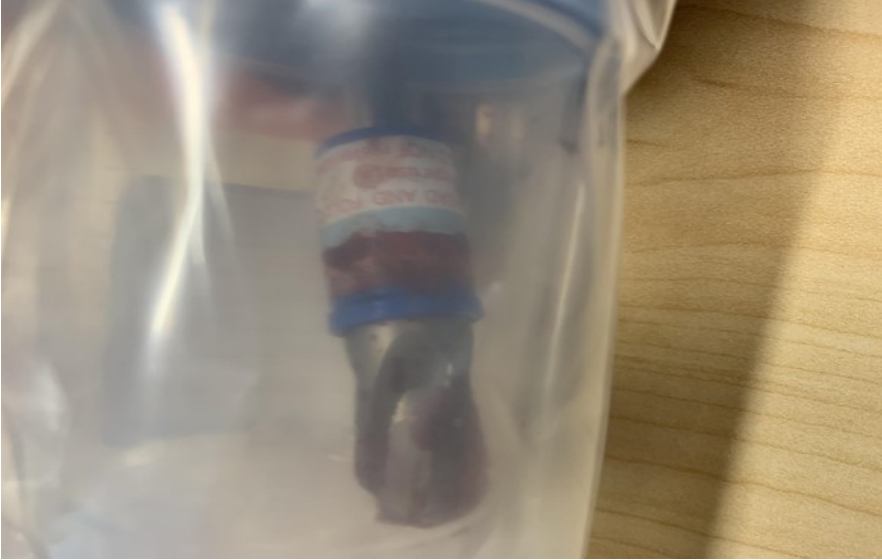
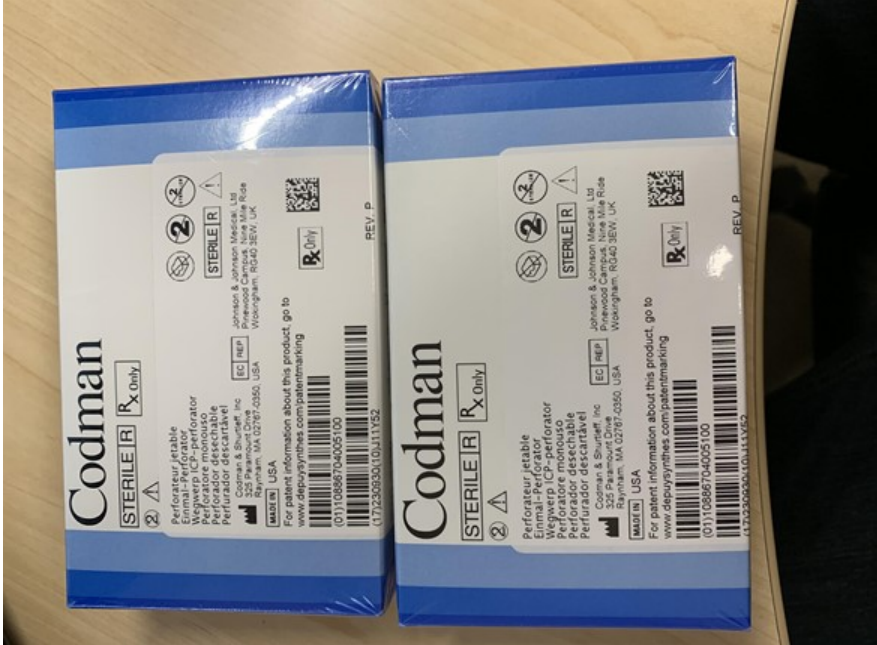
Device	Manufacturer	Problem
<p><b>Drills, Burrs, Trephines Accessories (Compound, Powered)</b></p> <p>Brand: Codman</p> <p>Model#: 26-1221</p> <p>Lot #: J11Y52</p> <p>Cat #: 261221</p>	<p>CODMAN &amp; SHURTLEFF, INC</p>	<p>During a craniotomy procedure, a perforator used to drill through the skull did not function as intended. Normally the usual CODMAN disposable perforator bit will stop as you breach the skull as to not affect the brain or dura. This one did not stop and resulted in torn dura and a small nick (cut or notch) to the brain. Surgeon reported that this was not the first bit to do this in the last week. No serious injury to the patient was noted during or after the incident. Requested product, CODMAN Disposable Perforator Drill, was returned to Integra Lifesciences.</p> <p>Please see pictures below:</p>
