August 2020

Volume 20, Issue 8

HIGHLIGHTED REPORTS

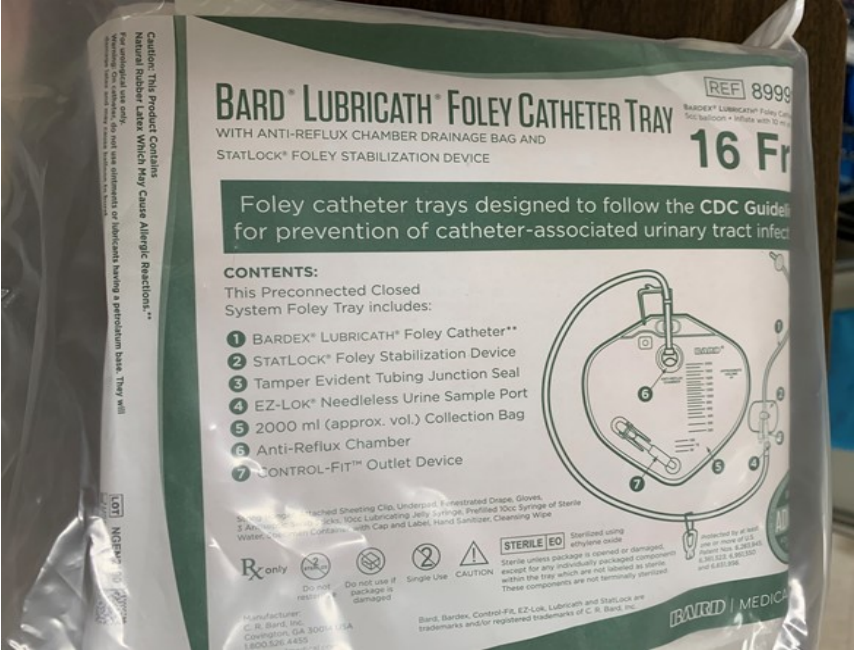
Device	Manufacturer	Problem
<p>Catheter, Coude</p> <p>Brand: Bardex® Lubricath® Foley Catheter Tray</p> <p>Model#: 899916</p> <p>Cat #: 899916</p>	<p>C. R. Bard, Inc.</p>	<p>The concern with this event was that the packaging doesn't make it very obvious that the product contains latex. Even though RN was aware of patient's allergy, they were not aware that product contained latex since it is not clearly marked. We can send one of these to the manufacturer if needed, but we wanted to raise this concern more in regard to the product labeling (which led to this adverse event) rather than product being contaminated or containing a compound that was not listed.</p> <p>Please see picture below:</p>

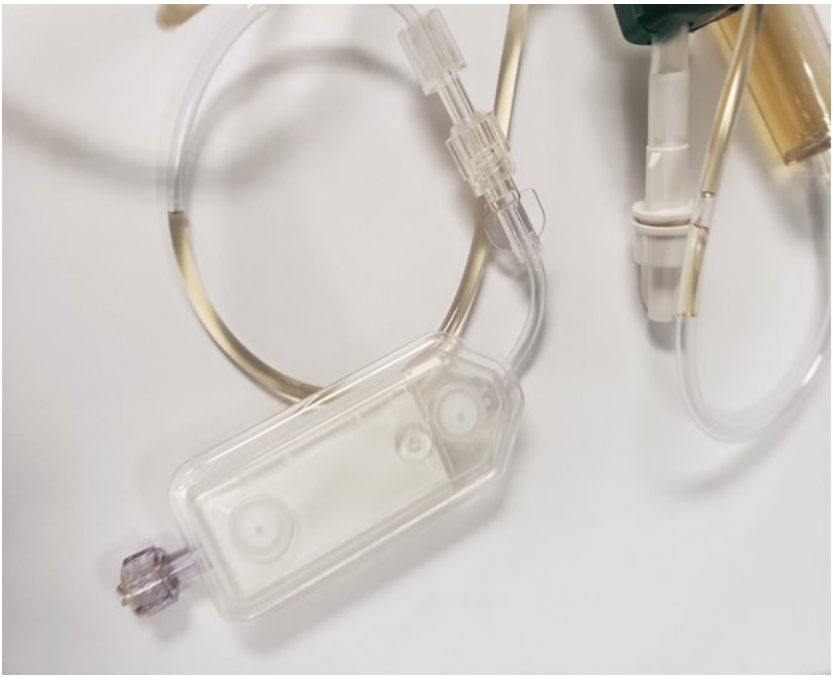
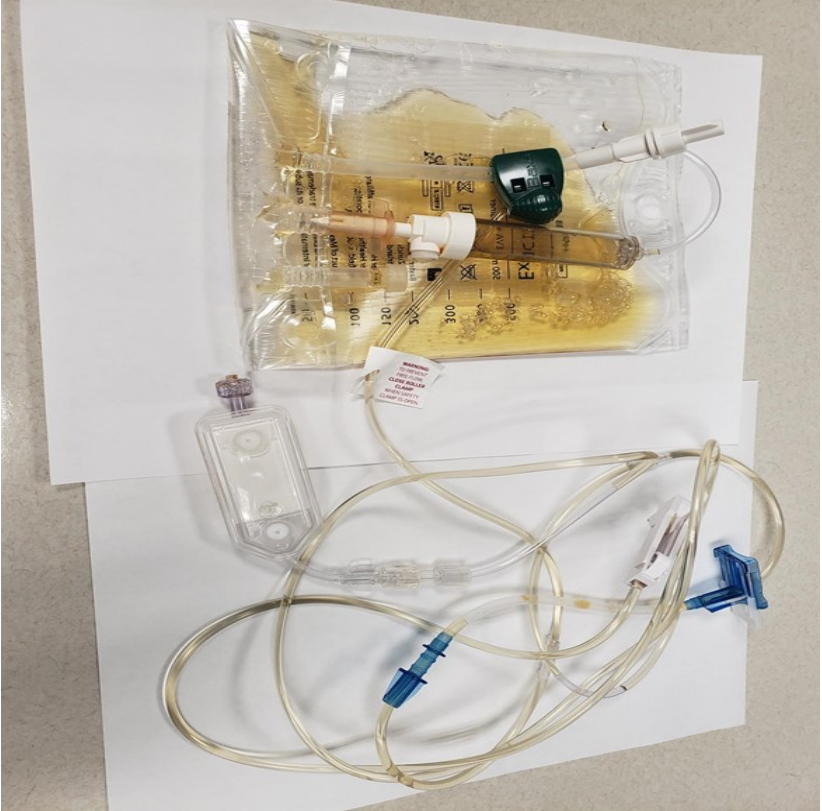
<p>ICU Medical, Inc.</p>	<p>There has been three separate events in the NICU involving the use of the ICU Medical B1729 Luer Lock Extension Set with 0.2 Micron Filter. The first event (EVN20034144) noted the malfunctioning of a B1729 IV Ext Set connected to an umbilical venous catheter (UVC). When the micron filter was placed at the same level as the newborn patient, the UVC bled back into the IV line and tubing. The micron filter worked as expected when held in the "house up" position. The IV flow rate during this event was 17.5 mL/hr. The issue with the B1729 Ext Set started when the filter had to be added to the no-port IV tubing. The 0.2 filter is shorter than the filters used in the past which are 14 cm in total length.</p> <p>The second event (EVN20029089) involved blood backing up in the UVC line using the B1729 micron filter connected to a BD Alaris IV infusion set. The BD IV pump was used to infuse fluids at a rate of 7.3 during a total parenteral nutrition (TPN) procedure. RN noted the presence of blood in the line and called the physician. Health care providers noted that fluid started to flow normally on the IV set when the filter was held in a vertical position (up higher in the air). Blood started backing up in the line immediately after the filter was lowered back down despite using a 7.3 pump rate. A large amount of backed up air was noted on the filter as well. The filter is being used a substitute product to a shortage of the regular product due to COVID-19.</p> <p>The third event (EVN20028764) involved the use of a dual lumen UVC, large volume bag and a syringe pump infusing fluids into a patient. The issue started with the infusion of gentamicin. All pumps began alarming occlusion and neither the outgoing nurse nor the neonatal nurse practitioner were able to flush line/lumen. It is unclear if the infusion into the lumen was from the large volume bag or syringe pump. Physician was called to assess line. Physician was able to get line to flush sluggishly. Physician ordered fluids to be infused by syringe pump only, and to loosen sutures on UVC for being too tight. Fluids were able to be infused into UVC without incident afterwards.</p> <p>Please see pictures below:</p>
