March 2021

Volume 21, Issue 3

HIGHLIGHTED REPORTS

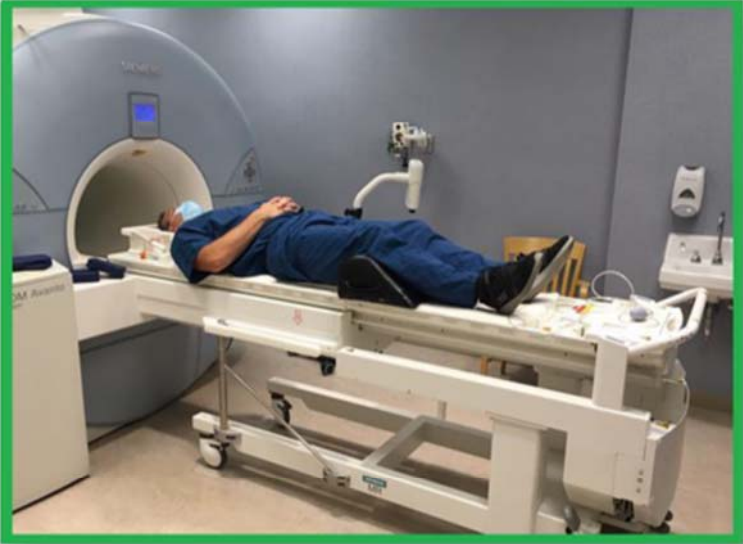
Device	Manufacturer	Problem
<p>System, Nuclear Magnetic Resonance Imaging</p> <p>GmbH</p> <p>Brand: Magnetom Avanto 1.5t</p> <p>Other #: 129028</p>	<p>Siemens Healthcare</p>	<p>Patient's finger was pinched in table trolley system on MR28 during lowering of the scanner bed after completion of scanning. Patient was sitting upright and their fingers were in the gap, and subsequently injured. Left 3rd digit tip was degloved. Patient sent to ED w/wife via ambulance for further evaluation and treatment (amputated part sent with patient in sterile container on ice).</p> <p>Please see pictures below:</p> <p>CORRECT POSITIONING OF PATIENT WHILE LOWERING THE TABLE:</p> <ul style="list-style-type: none"> • Patient in a supine position with their arms/hands resting on their chest or abdomen • Effective immediately, ALL patients must remain in the supine position while the table is being lowered to the trolley and it must be ensured that no body part is at risk of being caught in that closing gap.

<p>INCORRECT POSITIONING OF PATIENT WHILE LOWERING THE TABLE:</p> <ul style="list-style-type: none"> • Patient sitting in an upright position with their hands holding onto the table • This introduces a very high risk that the patients fingers will be pinched in the table because they have nothing to hold onto while the table is lowering.
