May 2021

**Volume 21, Issue 5**

## **HIGHLIGHTED REPORTS**

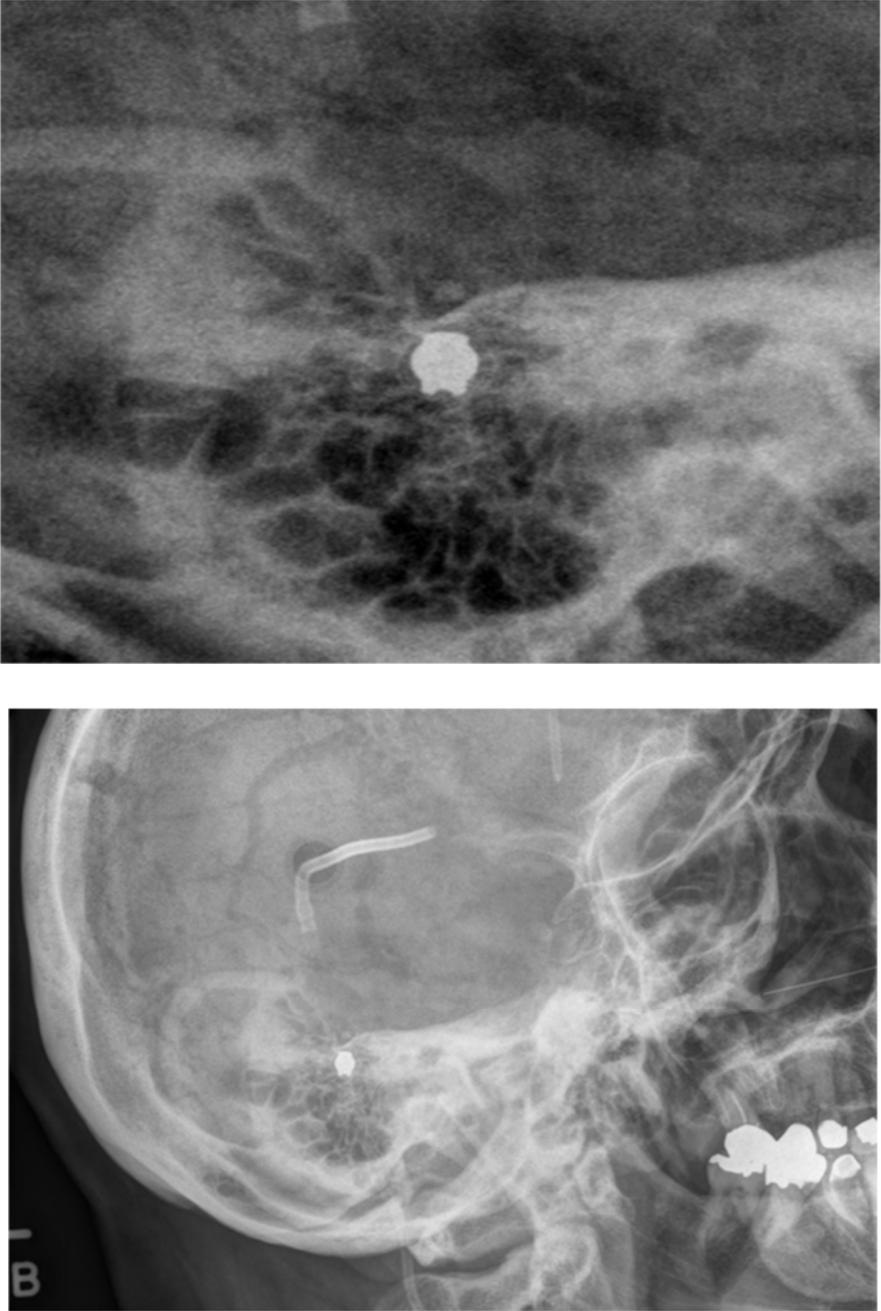
Device	Manufacturer	Problem
<p><b>Device 1: Shunt, Central Nervous System And Components</b></p> <p>Brand: Strata™ Model#: 42866 Lot #: 0220812938 Other #: LOG 1507121721</p> <p><b>Device 2: Shunt, Central Nervous System And Components</b></p> <p>Brand: Strata™ Model#: 42866 Lot #: 0219000135 Other #: TAG ID # W00401000091 6844</p>	<p>Medtronic PS Medical, Inc.</p> <p>Medtronic PS Medical, Inc.</p>	<p>A Medtronic ventriculo-peritoneal (VP) shunt was implanted into a patient. Post-operatively it was radiographically recognized that the shunt had poor radio-opaque markings required to confirm its orientation.</p>

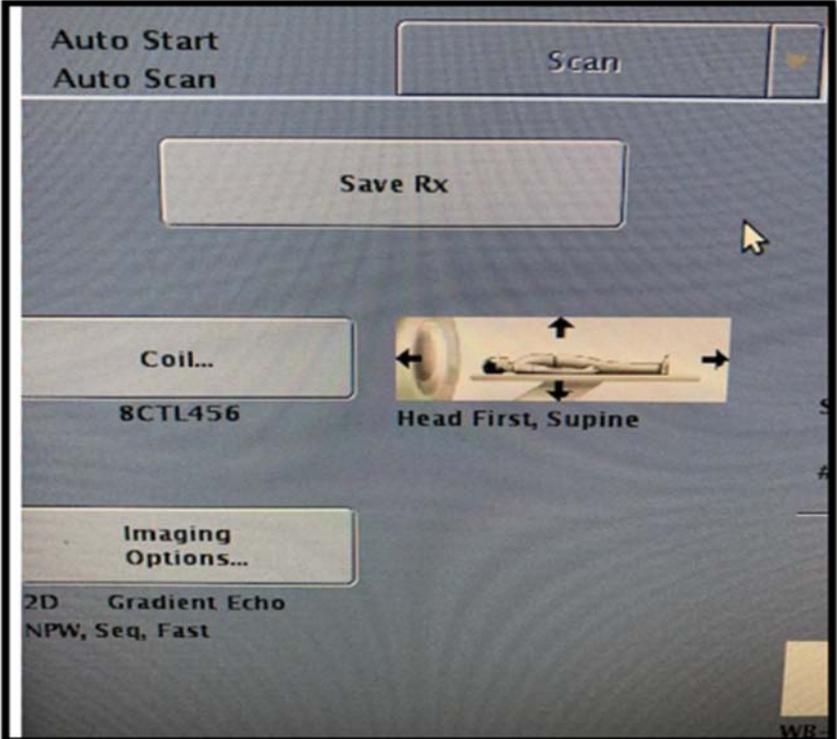
Device	Manufacturer	Problem
<p><b>System, Measurement, Blood-pressure, Non-invasive</b></p> <p>Brand: Good Neighbor Pharmacy Blood Pressure Monitor, Arm Auto Cuff Model#: 90-553</p>	<p>Veridian Healthcare LLC.</p>	<p>Device reading several mmHg higher than actual blood pressure.</p>
<p><b>System, Nuclear Magnetic Resonance Imaging</b></p> <p>Brand: Signa Artist Model#: SIGNA Artist Other #: Software DV28.1 R02 2002.a</p>	<p>General Electric Company</p>	<p>This is one of two recent events where RIGHT and LEFT (laterality) were reversed on the coronal MRI images performed on a GE. The neurosurgeon has been in contact with radiology/Imaging leadership about these laterality issues. The cause is evidently related to technologist's error in inputting data after a recent GE software upgrade, but the software allows this to happen with PATIENT ORIENTATION changes unknown to the technologist performing the study.</p> <p>This type of error obviously has significant risk of wrong sided surgery if the error is not caught. Even when the error is caught, there remains significant exposure for a patient error later because these images are included in the patient's electronic medical record and could be viewed by a surgeon in the future, who is unaware that this laterality issue impacted the views that she/he is seeing. Please see pictures below:</p> <p>Older GE 23.0 platform:</p>

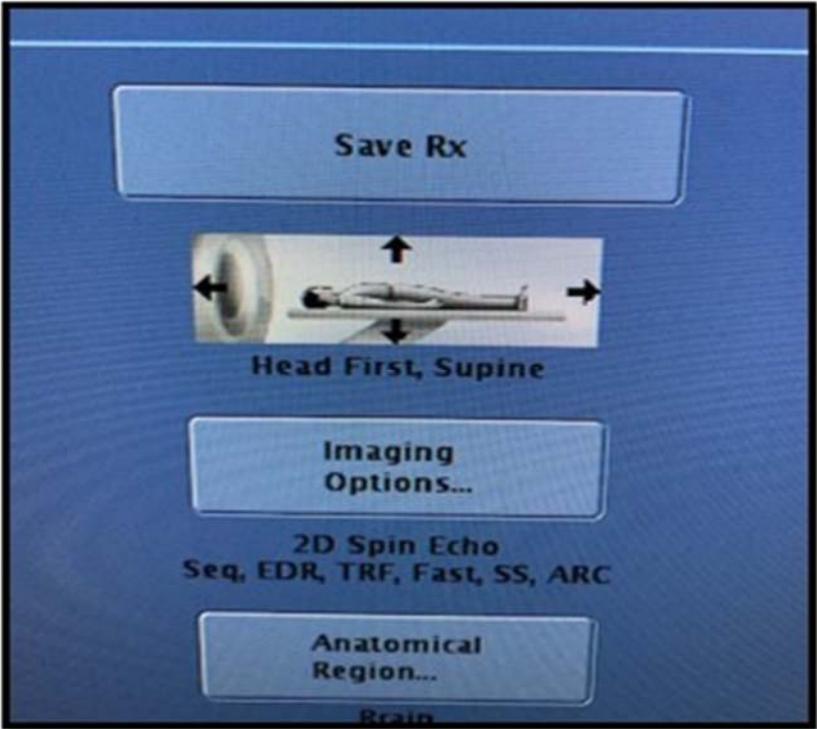
Device	Manufacturer	Problem
<p><b>System, Nuclear Magnetic Resonance Imaging</b></p> <p>Brand: Signa Artist  Model#: SIGNA Artist  Other #: Software DV28.1 R02 2002.a</p>	<p>General Electric Company</p>	<p>Newer 26 &amp; 28.0 platform:</p>

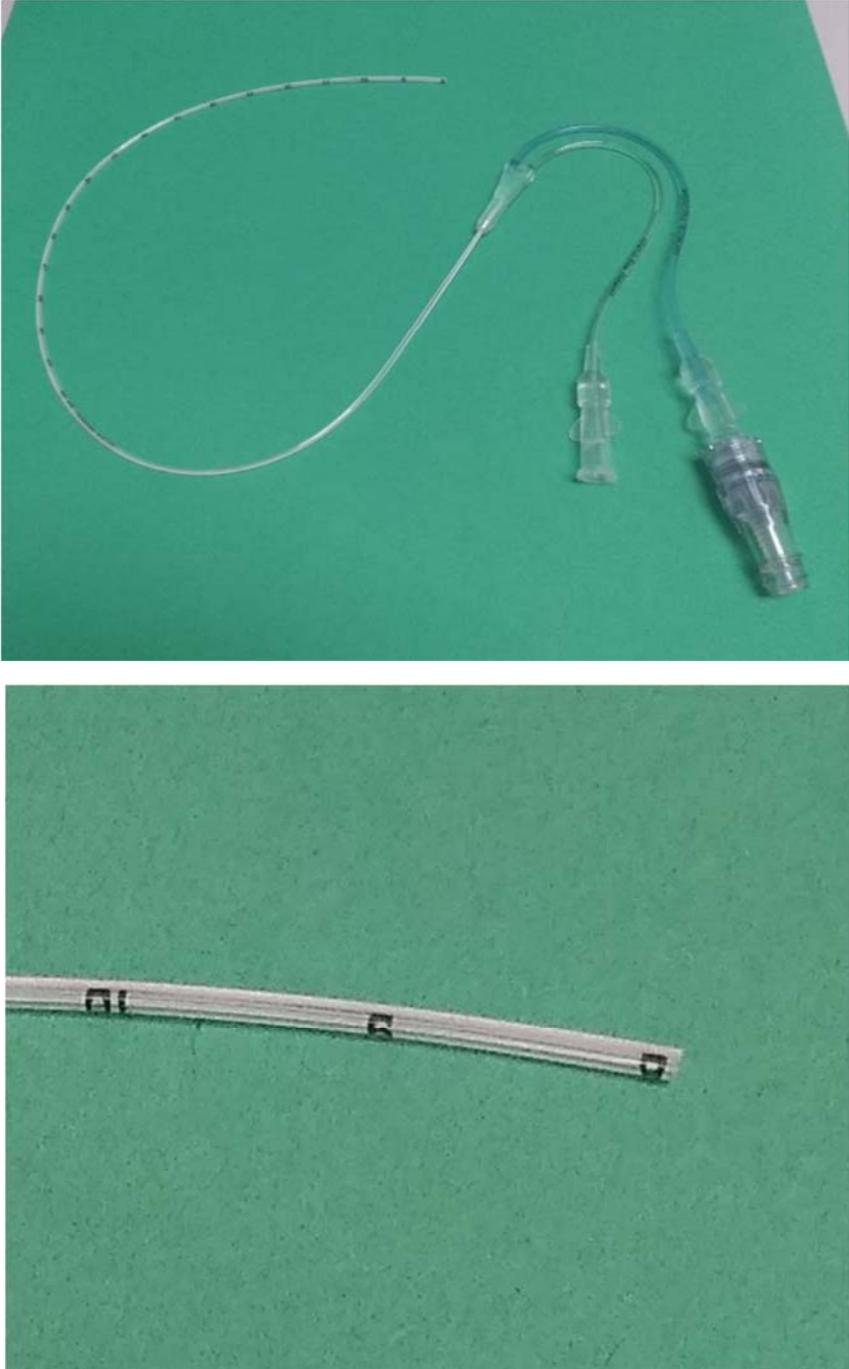
<p>Cardinal Health, Inc.</p>	<p>While suturing a Umbilical Catheter Argyle™ Vessel 3.5 Fr. 15 Inch Dual Lumen, it inadvertently broke at 8 cm and was unable to be retrieved. A chest x-ray was immediately taken and the line fragment was in the inferior vena cava. The newborn patient was transferred via LifeFlight to a children's specialty hospital. The newborn patient was taken to Interventional Radiology where they were able to retrieve the fragment from the left pulmonary artery.</p> <p>Please see pictures below:</p>
