**June 2021**

**Volume 21, Issue 6**

## HIGHLIGHTED REPORTS

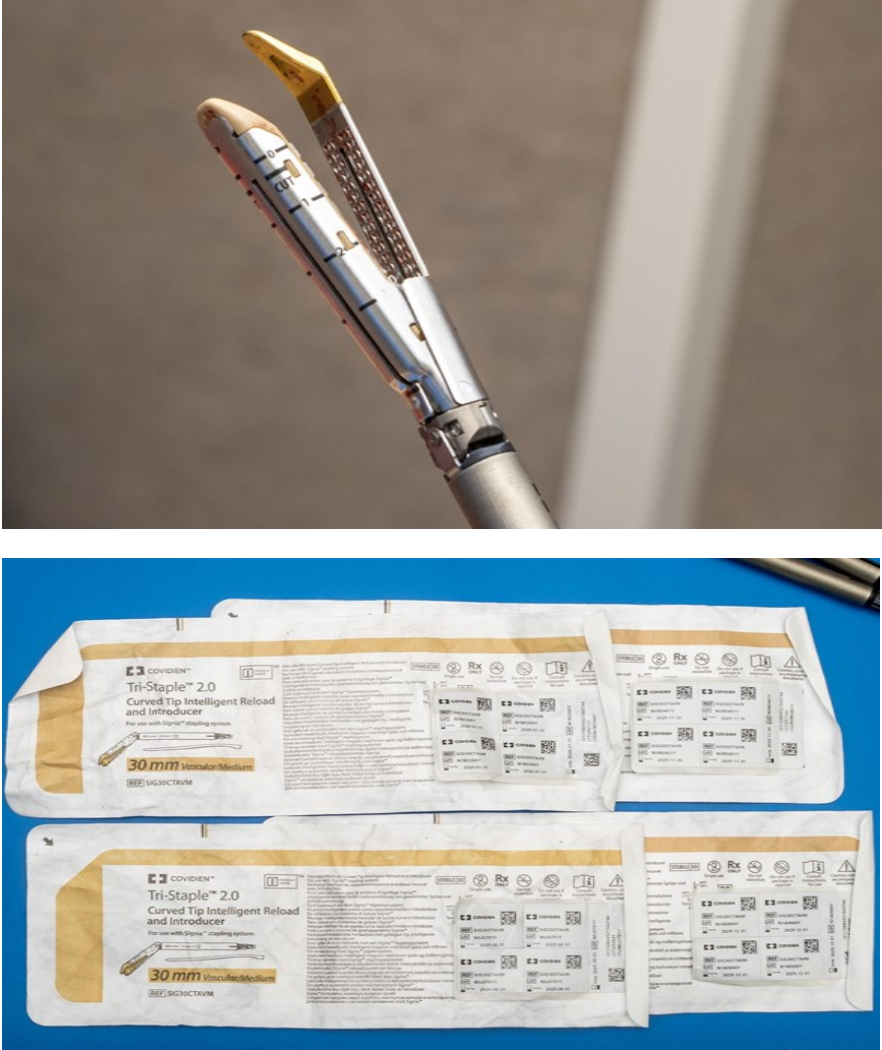
Device	Manufacturer	Problem
<p><b>Device 1: Staple, Implantable</b></p> <p>Brand: Endo Gia Ultra Model#: EGIAUSHORT Lot #: P1B1253 Cat #: (17)260131 (10)P1B1253</p> <p><b>Device 2: Staple, Implantable</b></p> <p>Brand: Endo Gia Ultra Model#: EGIAUSHORT Lot #: P1B1430 Cat #: (17)260131 (10)P1B1430</p> <p><b>Device 3: Staple, Implantable</b></p> <p>Brand: Tri-staple 2.0 Model#: SIG30C-TAVM Lot #: N1B0398Y Cat #: SIG30C-TAVM</p> <p><b>Device 4: Staple, Implantable</b></p> <p>Brand: Tri-staple 2.0 Model#: SIG30C-TAVM Lot #: N0M0461Y Cat #: SIG30C-TAVM</p> <p><b>Device 5: Staple, Implantable</b></p> <p>Brand: Tri-staple 2.0 Model#: SIG30C-TAVM Lot #: N0J0781Y Cat #: SIG30C-TAVM</p>	<p>Covidien LP</p> <p>Covidien LP</p> <p>Covidien LP</p> <p>Covidien LP</p> <p>Covidien LP</p>	<p>Once the pulmonary artery was freely dissected, the superior segmental artery was encircled in a vessel loop placed around it. Only one-third of the staples fired resulting in incomplete division of the artery. This necessitated control of bleeding. So, an additional vessel loop was placed around the remaining vessel. Another vascular staple load was fired and the same issue occurred with only one-third of the staples firing with inability of the operator to move the staples any further. A clamp was placed along the proximal aspect of the pulmonary artery. The stapler was removed and again bleeding was controlled. A stapler device from a different manufacturer was used to complete the pulmonary artery division. If the third device had not deployed staples successfully, the patient would have exsanguinated.</p> <p>All personnel were experienced in the use of these products. If the staple load had not been correctly connected, the stapler would not have fired. However, we have been made aware that there is about a 90% chance that if the load is not connected appropriately it will fire. The loading issue seems to be a possible design defect.</p> <p>Please see pictures below:</p>
