About the MedSun Program:

Volume 21, Issue 7

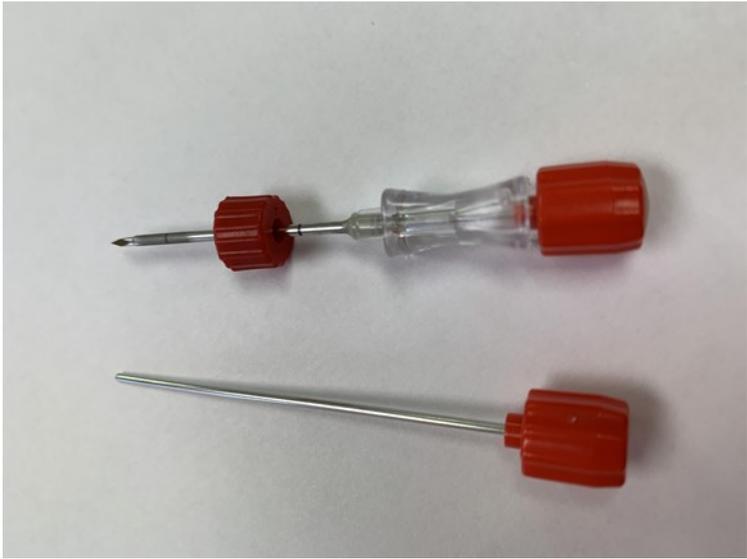
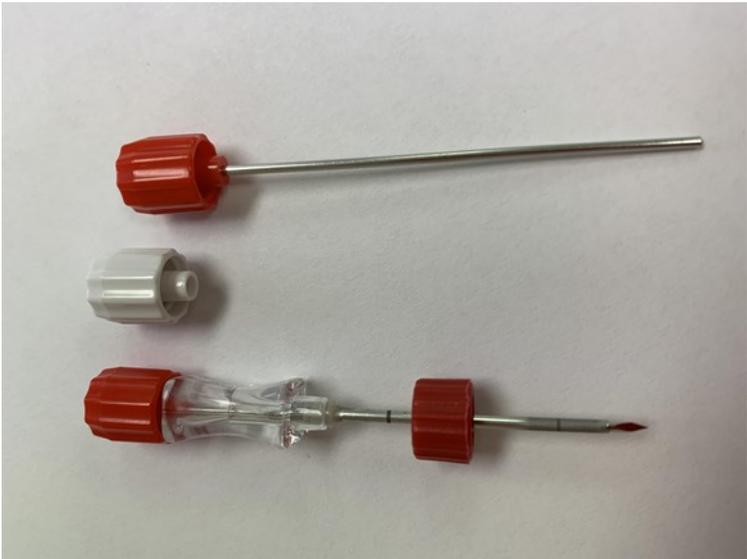
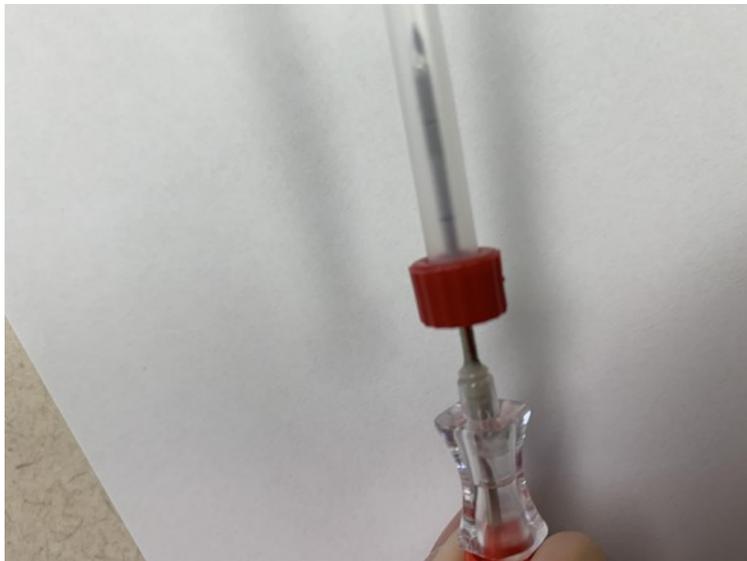
<p>Instrument, Biopsy</p> <p>Brand: Medeasy Model#: ML18080-K0 Lot #: 06186-20 Cat #: ML18080-K0</p>	<p>Medax Srl Unipersonale</p>	<p>Patient with history of chronic obstructive pulmonary disease and increasing shortness of breath was admitted for a soft-tissue right breast biopsy. Prior to inserting needle into patient, the Medax Srl Unipersonale Medeasy soft tissue semi-automatic biopsy needle 18G x 80 mm (Lot # 06186-20, Cat # ML18080-KO) came unglued. The defective needle was never placed into the patient. Another of the same type and Lot # of that needle was opened and used.</p> <p>This is not the first event for this product, reported same incident with this type of device in the recent past.</p>

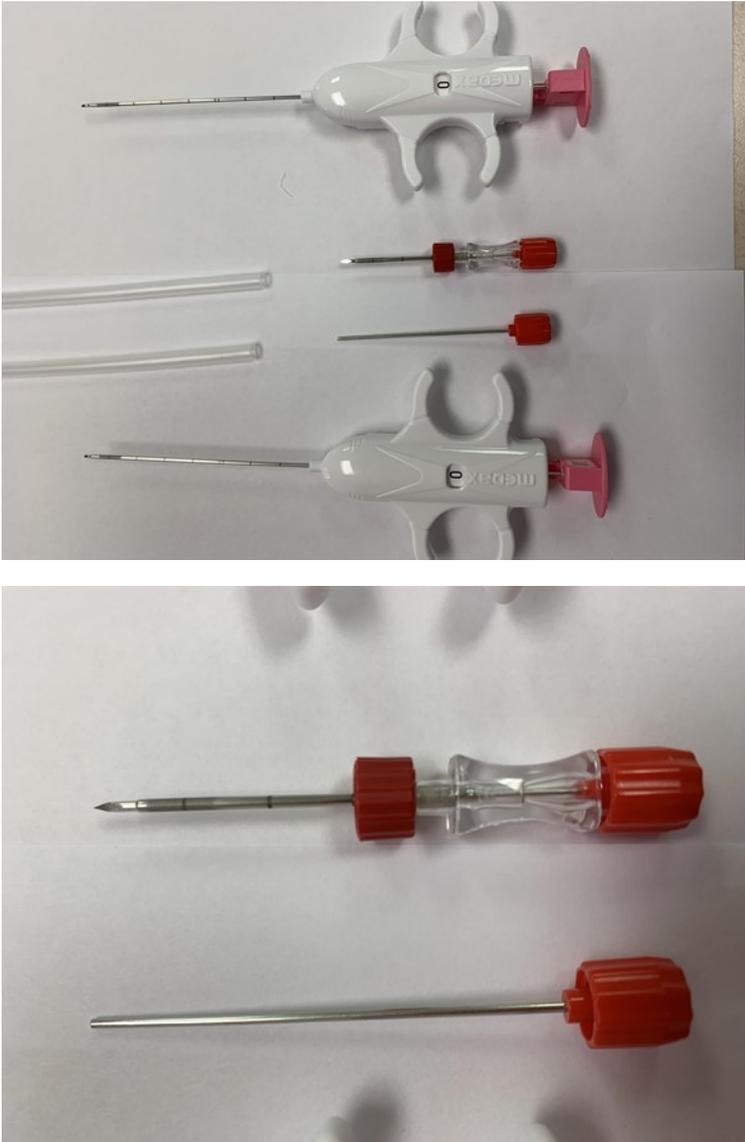
Device	Manufacturer	Problem
<p>Instrument, Biopsy</p> <p>Brand: Medeasy Model#: ML18080-K0 Lot #: 0618620</p>	<p>Medax Srl Unipersonale</p>	<p>Patient with history of Stage IV follicular lymphoma was admitted for an ultrasound biopsy of lymph node. While physician was doing the procedure, the Medax Srl Unipersonale Medeasy soft tissue semi-automatic biopsy needle came unglued. Another biopsy needle was used and it came unglued as well. Both biopsy needles had the same lot #. A third biopsy needle was used without problems. No known harm done to patient.</p> <p>This is the 6th report of this biopsy needle coming unglued. Purchasing department is aware and has all lot numbers: 21-121, 21-75, 21-67, 21-64.</p>
