**September 2021**

**Volume 21, Issue 9**

## BD to Begin Remediation for BD Alaris™ System Software

## HIGHLIGHTED REPORTS

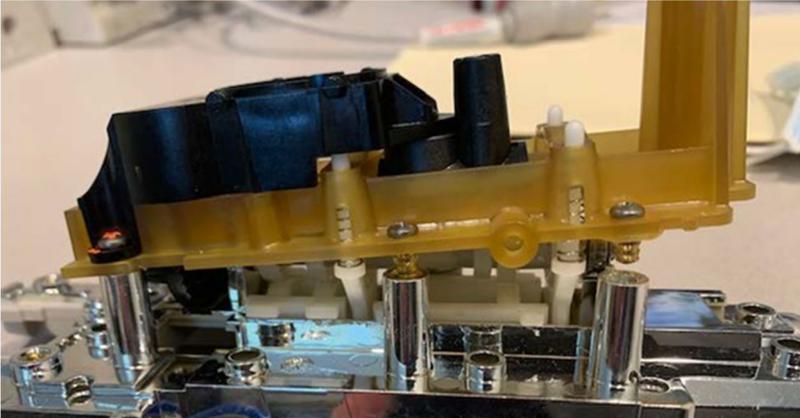
Device	Manufacturer	Problem
<p><b>Pump, Infusion</b></p> <p>Brand: Alaris Model#: 8100</p>	<p>Carefusion 303, Inc.</p>	<p>An instance of bezel separation was discovered during inspection of an Alaris 8100 Pump Module. The bezels in question are an after-market replacement product and were installed in modules supplied by Avante Patient Monitoring (formerly Pacific Medical). The issue is similar to that described in Avante's Urgent Medical Device Recall Notification dated March 24, 2021. However, this issue differs in that instead of "cracking and/or separation of the front bezel component posts", the threaded inserts connecting the pumping mechanism frame to the bezel assembly have come loose from the component posts. The posts otherwise appear intact and have not cracked or separated.</p> <p>We believe the resulting risks would be the same as if the posts had cracked or separated. That is, potential issues of free flow, over infusion, under infusion, or interruption of infusion could exist if this problem were to occur.</p>

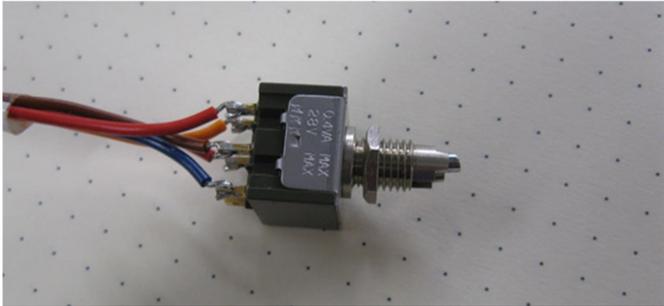
<p><b>Ventilator, Continuous, Facility Use</b></p> <p>Brand: Base Unit Servo-u Model#: 6694800 Cat #: 6694800</p>	<p>Getinge/Maquet Critical Care AB</p>	<p>While setting up the ventilator for patient ventilation therapy, the Respiratory Care Practitioner (RCP) attempted to turn the ventilator on to perform the power on self-test. As the therapist tried to power the ventilator on the toggle lever on the switch snapped off preventing the ventilator from turning on. The ventilator was removed from service and sent to Biomedical engineering for service and reporting. This is the second incident of these switch levers snapping off. Biomedical determined that the switch design is of the locking level style in which the user is supposed to raise the switch lever about 2mm and then toggle to the On/Off position. The locking switch is designed to prevent inadvertent ventilator shut downs, but the user may be breaking the switch unaware that the switch is the locking style.</p>

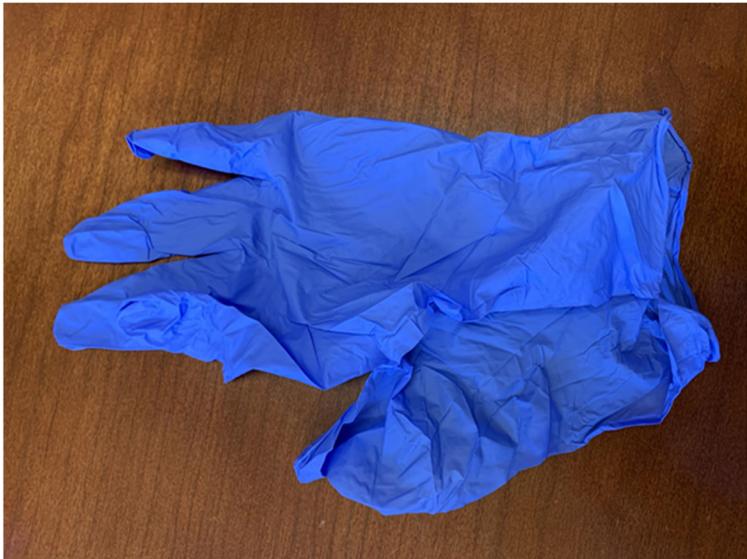
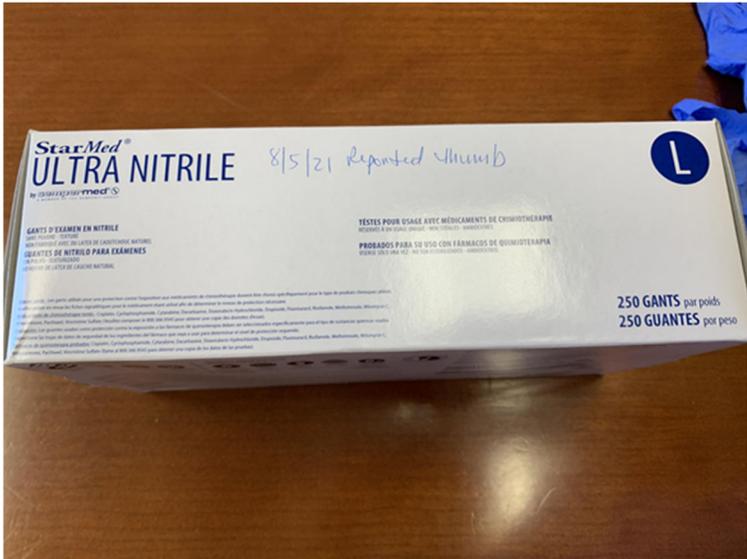
Device	Manufacturer	Problem
<p><b>Medical Gloves W/ Chemotherapy Labeling Claims -For Use W/ Chemotherapy Drugs</b></p> <p>Brand: StarMed Ultra Nitrile Exam Glove  Lot #s:  L074702,  L076327  Other #:  SMTN253</p>	<p>Sempermed USA, Inc.</p>	<p>When the StarMed Ultra nitrile exam gloves were removed from box, it was evident that they were "ripped" in box- prior to removal.</p> <p>Two separate events. (1) A glove was removed from the box and was ripped from the wrist all the way through the thumb. MFG Date/Lot# 2021-01 L074702 2101 size Large. The box was retained. (2) Box of medium StarMed Nitrile gloves, the first glove was found to be badly ripped and unusable. This issue has been a recurrent problem recently. Our center's glove spend has drastically increased this year and staff report it is due to high numbers of unusable gloves. MFG item number SMTN253. Date and Lot # 2021-02 L076327 2102(not saved).</p> <p>Sempermed USA, INC. will look into the recurrent issues.</p>
