November 2021

Volume 21, Issue 11

Potential for Medication Overdose with ENFit Low Dose Tip Syringe: FDA Safety Communication

HIGHLIGHTED REPORTS

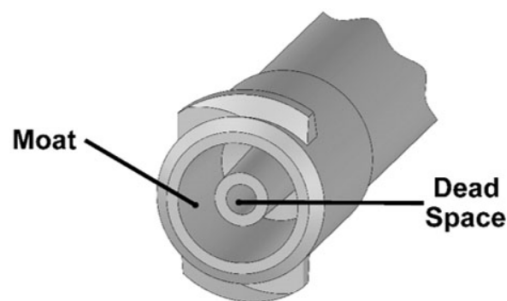
The FDA is aware of the potential for overdose if the user does not clear the moat area around the tip of the ENFit LDT syringe before administering a medication. The moat area is unique to the design of the ENFit LDT syringes. The FDA is providing recommendations for patients and health care providers to promote the safe use of ENFit LDT syringes, including steps users can take to optimize dose accuracy.

- Ensure the syringe is free of air bubbles and the moat of the syringe is free from fluids by tapping or flicking the tip of the syringe before administering the medication.
- Use a filling adapter, such as an ENFit compatible cap or medication straw, to prevent fluid and medications from entering the moat area of the syringe tip.
- Be aware that using a medicine cup to fill may cause fluid or medications to enter the moat of the syringe and lead to possible overdose.
- Use a new syringe to flush the medication or fluid after administering any medication to prevent overdose due to the dead space (remaining fluid in the tip of the syringe after administration) in the syringe.

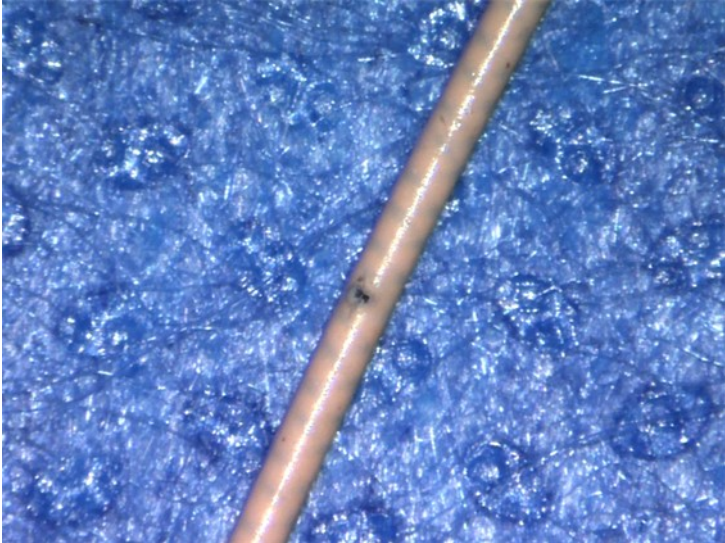
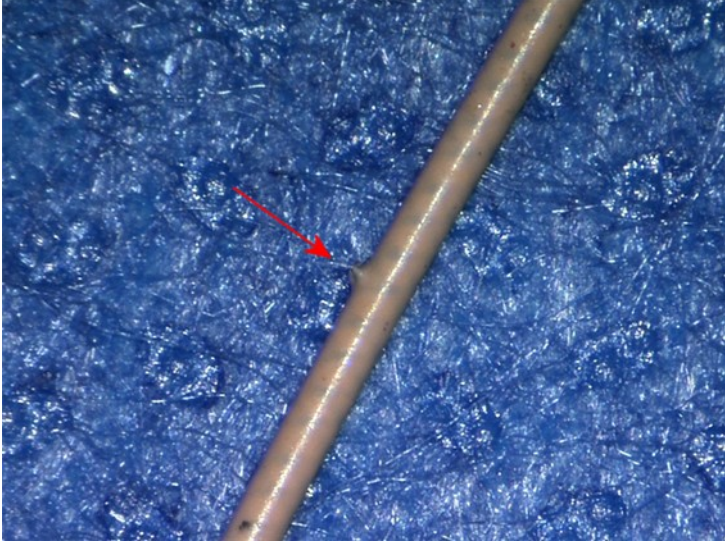
<p>Micro Therapeutics, Inc.</p>	<p>Patient underwent a cerebral angiogram and ethylene-vinyl alcohol copolymer (EVOH) embolization. While injecting the embolic agent during the procedure, the agent was observed to be coming out of the catheter at a point proximal to the tip, which led to a stroke. Patient is currently reported to be stable but guarded. Post procedure, the catheter was examined under a microscope and a small hole was found about 6cm from the tip.</p>
