June 2026

Volume 26, Issue 6

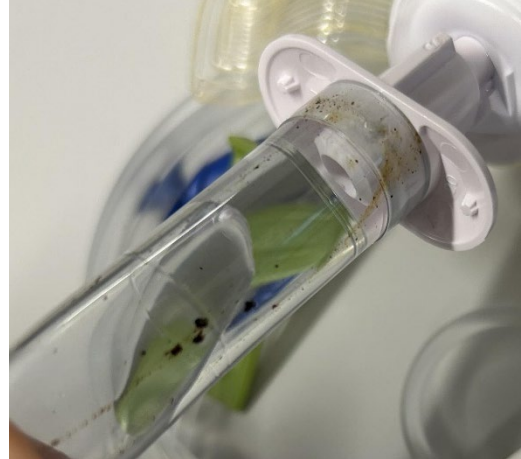
Event 1: In the Emergency Department, black spots and debris were noted in the drip chamber of the IV tubing by the RN who immediately removed and sequestered it. The contaminant is suspected to have originated in the IV tubing. All IV tubing with that lot was pulled from our stock and the product was returned to ICU Medical. Since that time, we have identified multiple tubing lots that are affected by the problem. We continue to inspect and monitor additional supply issues.
