**Establishment Inspection Report**

Bravo Farms Cheese, LLC

**ADDENDUM**

The following addendum was created to add additional information to the section title in the EIR as Supporting Evidence and Relevance of Objectionable Conditions and Management's Response:

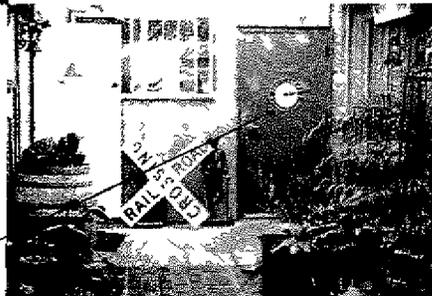
Exhibit #35, Photo #2055

This restroom is for public use not for processing/packaging employees. The red door is an employee entry to the facility.

IMG\_2055 jpg-Copy of photograph of public men's restroom near the door to the processing facility. This restroom was regularly used by employees

Employee door is kept unlocked

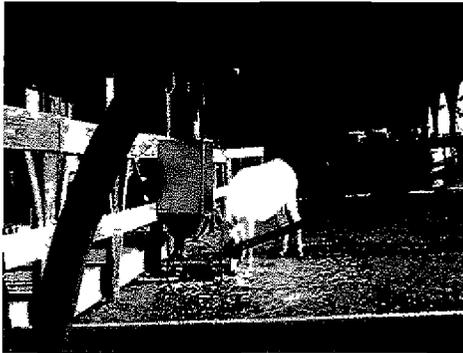
Exhibit #37. Photo #0575

- The photographs below, taken on 11/10/10, is of the same rabbit seen coming out of the storage trailer.

IMG\_0575 jpg-Copy of photograph taken of black rabbit roaming freely in the donkey pen.

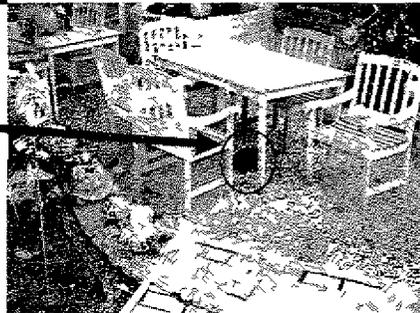
Exhibit #37, Photo #0589

MG\_0589 jpg-Copy of photograph taken of black rabbit roaming in the picnic area used by the public.
