Subject: Memorandum to the File on the Environmental Assessment; Yuma 2018 *E. coli* O157:H7 Outbreak Associated with Romaine Lettuce

ENVIRONMENTAL ASSESSMENT COMPLETE NARRATIVE REPORT

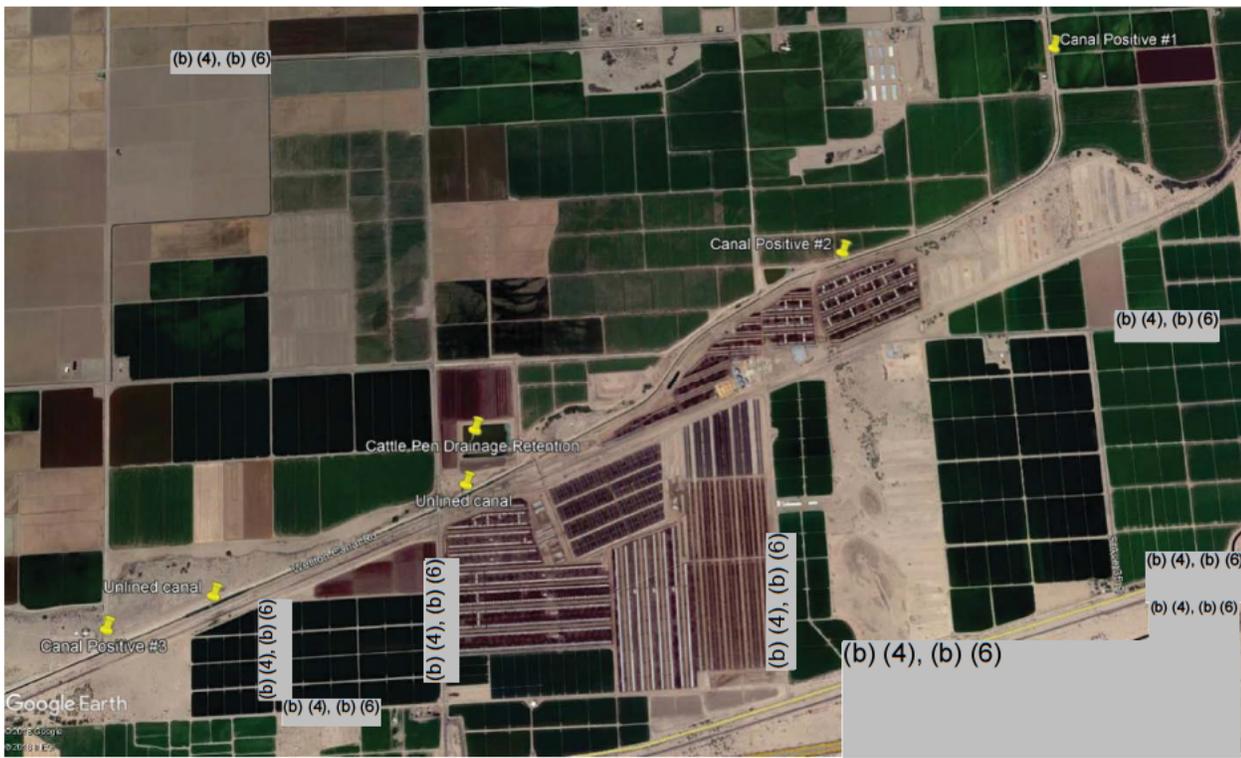
Figure 1. Wellton Irrigation Canal. This Google Earth view depicts a section of the Wellton main canal adjacent to a CAFO and locations of three outbreak-pathogen-positive irrigation water samples. The sample locations are upstream, adjacent to, and downstream of the Wellton-area CAFO. Also noted are unlined irrigation canal sections and a CAFO retention pond. Water in the canal flows from west (left) to east (right) in the figure above. The CAFO at the bottom center of Figure 1. See Figure 2 for an enlarged image of the CAFO.

Through ultrafiltration sampling of irrigation water conducted during the initial site visit in June, *E. coli* O157:H7 was detected in three places along a 3.5-mile section of the Wellton irrigation canal that is operated by the WMIDD. The locations of the three samples were approximately one mile upstream of a CAFO, adjacent to the CAFO, and approximately one mile downstream of the CAFO (Figure 1). Genetic analyses of these isolates using pulsed field gel electrophoresis (PFGE) and WGS determined that the *E. coli* O157:H7 found in these three Wellton irrigation canal water samples is the same strain that caused the outbreak. Some of the EA activities described in this report were conducted throughout the Yuma growing region before the EA team was aware of this significant finding. Once the EA team became aware of the positive findings, certain activities were focused on areas around the section of the irrigation canal where these positive water samples were obtained.

As noted previously, *E. coli* O157:H7 was detected in three places along an approximate 3.5-mile section of the WMIDD Wellton irrigation canal. The locations of the three samples were approximately one mile upstream of a CAFO, adjacent to a CAFO, and approximately one mile downstream of the CAFO (Figure 1). Genetic analyses of these isolates using PFGE and WGS determined that the *E. coli* O157:H7 found in the Wellton irrigation canal water in all three locations was the same strain that caused the outbreak. In June, water samples were also collected from one CAFO well serving the feedlot (approx. 150 ft. deep) and retention pond located on the feedlot property. The well sample was collected after the water passed through a plumbed sand filtration system that was not feasible to bypass for sampling. *E. coli* O157:H7 was not detected in either sample.

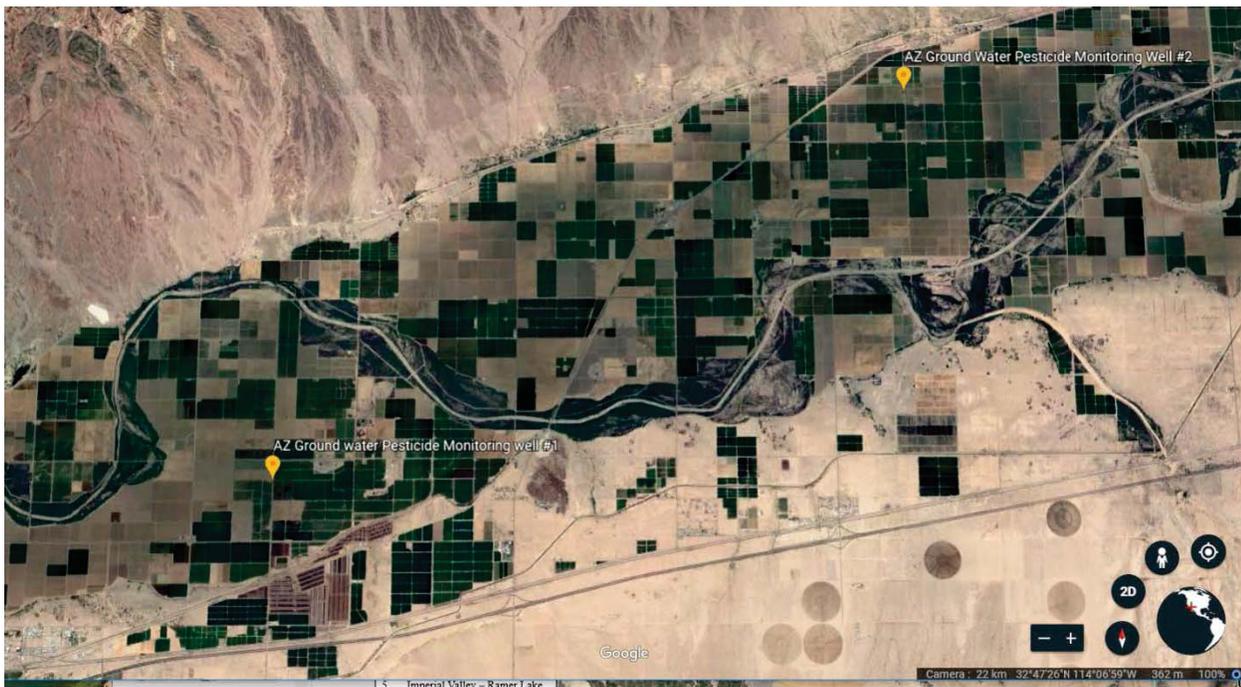
Figure 3. Map of July water sampling locations from State of Arizona ground water pesticide monitoring wells.

In July, water samples were collected from two State of Arizona pesticide ground water monitoring wells (Figure 3), as well as from the salt drainage canal downstream of the WMIDD area of responsibility (Figure 4). *E. coli* O157:H7 was not detected in either the ground water monitoring wells or the salt drainage canal.

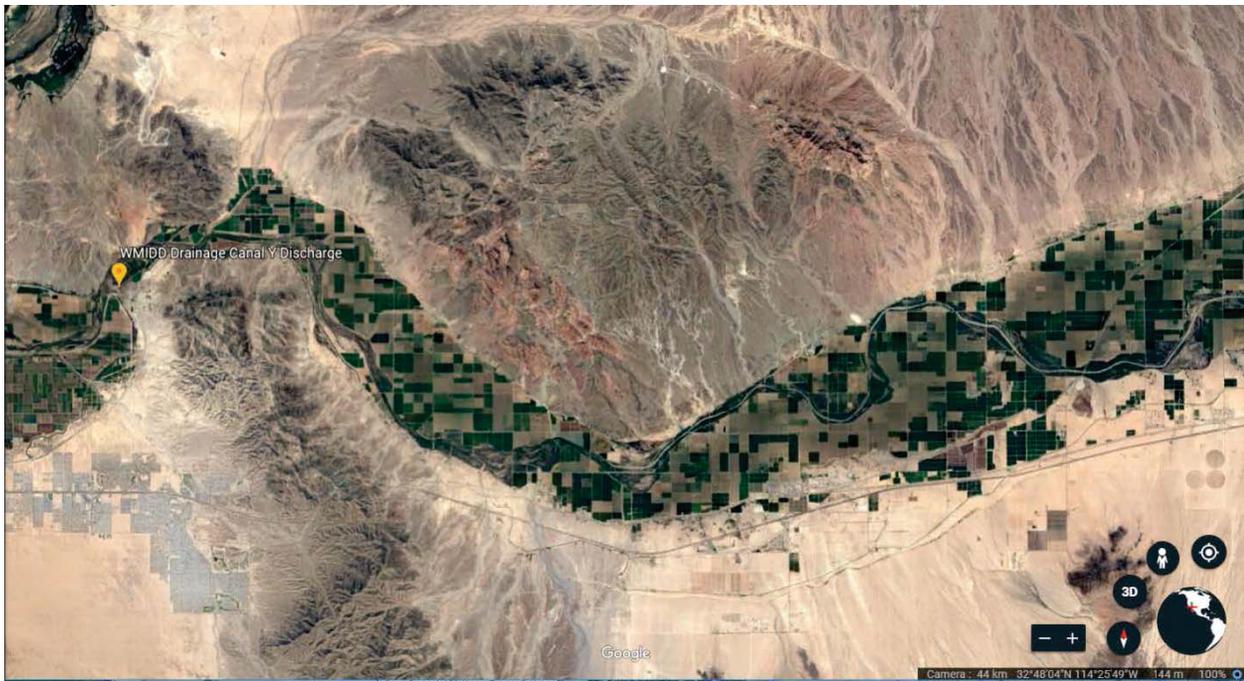
Figure 4. Map of July sampling location in salt water drain canal downstream of the WMIDD area of responsibility.

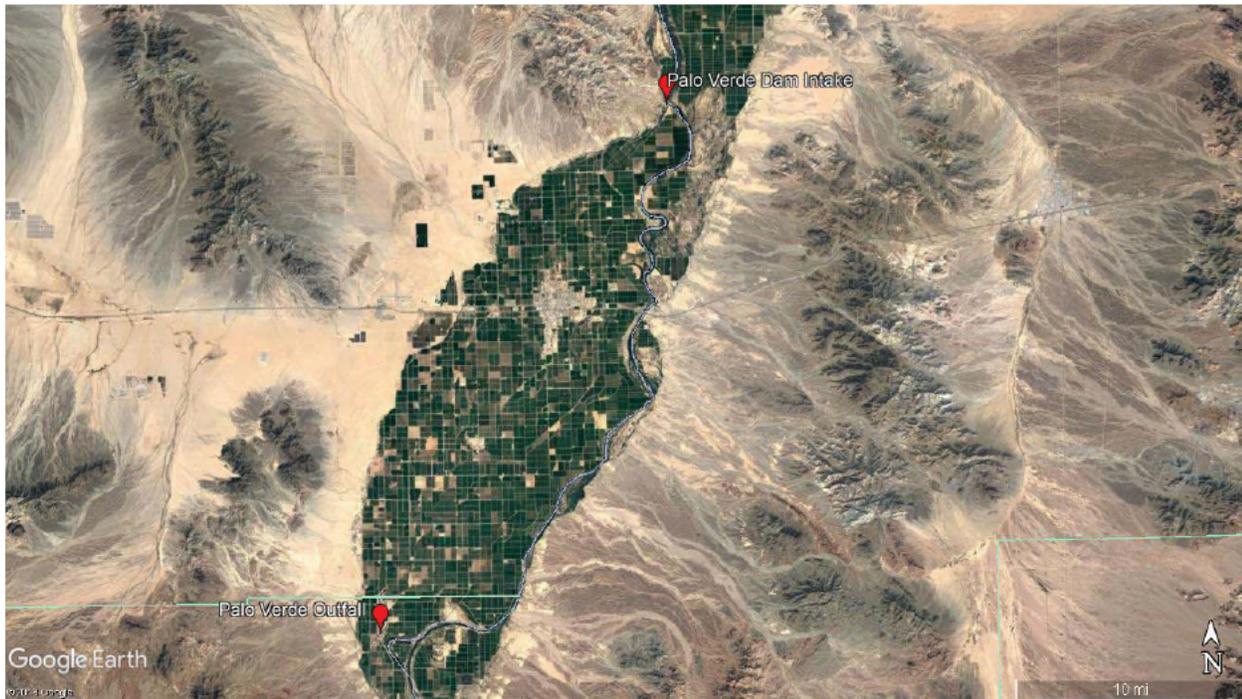
Figure 5. Map of June sampling locations at PV Dam and PV Irrigation Canal discharge into the river.

Water samples were collected from the Palo Verde (PV) valley and Imperial Dam area (Figures 5 & 6).

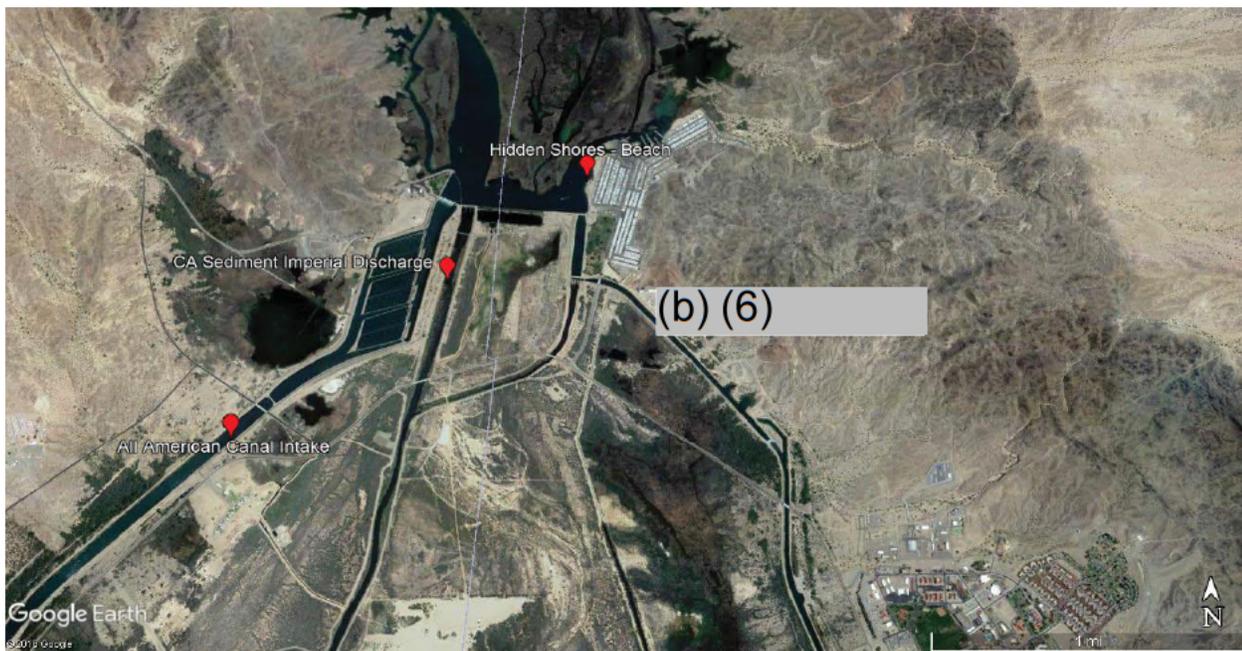
Figure 6. Map of June sampling locations at Imperial Dam and All American and AZ irrigation canals.

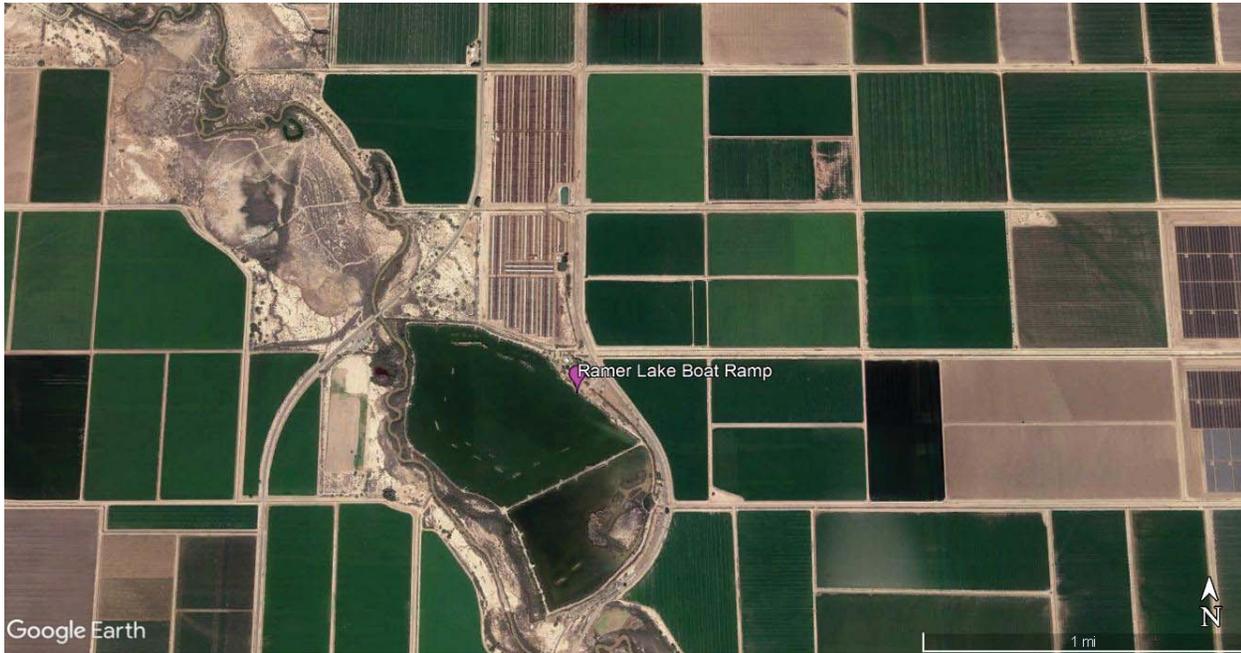
Figure 7. Map of June water sampling location in Imperial Valley at Ramer Lake adjacent to cattle feedlot

In June, the EA team collected samples of surface water from a public pond (Figure 7) immediately adjacent to an Imperial County CAFO near Imperial County farms identified by traceback and from irrigation canal drainage into the Salton Sea (Figure 8). The outbreak strain was not detected.

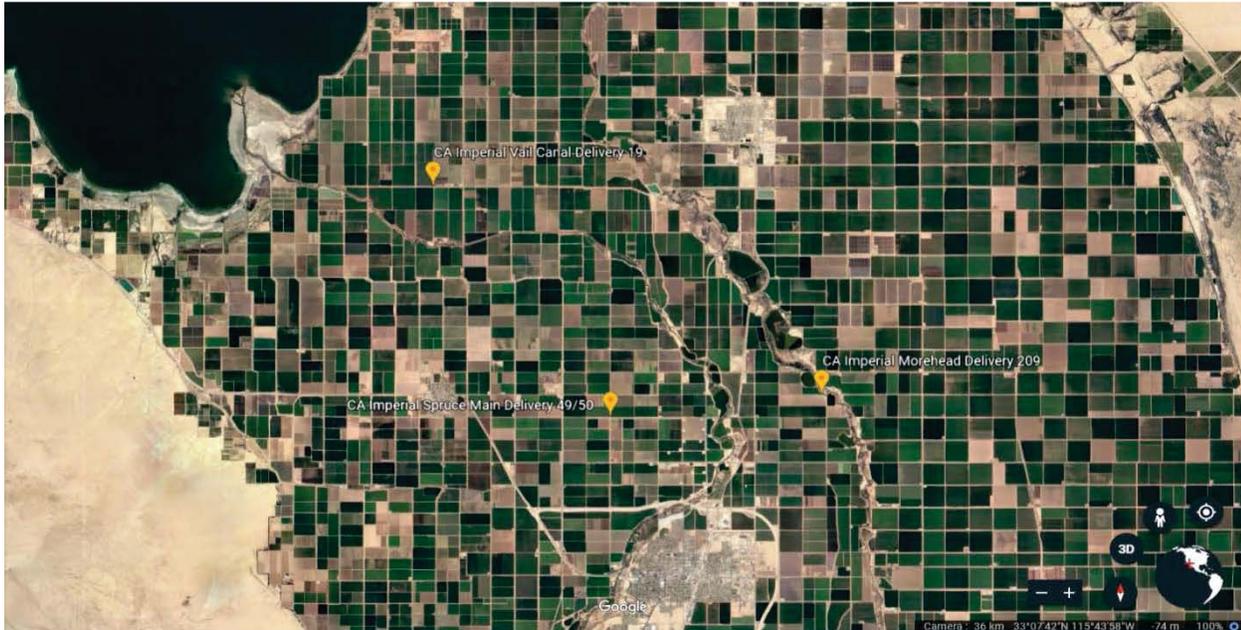
Figure 9. Map of July water sampling locations in CA Imperial Drainage District canals.

In July, the team also collected irrigation water from three Imperial County irrigation canals that provide water to Imperial County farms identified by traceback (Figure 9); all three of these irrigation canals have CAFOs near them. Six strains of *E. coli* O157:H7, each genetically distinct from each other, were detected at one canal water site (Spruce Main Delivery 49/50) in Imperial Valley, although none match the outbreak strain. (See Table 3.)

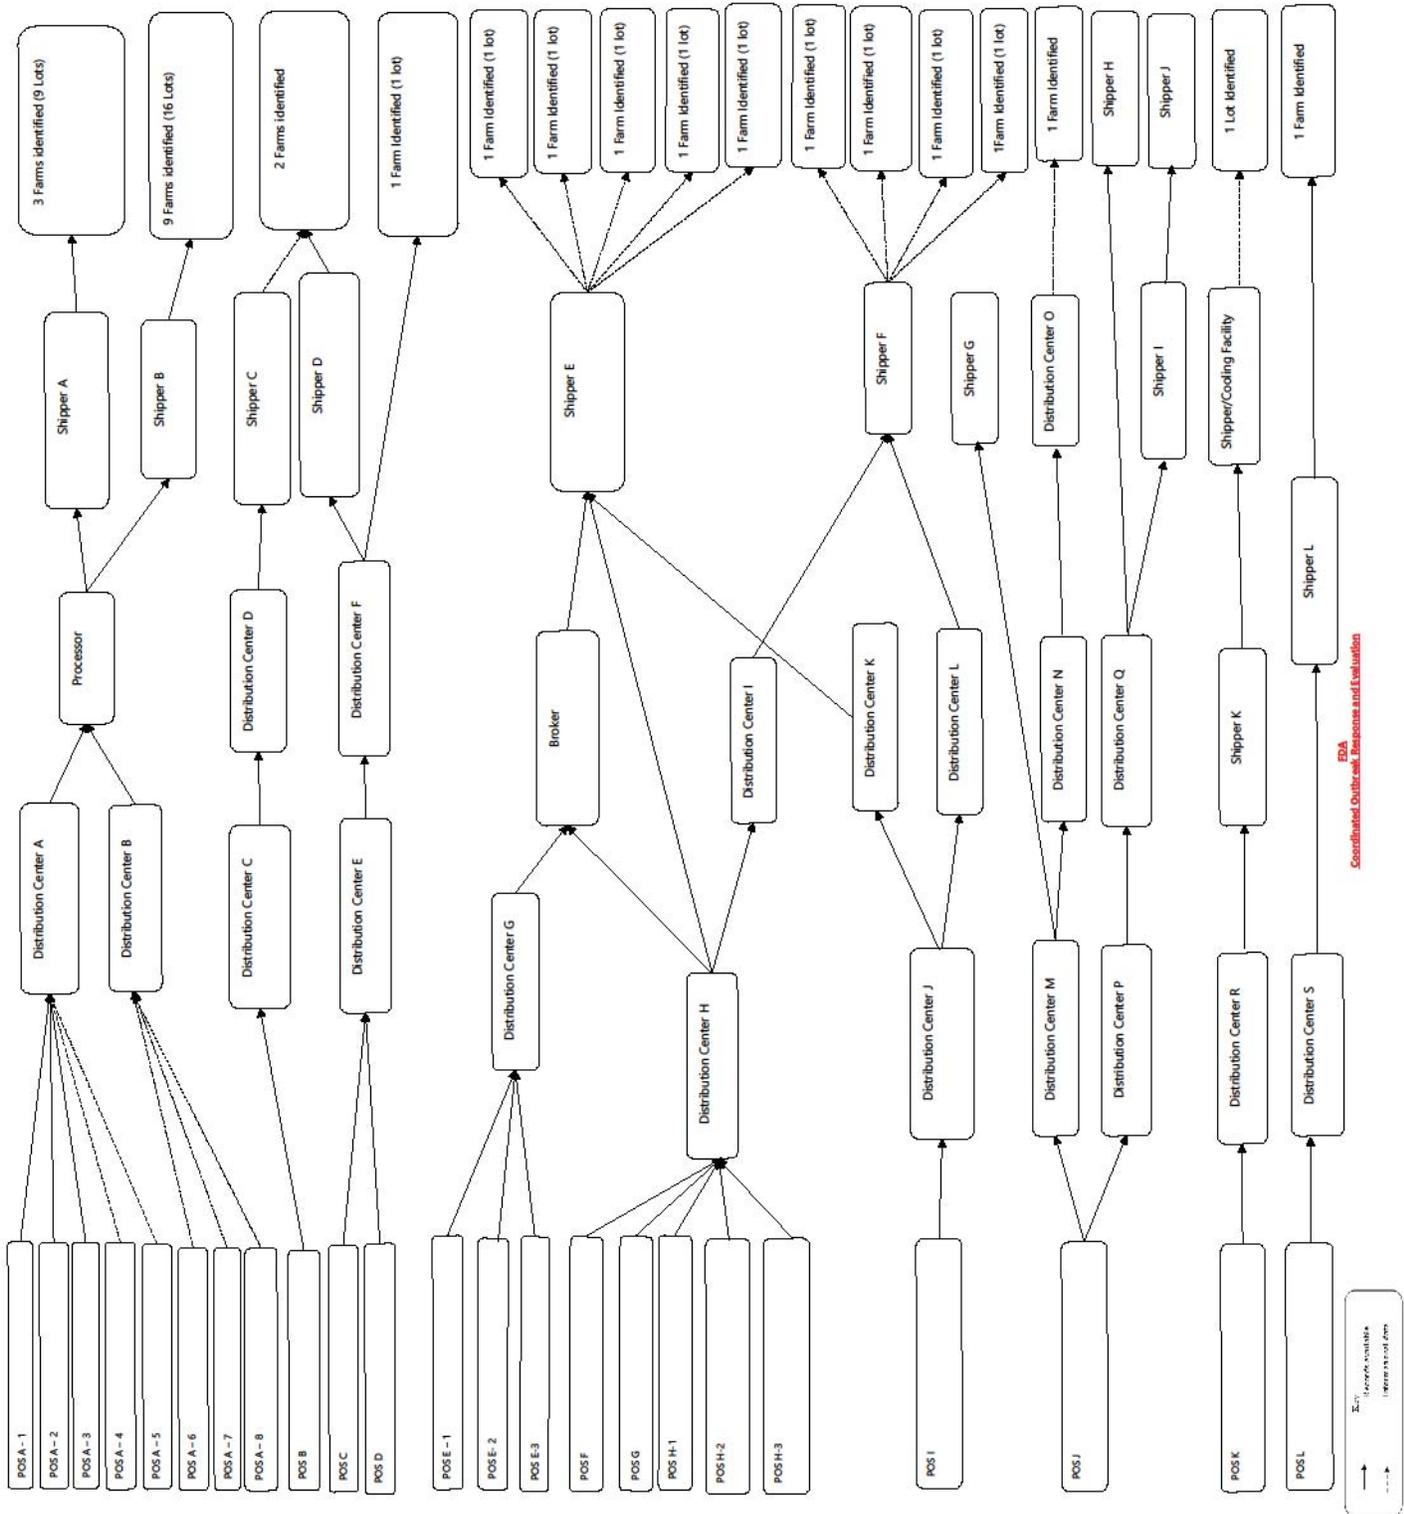
ATTACHMENT A – MASTER TRACEBACK DIAGRAM

E. coli O157:H7 – Remainse
Multi-state Outbreak April 2018
Master Redacted Traceback Diagram
This report should not be further distributed beyond its intended FDA audience without express permission from FDA

The traceback investigation identified a total of 36 growing fields on 23 farms in Arizona and California as potential sources of contaminated lettuce consumed during the outbreak. (See Attachment A.) A total of seven intermediate shippers received the romaine lettuce from these 23 farms, and all but one of these intermediate shippers commingled romaine lettuce from multiple farms upon receipt. The exception was an intermediate shipper that received romaine lettuce associated with the outbreak from only one farm. Whole-head romaine lettuce was traced from this one farm through the intermediate shipper to a correctional facility in Alaska where exposed inmates became infected with the outbreak strain.
