Memorandum

Subject: Memorandum to the File on the Environmental Assessment; Yuma 2018 *E. coli* O157:H7 Outbreak Associated with Romaine Lettuce

ENVIRONMENTAL ASSESSMENT COMPLETE NARRATIVE REPORT

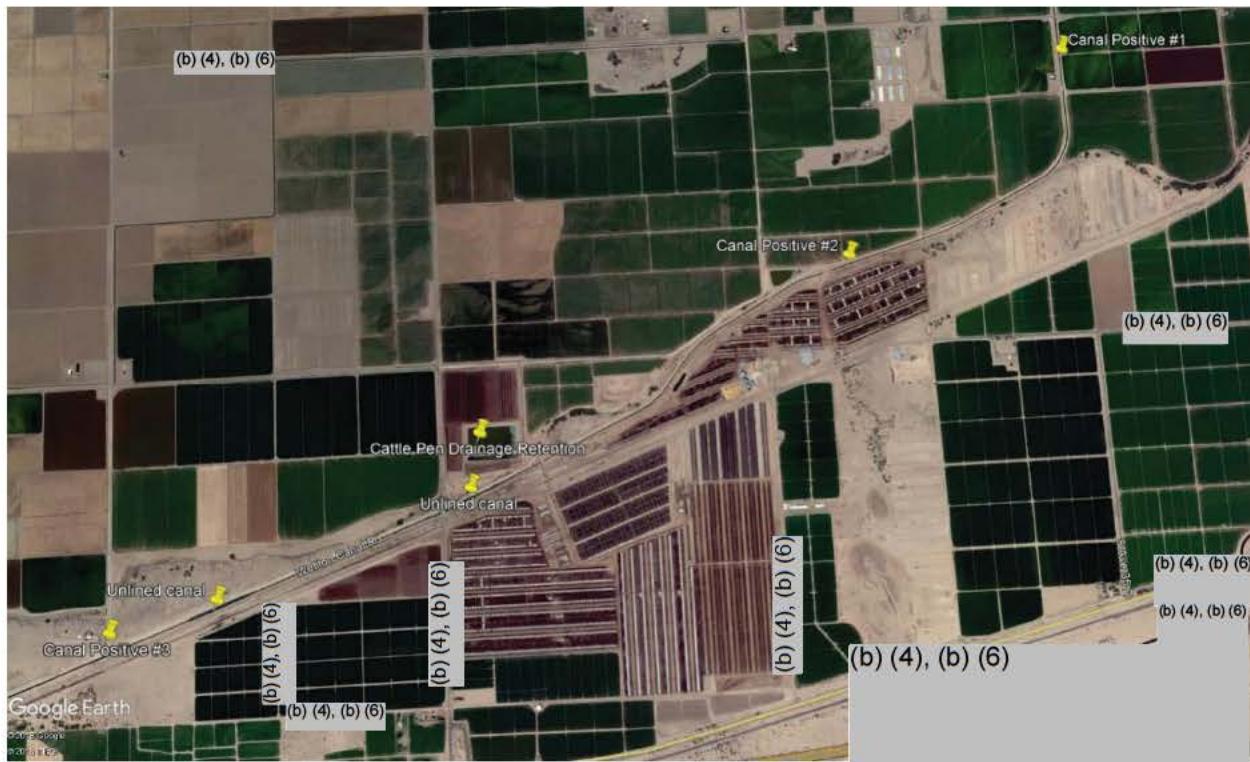
Figure 1. Wellton Irrigation Canal. This Google Earth view depicts a section of the Wellton main canal adjacent to a CAFO and locations of three outbreak-pathogen-positive irrigation water samples. The sample locations are upstream, adjacent to, and downstream of the Wellton-area CAFO. Also noted are unlined irrigation canal sections and a CAFO retention pond. Water in the canal flows from west (left) to east (right) in the figure above. The CAFO at the bottom center of Figure 1. See Figure 2 for an enlarged image of the CAFO.

Through ultrafiltration sampling of irrigation water conducted during the initial site visit in June, *E. coli* O157:H7 was detected in three places along a 3.5-mile section of the Wellton irrigation canal that is operated by the WMIDD. The locations of the three samples were approximately one mile upstream of a CAFO, adjacent to the CAFO, and approximately one mile downstream of the CAFO (Figure 1). Genetic analyses of these isolates using pulsed field gel electrophoresis (PFGE) and WGS determined that the *E. coli* O157:H7 found in these three Wellton irrigation canal water samples is the same strain that caused the outbreak. Some of the EA activities described in this report were conducted throughout the Yuma growing region before the EA team was aware of this significant finding. Once the EA team became aware of the positive findings, certain activities were focused on areas around the section of the irrigation canal where these positive water samples were obtained.

As noted previously, *E. coli* O157:H7 was detected in three places along an approximate 3.5-mile section of the WMIDD Wellton irrigation canal. The locations of the three samples were approximately one mile upstream of a CAFO, adjacent to a CAFO, and approximately one mile downstream of the CAFO (Figure 1). Genetic analyses of these isolates using PFGE and WGS determined that the *E. coli* O157:H7 found in the Wellton irrigation canal water in all three locations was the same strain that caused the outbreak. In June, water samples were also collected from one CAFO well serving the feedlot (approx. 150 ft. deep) and retention pond located on the feedlot property. The well sample was collected after the water passed through a plumbed sand filtration system that was not feasible to bypass for sampling. *E. coli* O157:H7 was not detected in either sample.

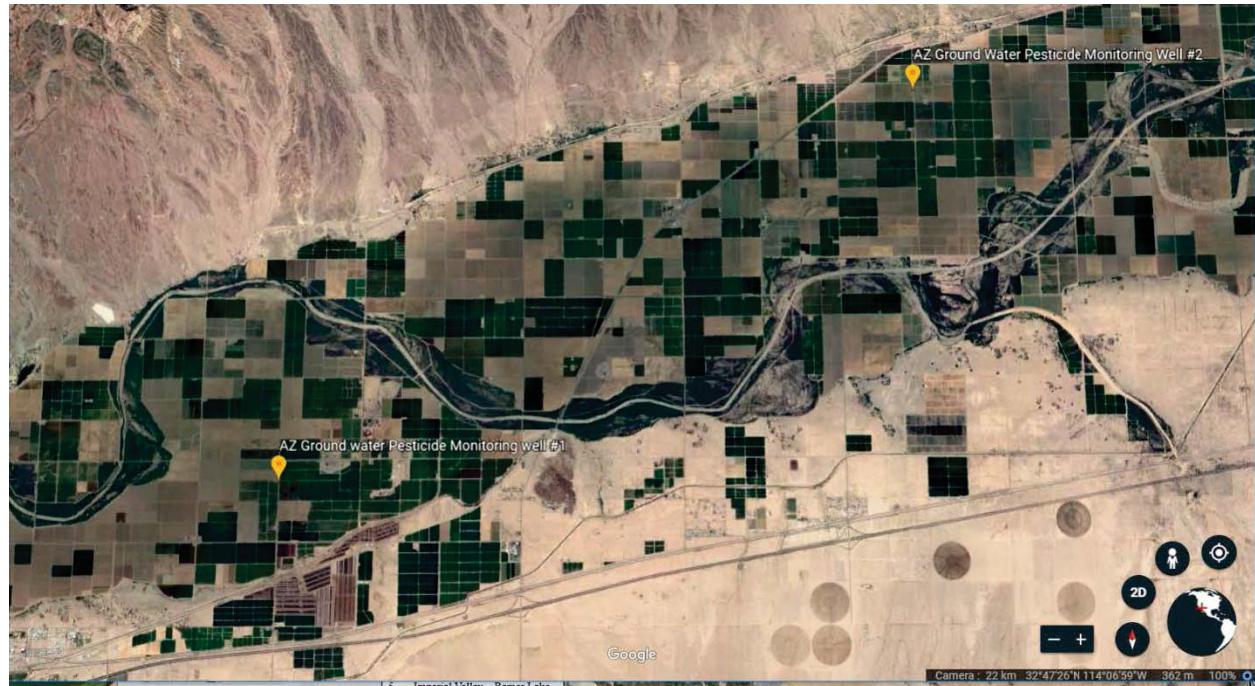
Figure 3. Map of July water sampling locations from State of Arizona ground water pesticide monitoring wells.

In July, water samples were collected from two State of Arizona pesticide ground water monitoring wells (Figure 3), as well as from the salt drainage canal downstream of the WMIDD area of responsibility (Figure 4). *E. coli* O157:H7 was not detected in either the ground water monitoring wells or the salt drainage canal.

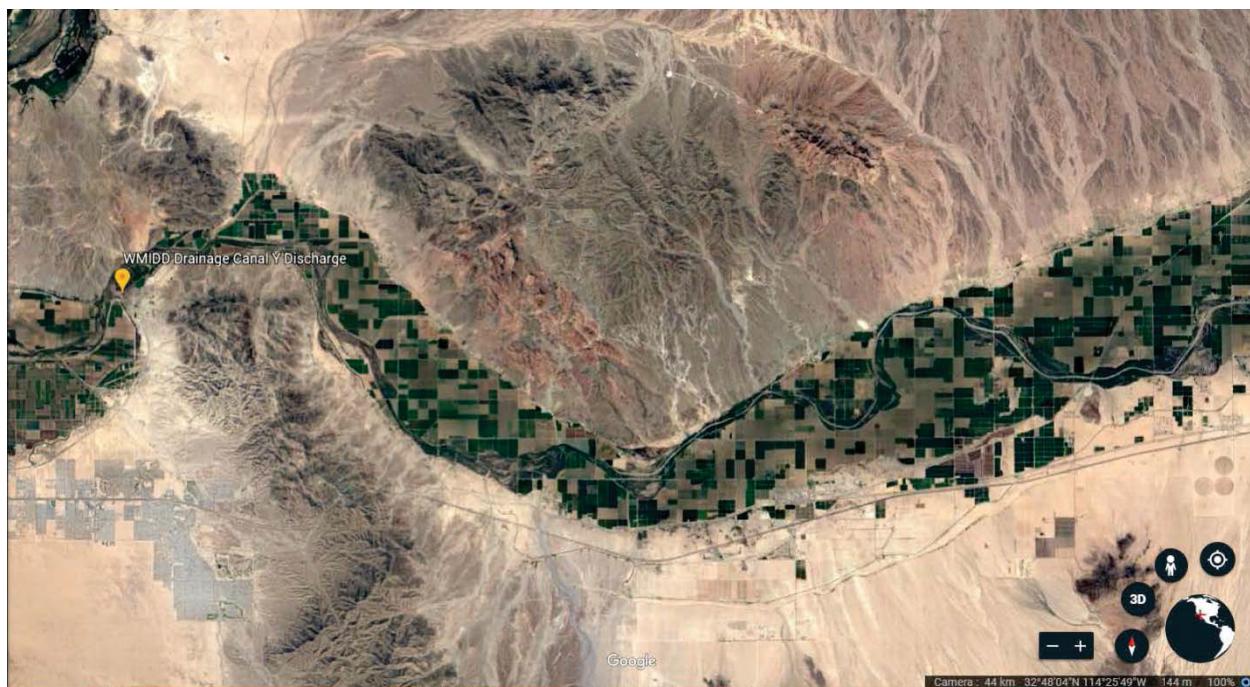
Figure 4. Map of July sampling location in salt water drain canal downstream of the WMIDD area of responsibility.

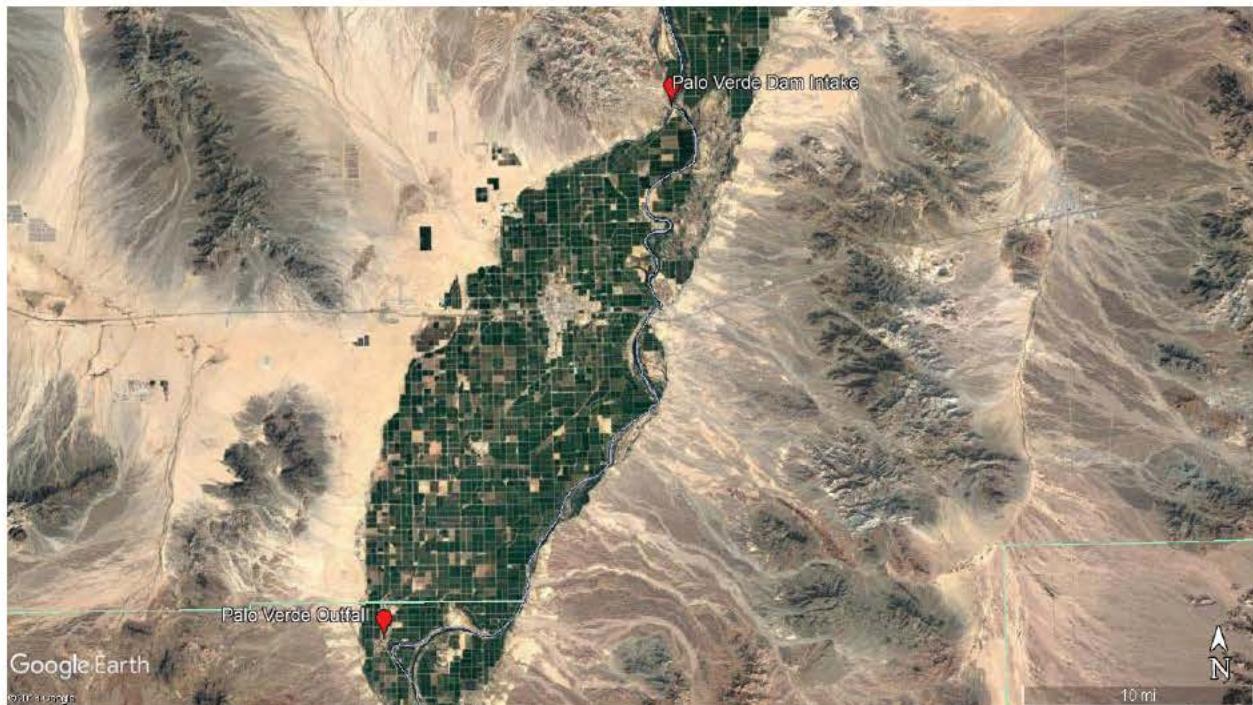
Figure 5. Map of June sampling locations at PV Dam and PV Irrigation Canal discharge into the river.

Water samples were collected from the Palo Verde (PV) valley and Imperial Dam area (Figures 5 & 6).

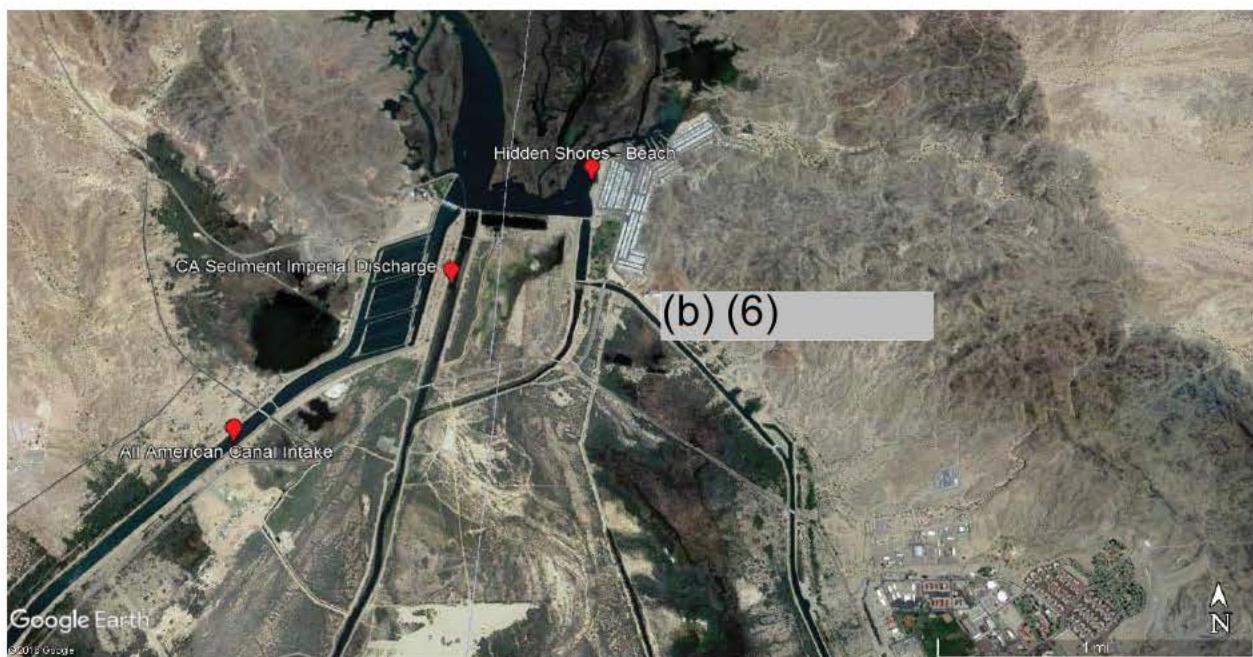
Figure 6. Map of June sampling locations at Imperial Dam and All American and AZ irrigation canals.

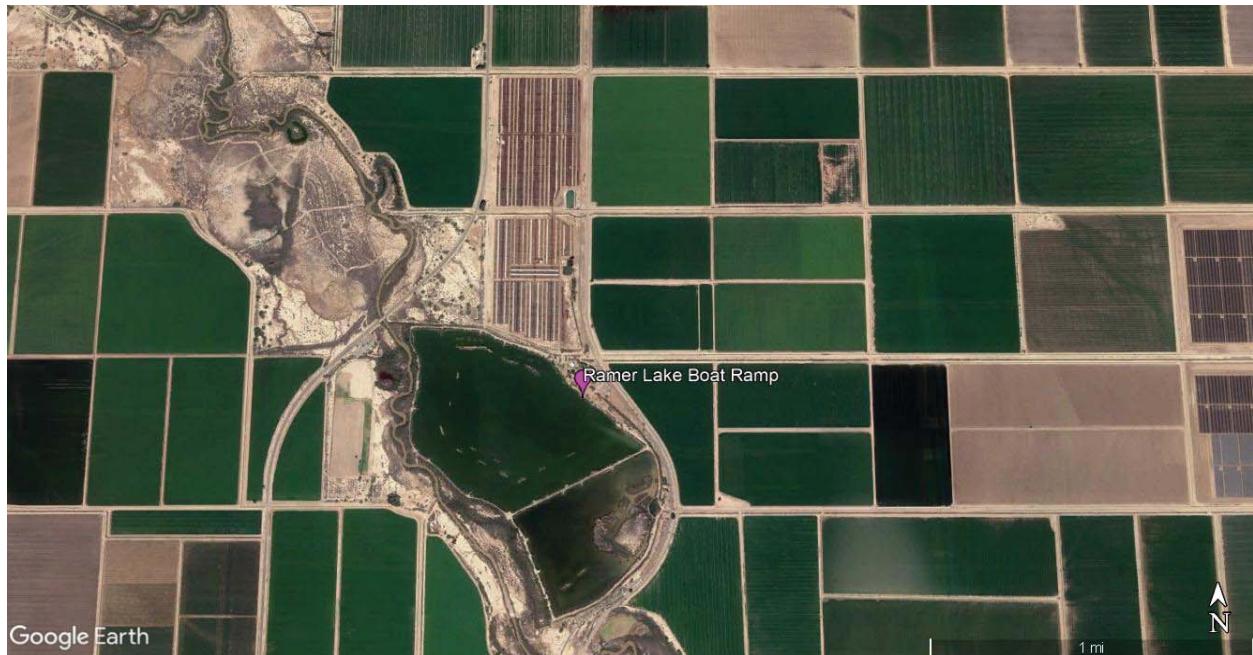
Figure 7. *Map of June water sampling location in Imperial Valley at Ramer Lake adjacent to cattle feedlot*

In June, the EA team collected samples of surface water from a public pond (Figure 7) immediately adjacent to an Imperial County CAFO near Imperial County farms identified by traceback and from irrigation canal drainage into the Salton Sea (Figure 8). The outbreak strain was not detected.
