RE: Post Comments to the following Dockets:
- Docket No. 02N-0534: Medical Device User Fee and Modernization Act (MDUFMA) &
- Docket No. 03N-0161: Medical Devices; Reprocessed Single-Use Devices; Termination
of Exemptions from Premarket Notification; Requirement for Submission of Validation
Data

Report on Observations of New and Reprocessed Octopus 3[®] Tissue Stabilizers and Octopus 4[®] Tissue Stabilizers

The objective of this study was to evaluate new sterile and reprocessed sterile Medtronic Octopus 3[®] and Octopus 4[®] Tissue Stabilizers (see attached product PDF files). A report dated May 24, 2004 contained information and data describing the differences observed between new sterile and reprocessed sterile Medtronic Octopus 3[®] and Octopus 4[®] Tissue Stabilizers. In that report a total of four devices were assessed, one new sterile Medtronic Octopus 3[®], one new sterile Medtronic Octopus 4[®], one reprocessed sterile Medtronic Octopus 3[®] (SterilMed) and one reprocessed sterile Medtronic Octopus 4[®] (Alliance). Subsequent to that report, eight additional reprocessed Medtronic Octopus 3[®] and Octopus 4[®] Tissue Stabilizers from the same two reprocessors were examined

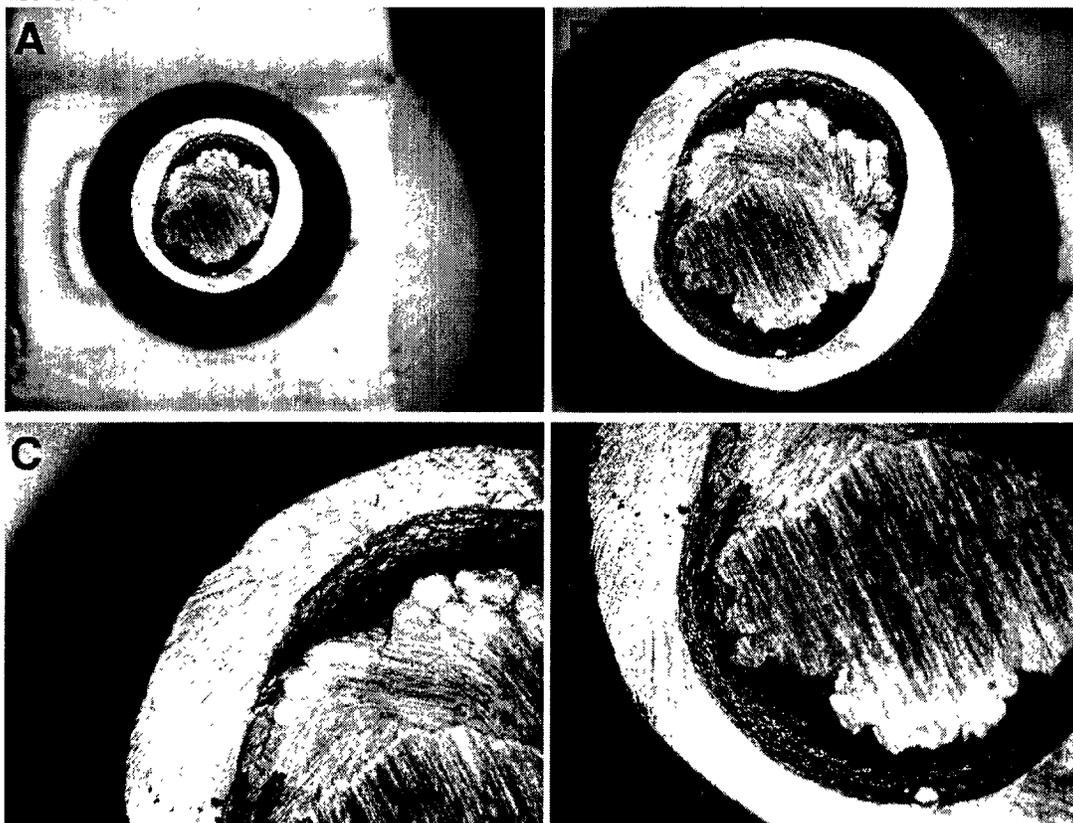
Figure 8. Ball joint region from a new sterile **Octopus 4[®]** (MT-104-4). No corrosion or debris was observed.

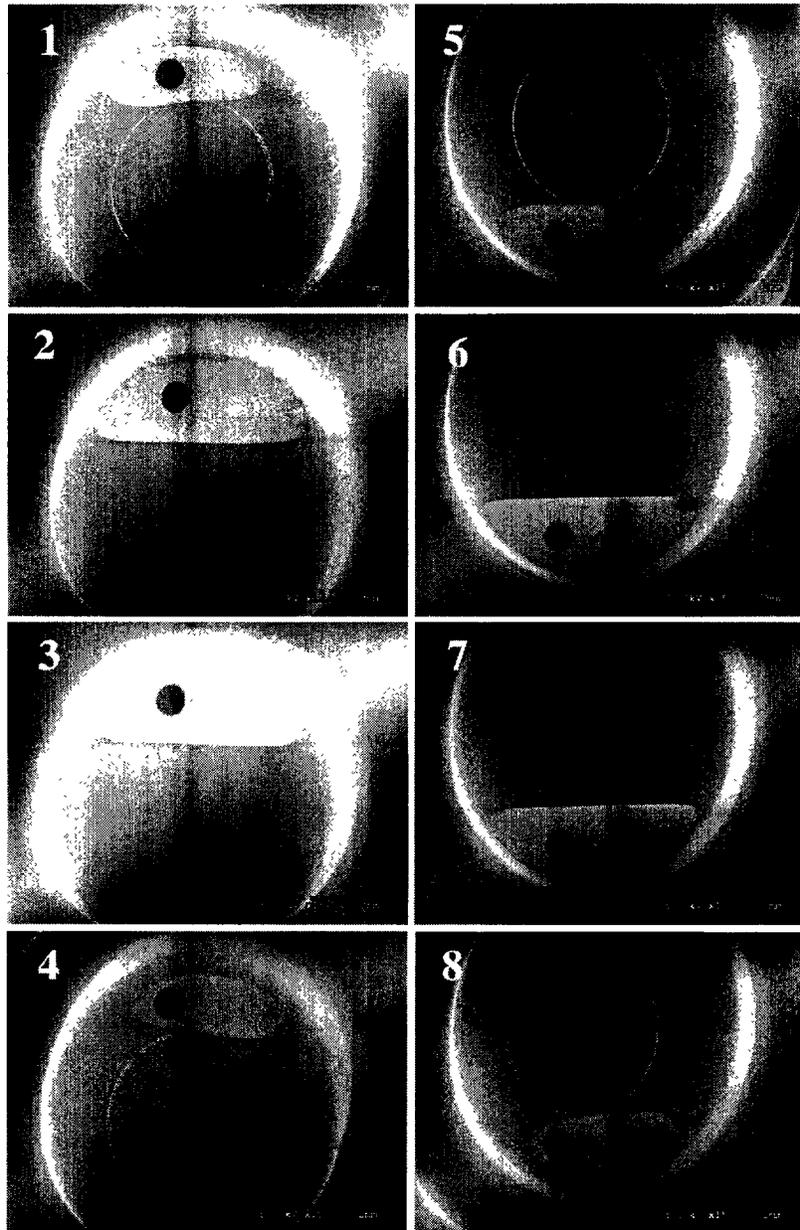
Figure 15. Series of images collected from Hitachi S3500N variable pressure scanning electron microscope in the areas of the pods on the **new Octopus 3[®] (MT-104-1)**. The images show uniform surface structure in the wells and tubing. There are what appear to be small pieces of the same material as the pod in some wells (e.g. #2 and #6). The numbers indicate the pod # (see Figure 5). Scale bar in each image.

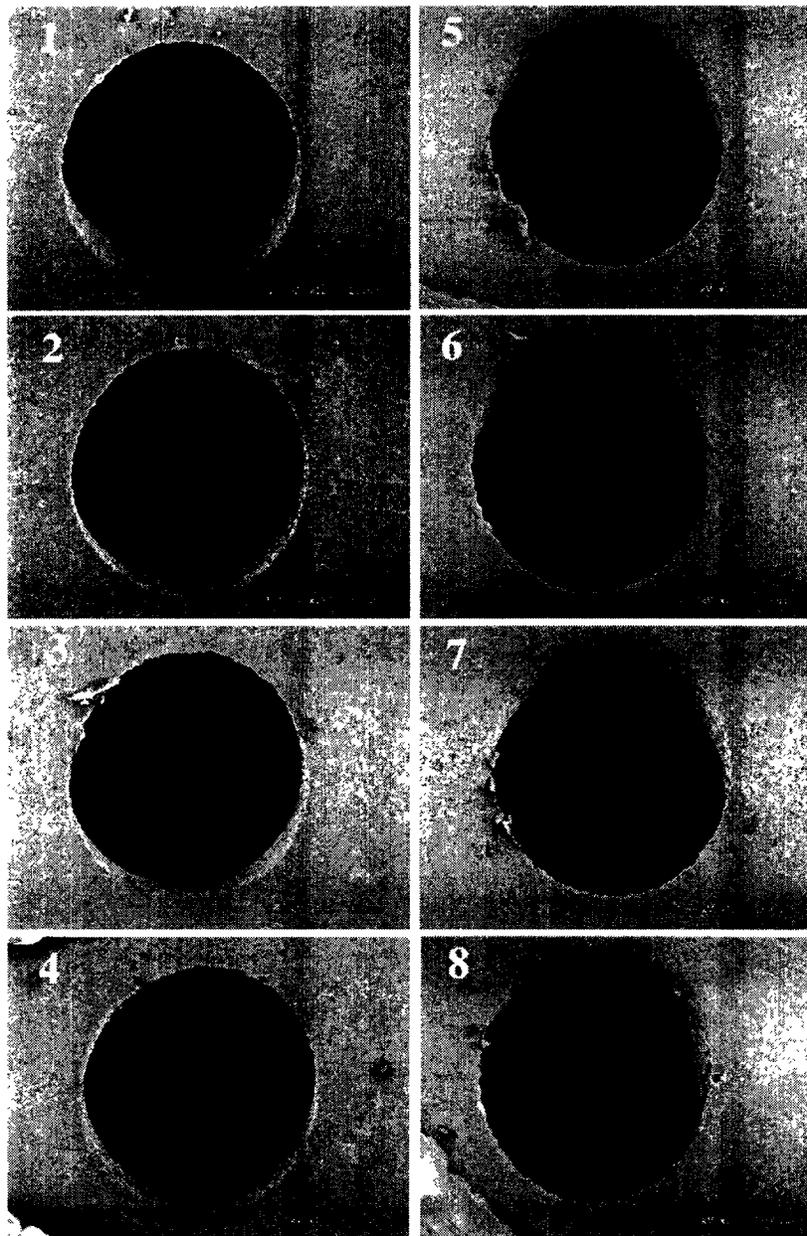
Figure 16. Series of images collected from Hitachi S3500N variable pressure scanning electron microscope in the areas of the orifices in the tubing within each pod on the **new Octopus 3[®] (MT-104-1)**. The images show uniform surface structure on the metal surface of the tubing. The openings appear to be uniform in size and composition. There are what appear to be small pieces of debris in some wells (e.g. #3, #7 and #8). The debris does not appear organic. The numbers indicate the pod # (see Figure 5). Scale bar in each image.

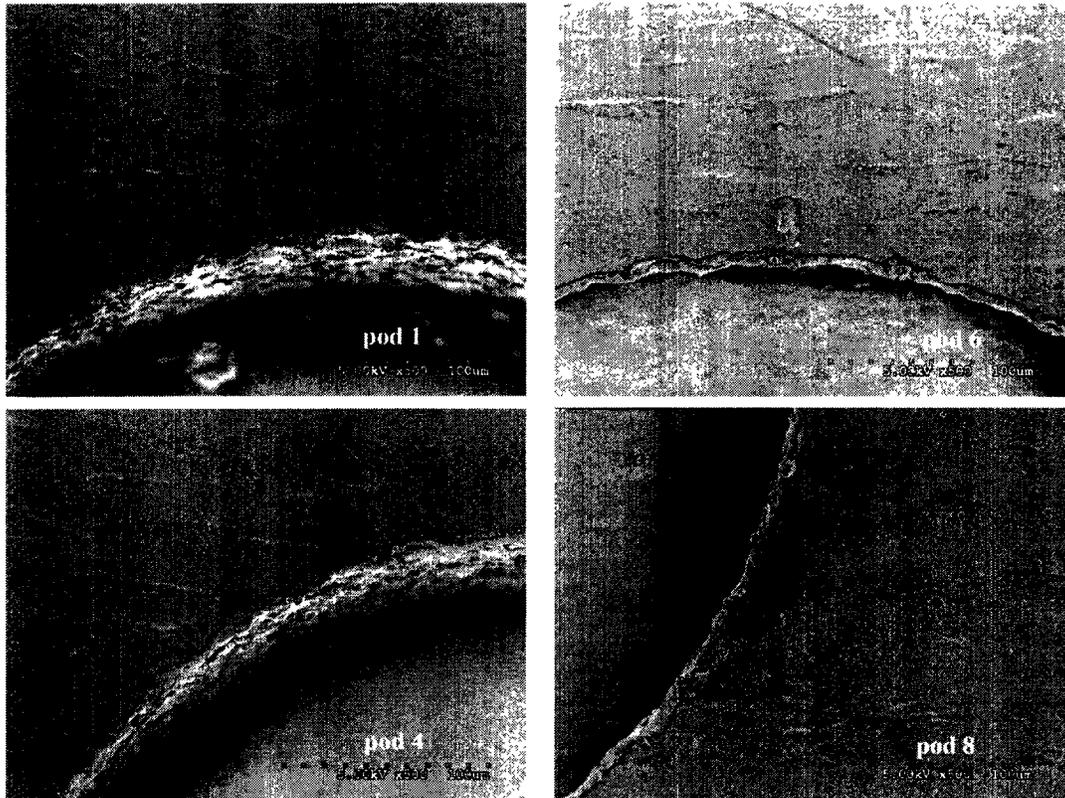
Figure 17. Series of images collected from Hitachi S3500N variable pressure scanning electron microscope of the inner surfaces following cutting in the areas of the orifices in the hypotube on the **new Octopus 3[®]** (MT-104-1). The images show relatively uniform surface structure on the metal surface of the tubing. The openings appear to be uniform in size and composition. There are what appear to be small pieces of debris in some wells. The debris does not appear organic. The label indicates the pod # (see Figure 5). Scale bar in each image.

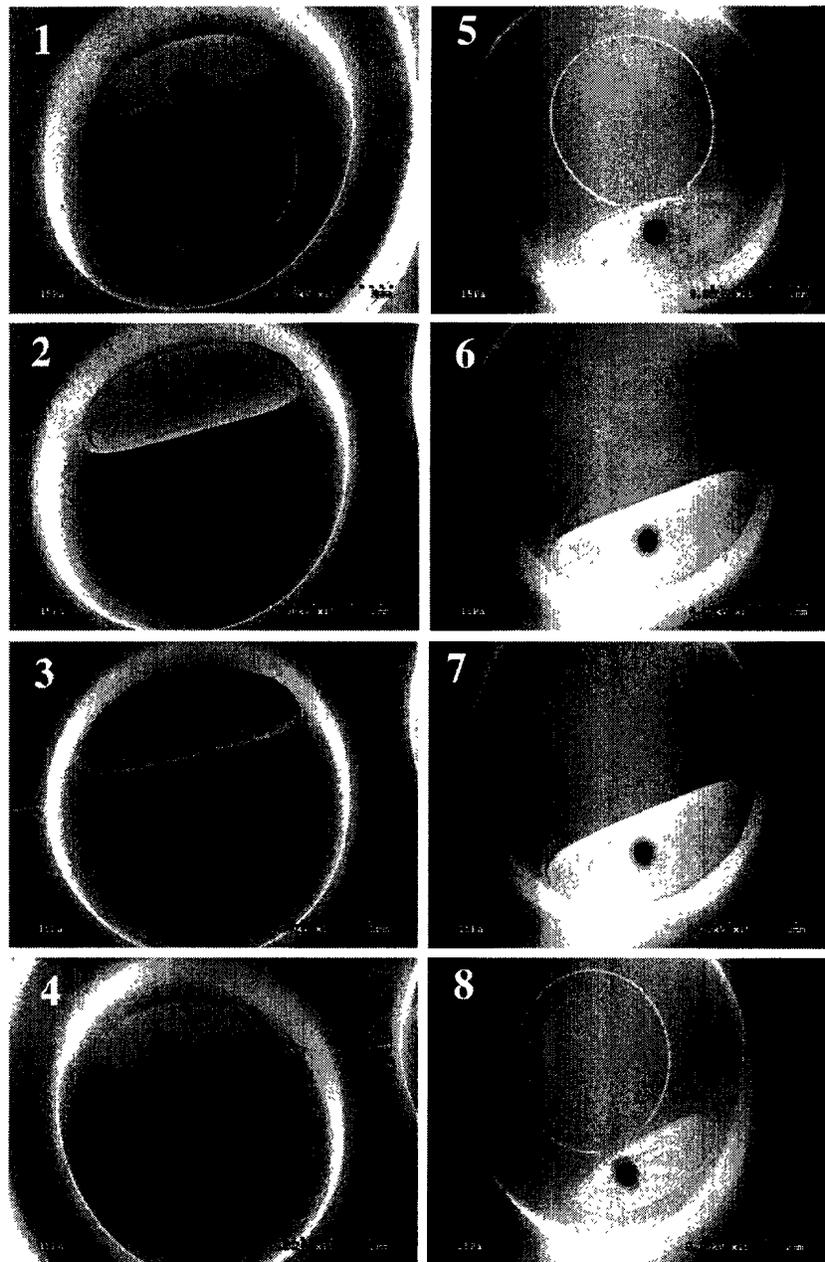
Figure 21. Series of images collected from Hitachi S3500N variable pressure scanning electron microscope in the areas of the pods on the **reprocessed Octopus 3[®] MT-104-3**. The images show irregularities on surface structure in the wells and tubing. There are irregularities and debris present in the orifices of the tubing. The numbers indicate the pod # (see Figure 5). Scale bar in each image.

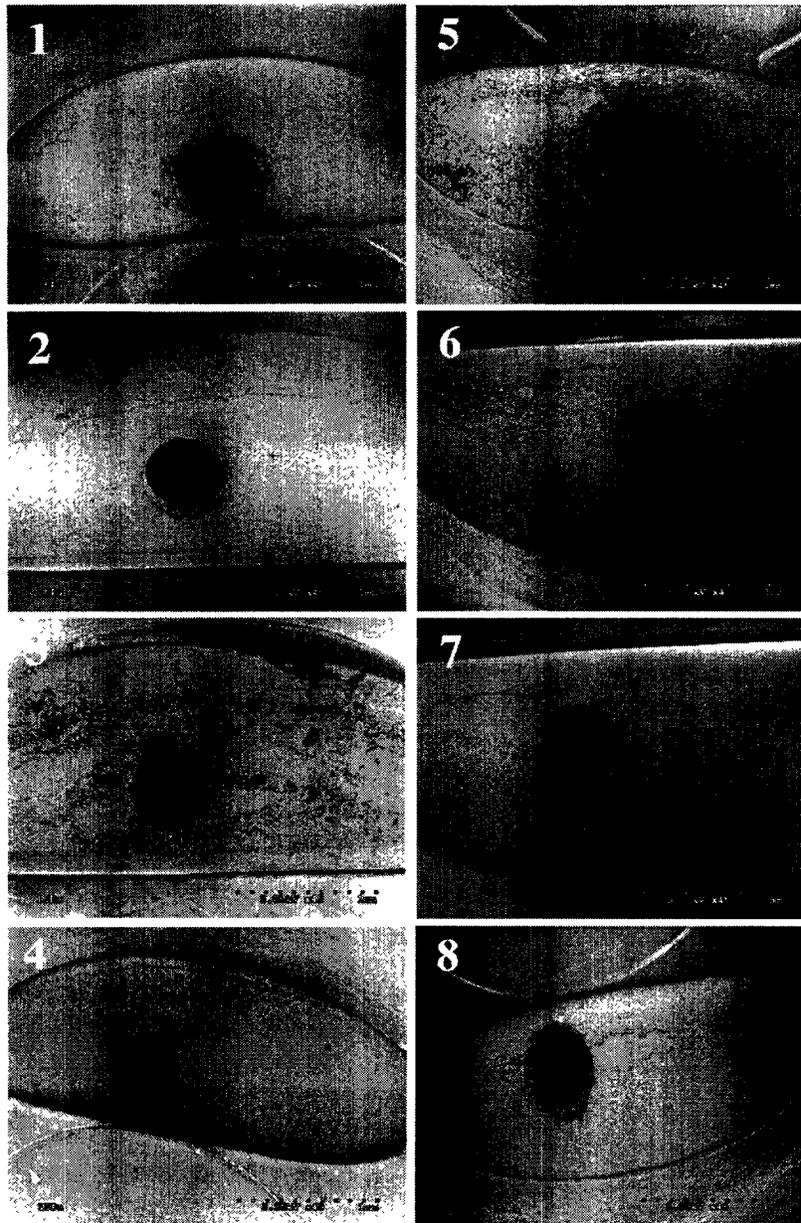
Figure 22. Series of images collected from Hitachi S3500N variable pressure scanning electron microscope in the areas of the tubing within the pods on the **reprocessed Octopus 3[®] MT-104-3**. The images show irregularities on surface structure of the tubing (e.g. in all pods to varying degrees). There is debris and irregularities present in the orifices of the tubing (e.g. in #1, #3, #5, #6, #7 and #8). The orifices are not as uniform in shape when compared to the “new” Octopus 3[®] (Figure 15). The numbers indicate the pod # (see Figure 5). Scale bar in each image.

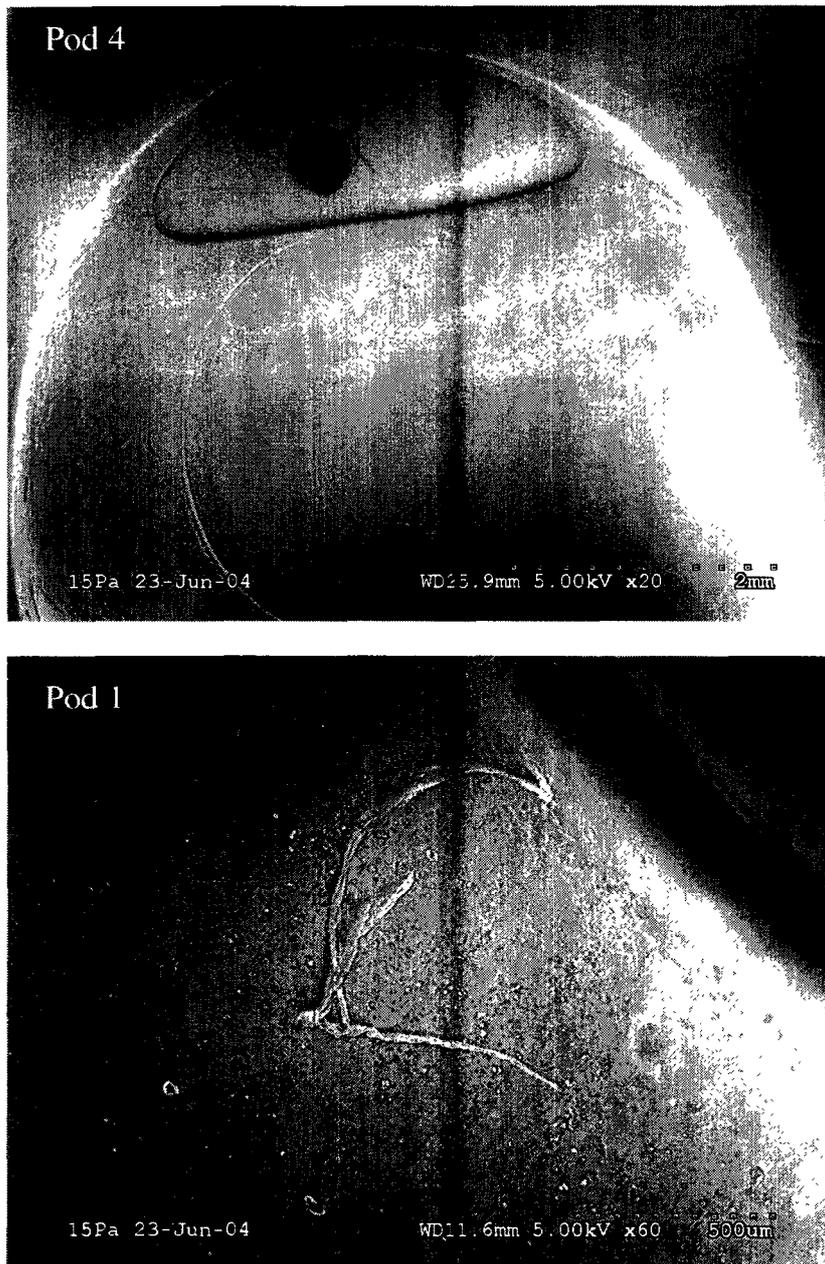
Figure 28. Images collected from Hitachi S3500N variable pressure scanning electron microscope in the areas of the pods on the **reprocessed Octopus 3[®] MT-104-5**. The images show hair-like fibers on surface of the hypotubing near the opening. There is also debris present in the surface of the tubing. The numbers in the upper left indicate the pod # (see Figure 5). Scale bar in each image.

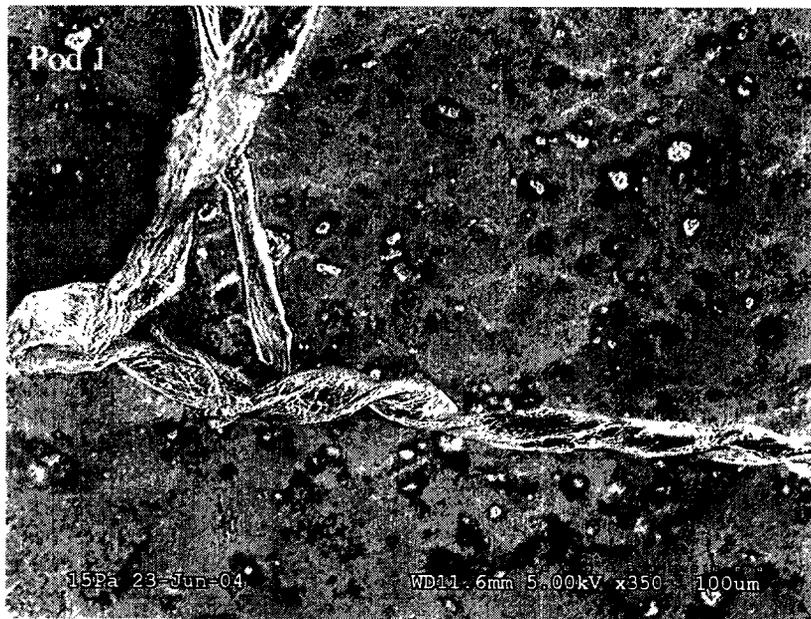
Figure 29. Image collected from Hitachi S3500N variable pressure scanning electron microscope in the areas of pod 1 on the **reprocessed Octopus 3[®] MT-104-5**. The images show hair-like fibers on surface of the hypotubing near the opening. There is also debris present in the surface of the tubing. The number in the upper left indicates the pod # (see Figure 5). Scale bar in each image.

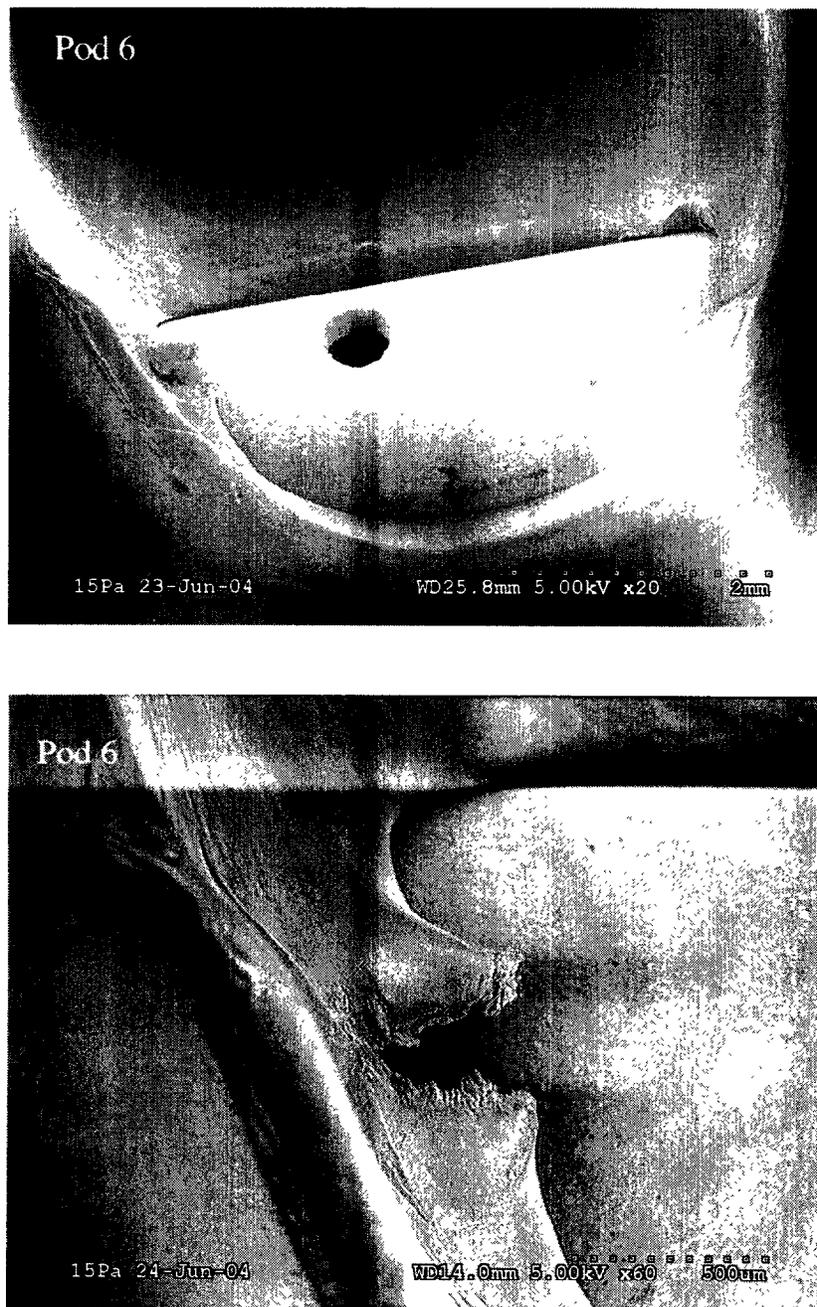
Figure 30. Image collected from Hitachi S3500N variable pressure scanning electron microscope in the areas of pod 6 on the **reprocessed Octopus 3[®] MT-104-5**. The images show a tear of the material surrounding the hypotube. There is also debris present in the surface of the tubing (upper panel). The number in the upper left indicates the pod # (see Figure 5). Scale bar in each image.

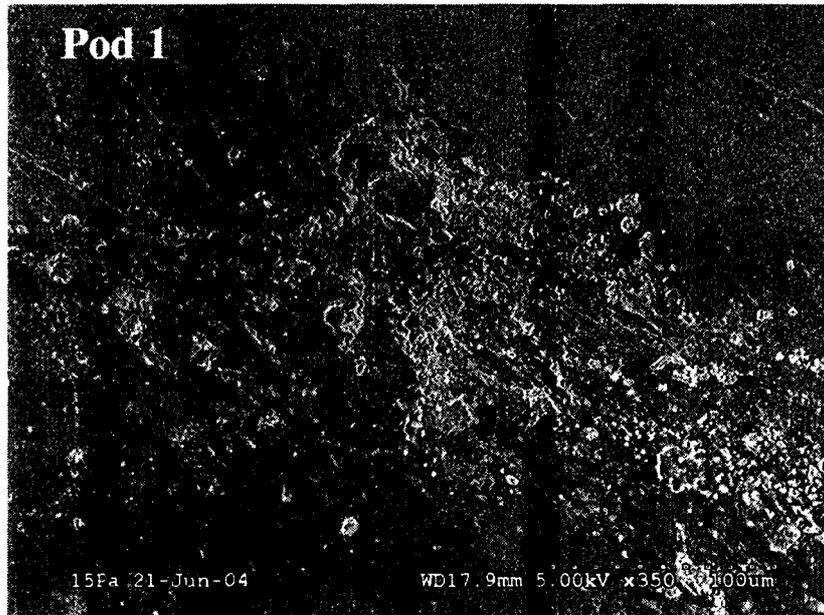
Figure 31. Image collected from Hitachi S3500N variable pressure scanning electron microscope in the areas of pod 1 on the **reprocessed Octopus 3[®] MT-104-7**. The images show debris on surface of the hypotube. The number in the upper left indicates the pod # (see Figure 5). Scale bar in each image.

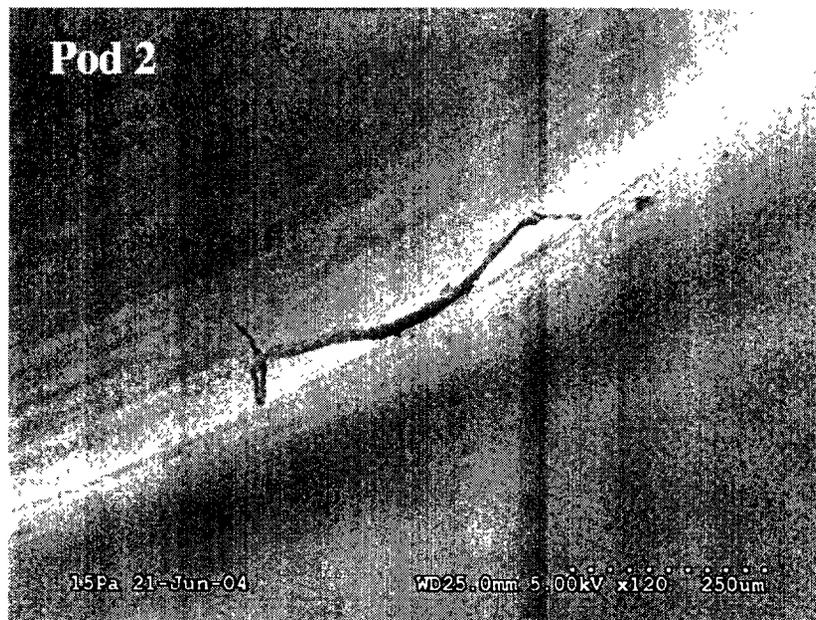
Figure 33. Image collected from Hitachi S3500N variable pressure scanning electron microscope in the areas of pod 2 on the **reprocessed Octopus 3[®] MT-104-7**. The images show hair-like fiber on surface of the pod. The number in the upper left indicates the pod # (see Figure 5). Scale bar in each image.

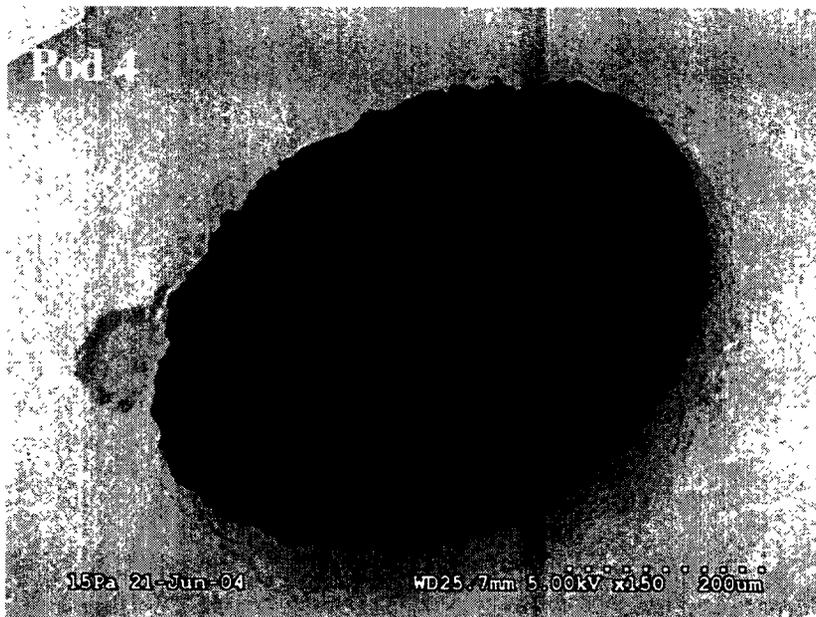
Figure 34. Series of images collected from Hitachi S3500N variable pressure scanning electron microscope of the tubing within pod 4 on the **reprocessed Octopus 3[®] MT-104-7**. Note material near the opening of the tubing orifice and the irregular shape. Scale bar in each image

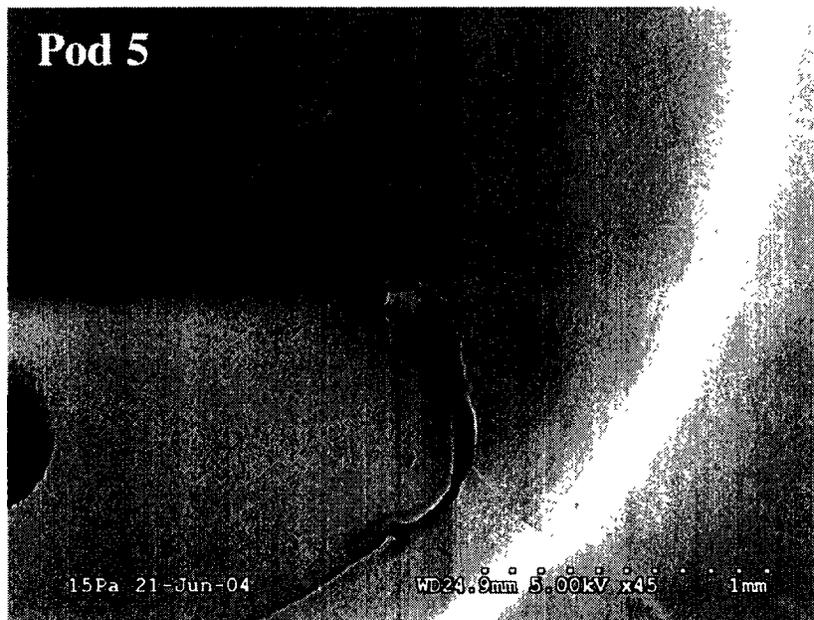
Figure 35. Image collected from Hitachi S3500N variable pressure scanning electron microscope in the areas of pod 5 on the **reprocessed Octopus 3[®] MT-104-7**. The images show a tear of the material surrounding the hypotube. There is also debris present. The number in the upper left indicates the pod # (see Figure 5). Scale bar in each image.

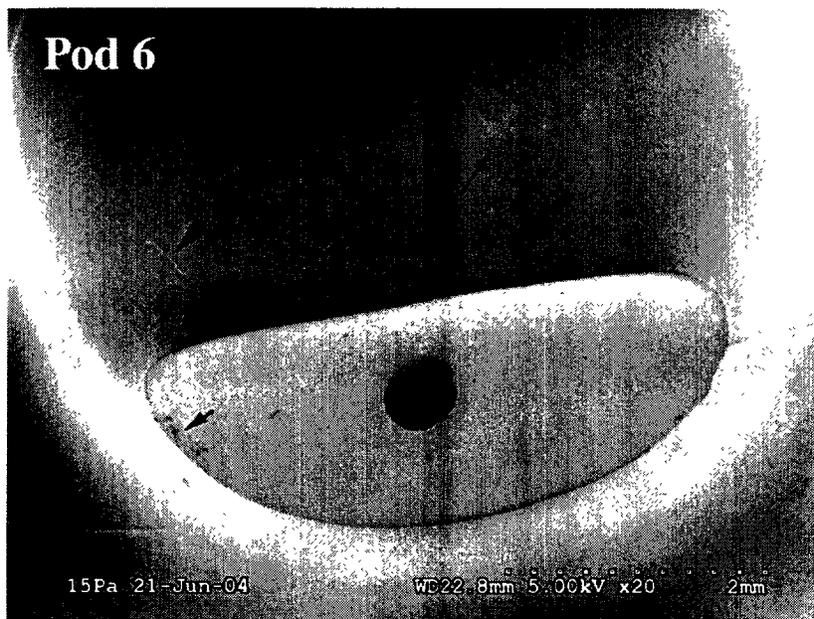
Figure 36. Image collected from Hitachi S3500N variable pressure scanning electron microscope in the areas of pod 6 on the **reprocessed Octopus 3[®] MT-104-7**. The images show a fiber (arrowhead) and debris on surface of pod and hypotube (arrows). The number in the upper left indicates the pod # (see Figure 5). Scale bar in each image.

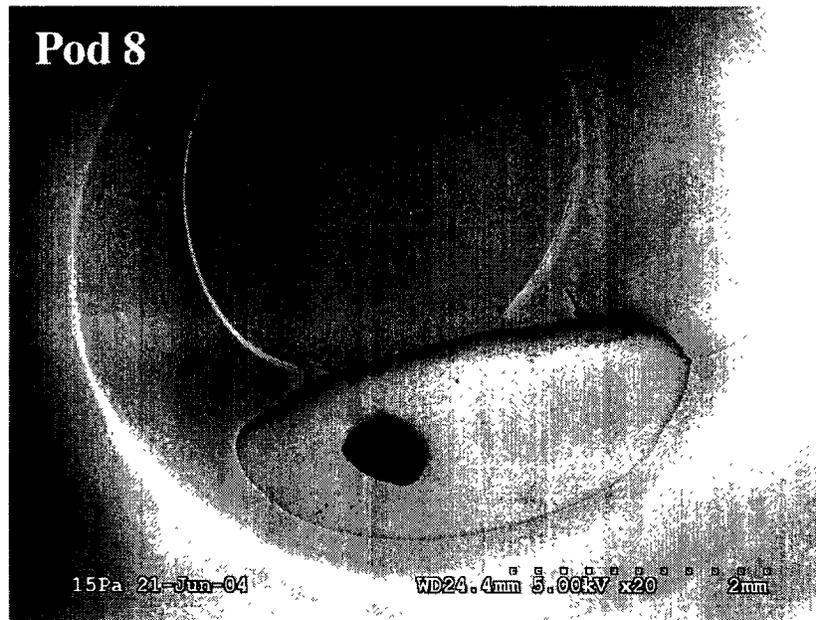
Figure 37. Image collected from Hitachi S3500N variable pressure scanning electron microscope in the areas of pod 8 on the **reprocessed Octopus 3[®] MT-104-7**. The images show debris on surface of pod and hypotube (arrows). Note gap between the hypotube and the pod. The number in the upper left indicates the pod # (see Figure 5). Scale bar in each image.

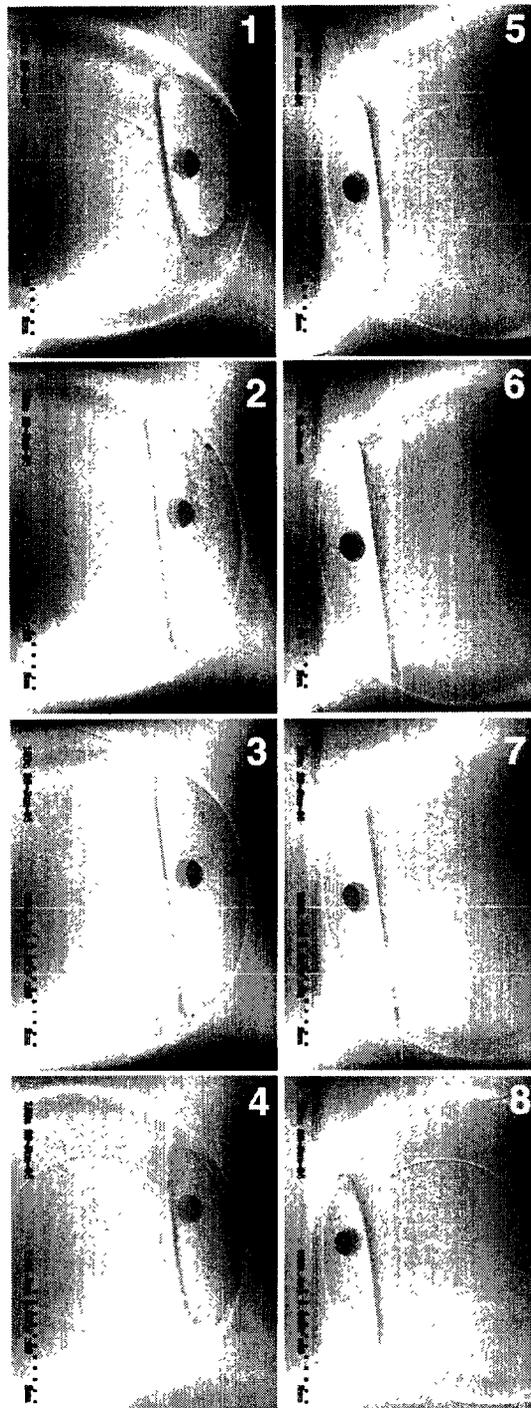
Figure 40. Series of images collected from Hitachi S3500N variable pressure scanning electron microscope in the areas of the pods on the **reprocessed Octopus 3[®] MT-104-9**. The images show irregularities on surface structure in the wells and tubing. There are irregularities and debris present in the orifices of the tubing. The numbers indicate the pod # (see Figure 5). Scale bar in each image.

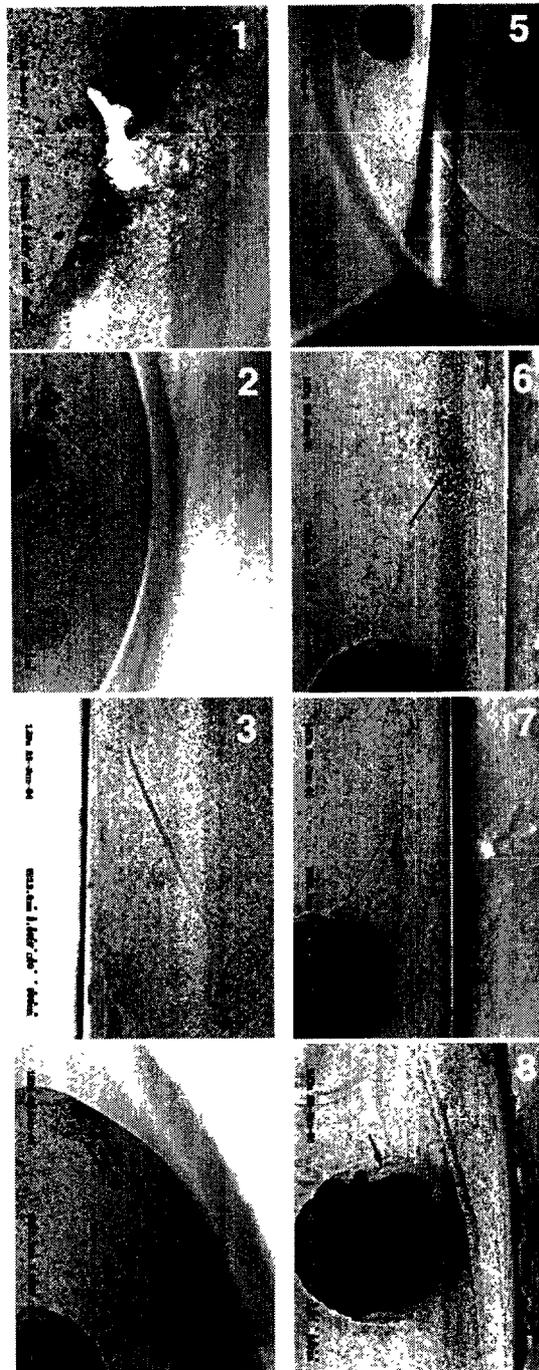
Figure 41. Series of images collected from Hitachi S3500N variable pressure scanning electron microscope in the areas of the tubing within the pods on the **reprocessed Octopus 3[®] MT-104-9**. The images show irregularities on surface structure of the tubing (e.g. in all pods to varying degrees). There is debris and irregularities present in the orifices of the tubing (e.g. in #2, #5, #6, #7 and #8). The numbers indicate the pod # (see Figure 5). Scale bar in each image.

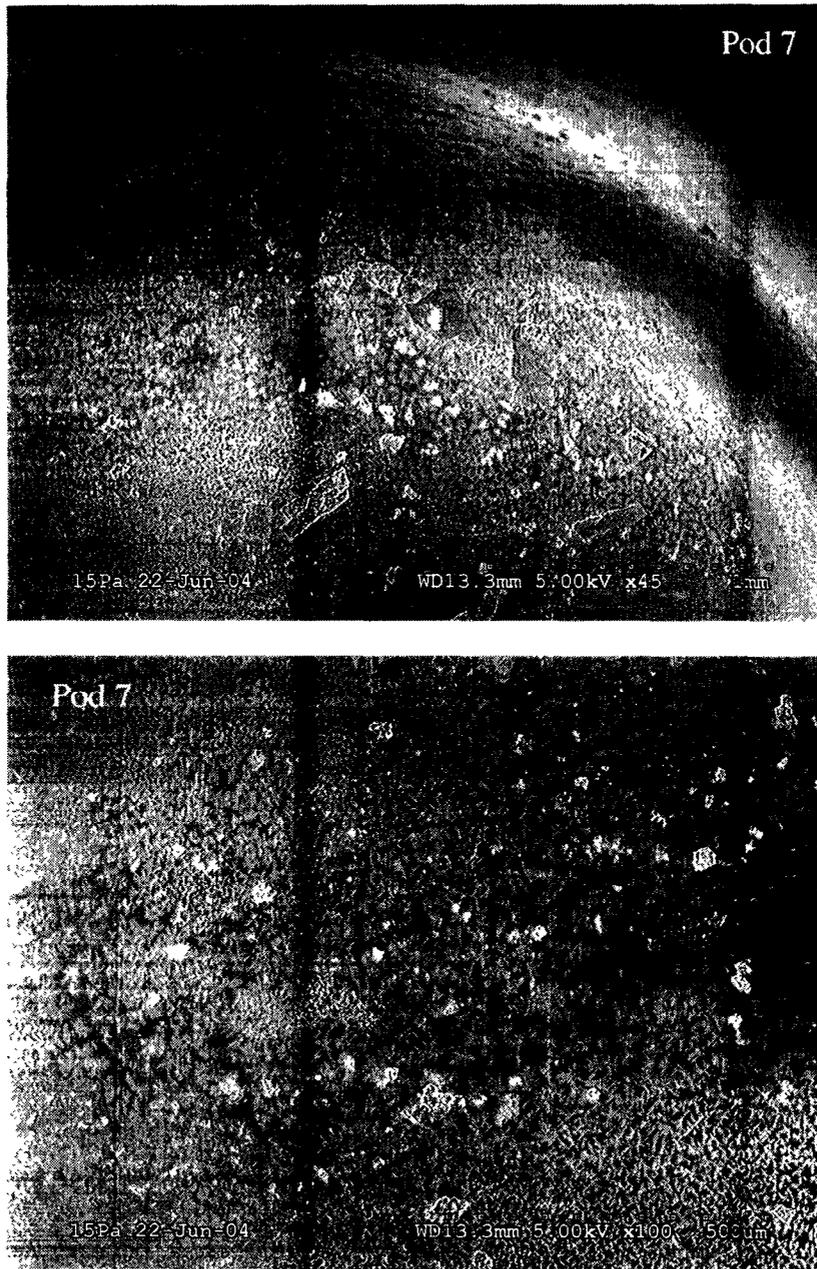
Figure 42. Images collected from Hitachi S3500N variable pressure scanning electron microscope in the areas of pod 1 on the **reprocessed Octopus 3[®] MT-104-9**. The images show bioburden and crystalline debris present in the surface of the tubing. The number in the upper corner indicates the pod # (see Figure 5). Scale bar in each image.

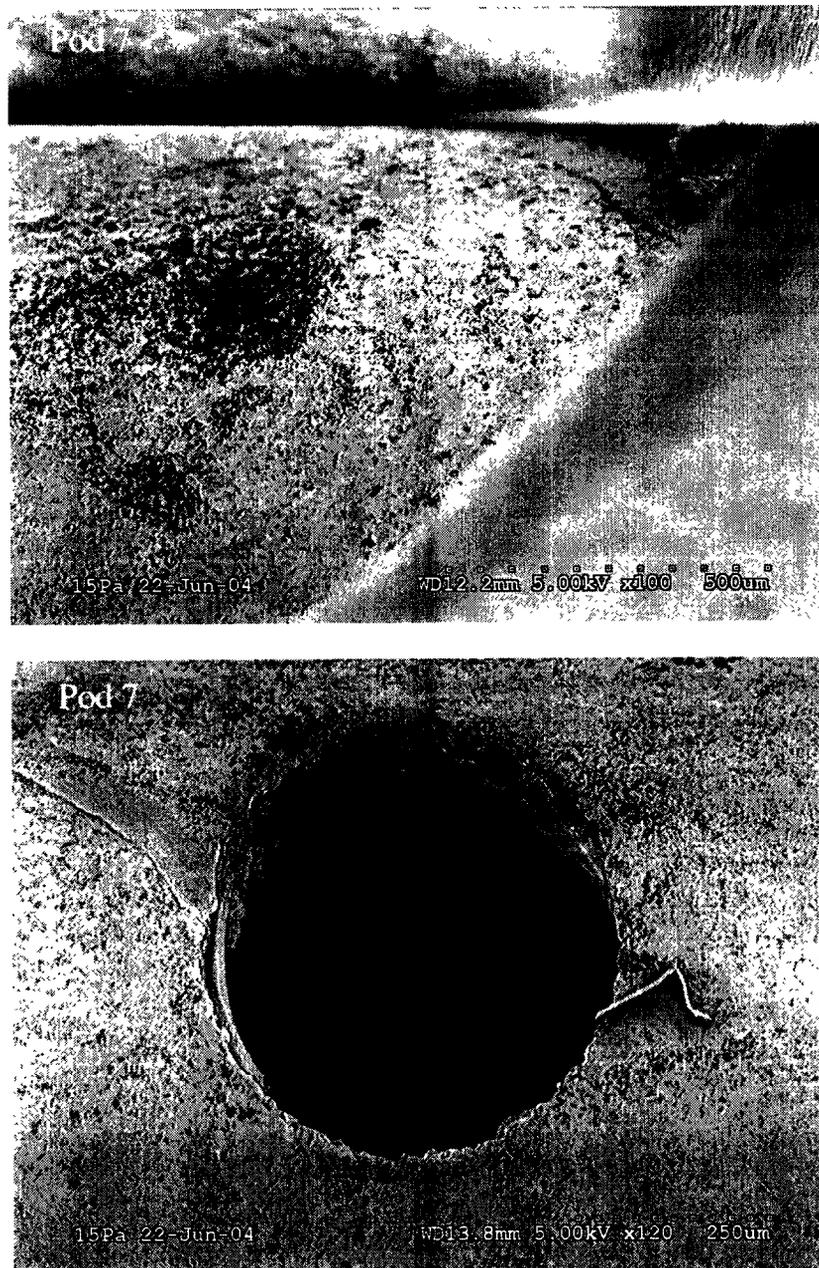
Figure 43. Series of images collected from Hitachi S3500N variable pressure scanning electron microscope in the areas of the tubing within the pods on the **reprocessed Octopus 3® MT-104-9**. The images show irregularities on surface structure of the tubing. There is debris and irregularities present in the orifices of the tubing. Note fiber near orifice and gouge near the opening of the hypotube. The numbers indicate the pod # (see Figure 5). Scale bar in each image.

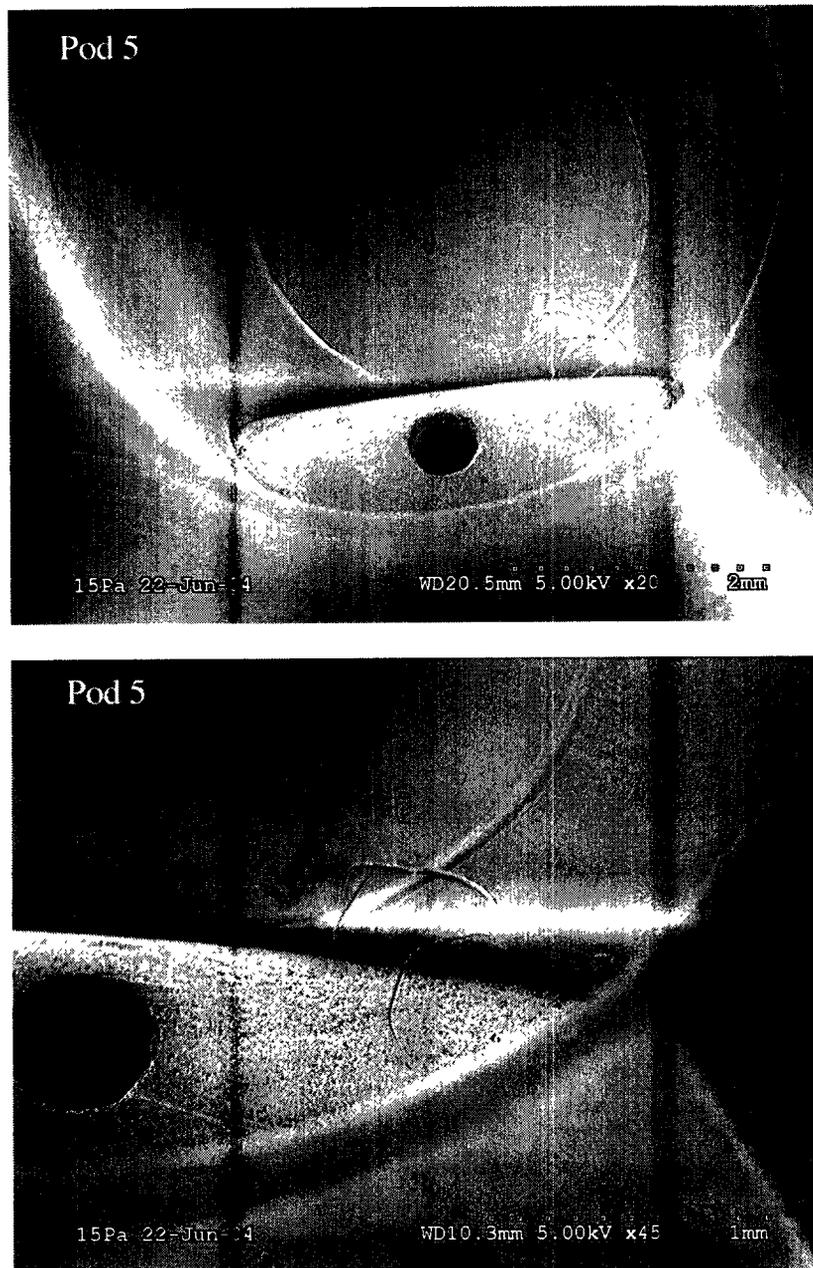
Figure 44. Series of images collected from Hitachi S3500N variable pressure scanning electron microscope in the areas of the tubing within the pods on the **reprocessed Octopus 3[®] MT-104-9**. The images show irregularities on surface structure of the tubing. Note the hair and the enlarged gap between the hypotubing and the pod. The numbers indicate the pod # (see Figure 5). Scale bar in each image.

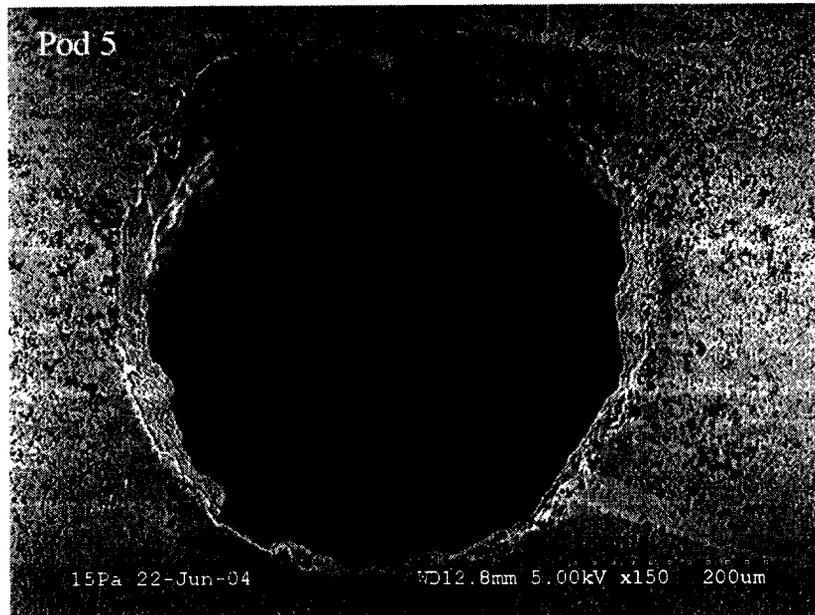
Figure 46. Image collected from Hitachi S3500N variable pressure scanning electron microscope in the areas of the hypotube opening of the **reprocessed Octopus 3[®] MT-104-9**. There is debris and irregularities present in the orifices of the tubing. The numbers indicate the pod # (see Figure 5). Scale bar in each image.

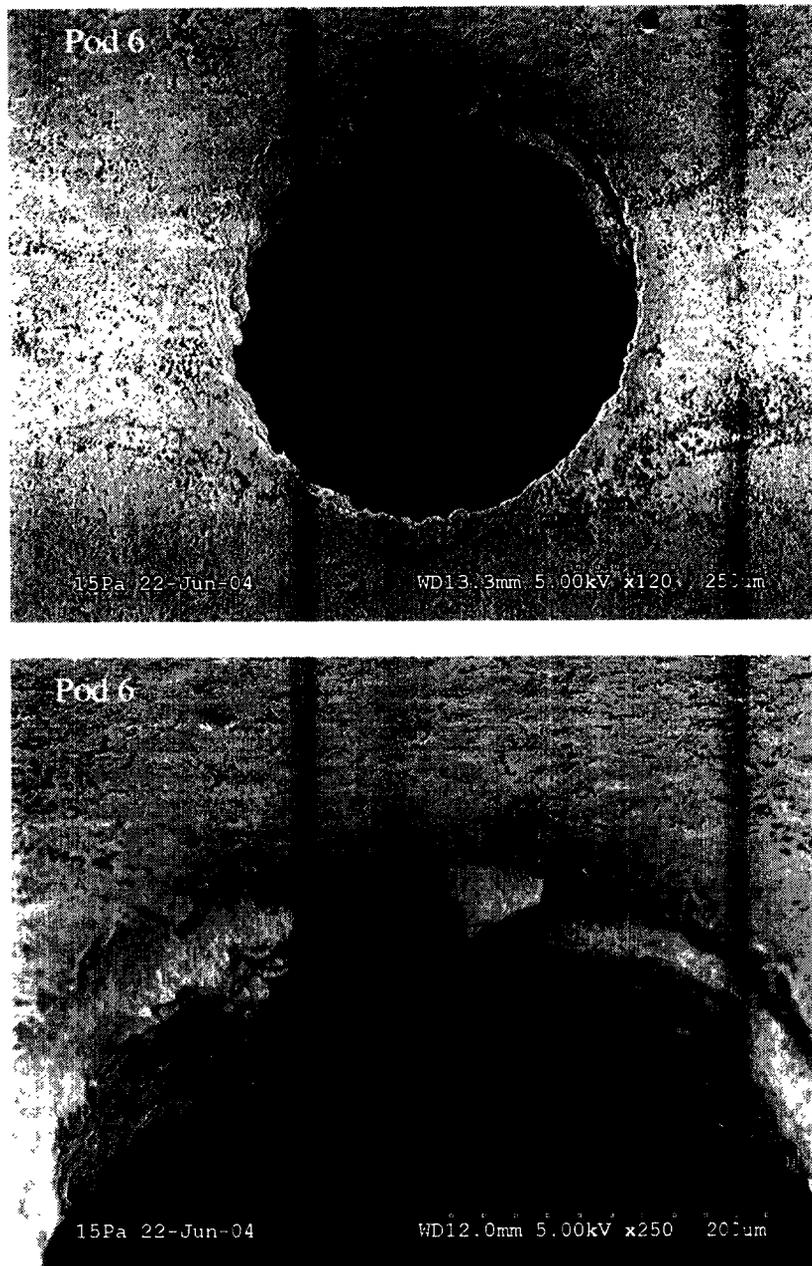
Figure 47. Image collected from Hitachi S3500N variable pressure scanning electron microscope in the areas of the hypotube opening of pod 6 of the **reprocessed Octopus 3® MT-104-9**. There is bioburden debris and irregularities present in the orifices of the tubing. The numbers indicate the pod # (see Figure 5). Scale bar in each image.

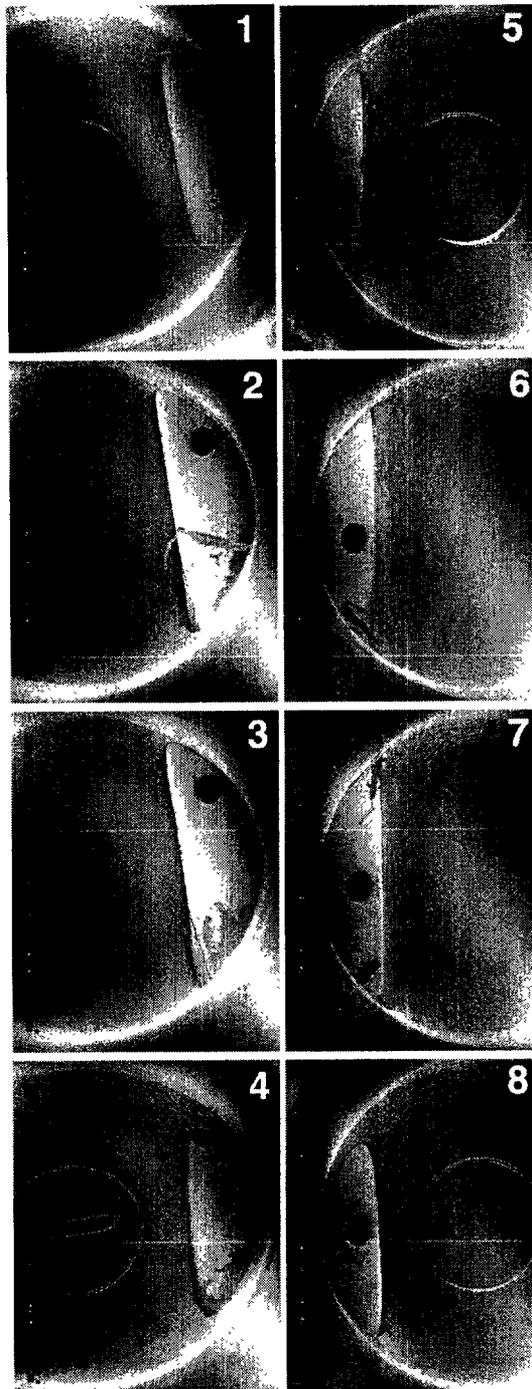
Figure 48. Series of images collected from Hitachi S3500N variable pressure scanning electron microscope of the pods on the **reprocessed Octopus 4[®] MT-104-10**. The images show various irregularities and contamination on the surface structure of the tubing and the pods. All images show foreign debris and contamination present on the surface of the tubing when compared to “new”. Scale bar in each image.

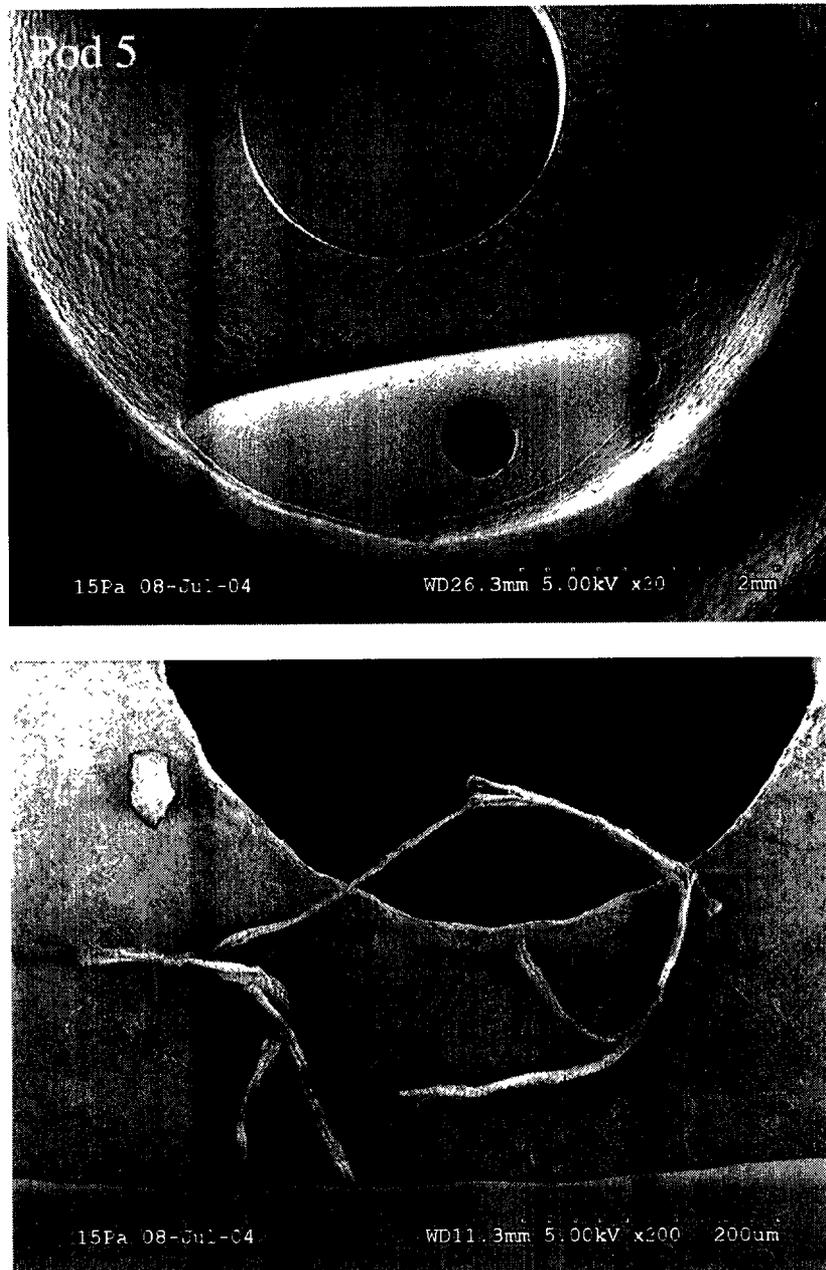
Figure 57. Images collected from Hitachi S3500N variable pressure scanning electron microscope in the areas of pod 5 on the **reprocessed Octopus 4[®] MT-104-11**. The images show hair-like fibers on surface of the hypotubing near the opening. There is also debris present in the surface of the tubing. The number in the upper left indicates the pod # (see Figure 5). Scale bar in each image.
