RE: Post Comments to the following Dockets:
- Docket No. 02N-0534: Medical Device User Fee and Modernization Act (MDUFMA) &
- Docket No. 03N-0161: Medical Devices; Reprocessed Single-Use Devices; Termination
of Exemptions from Premarket Notification; Requirement for Submission of Validation
Data

Report on Observations of New and Reprocessed Octopus 3[®] Tissue Stabilizers and Octopus 4[®] Tissue Stabilizers

The objective of this study was to evaluate new sterile and reprocessed sterile Medtronic Octopus 3[®] and Octopus 4[®] Tissue Stabilizers (see attached product PDF files). A report dated May 24, 2004 contained information and data describing the differences observed between new sterile and reprocessed sterile Medtronic Octopus 3[®] and Octopus 4[®] Tissue Stabilizers. In that report a total of four devices were assessed, one new sterile Medtronic Octopus 3[®], one new sterile Medtronic Octopus 4[®], one reprocessed sterile Medtronic Octopus 3[®] (SterilMed) and one reprocessed sterile Medtronic Octopus 4[®] (Alliance). Subsequent to that report, eight additional reprocessed Medtronic Octopus 3[®] and Octopus 4[®] Tissue Stabilizers from the same two reprocessors were examined

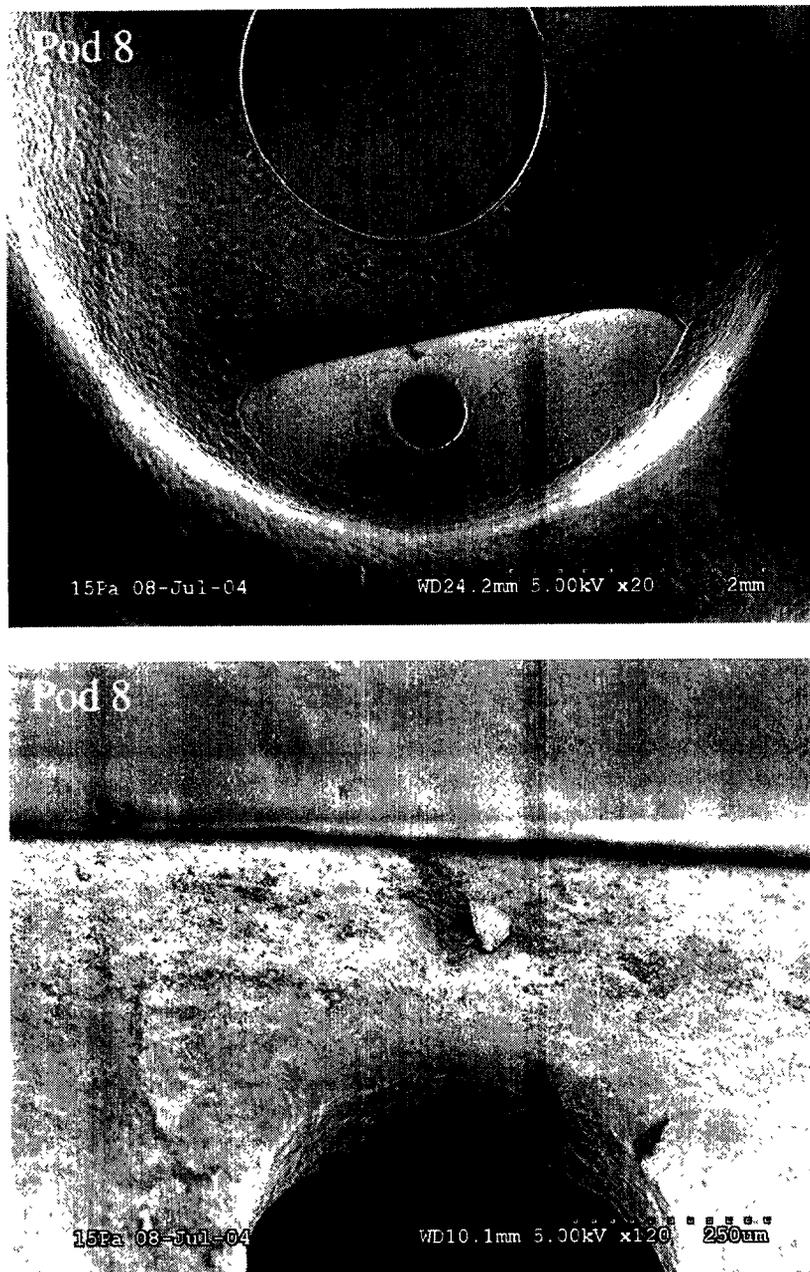
Figure 58. Images collected from Hitachi S3500N variable pressure scanning electron microscope in the areas of pod 8 on the **reprocessed Octopus 4[®] MT-104-11**. The images show contamination on surface of the hypotubing near the opening. There is also debris present on the surface of the tubing. The number in the upper left indicates the pod # (see Figure 5). Scale bar in each image.

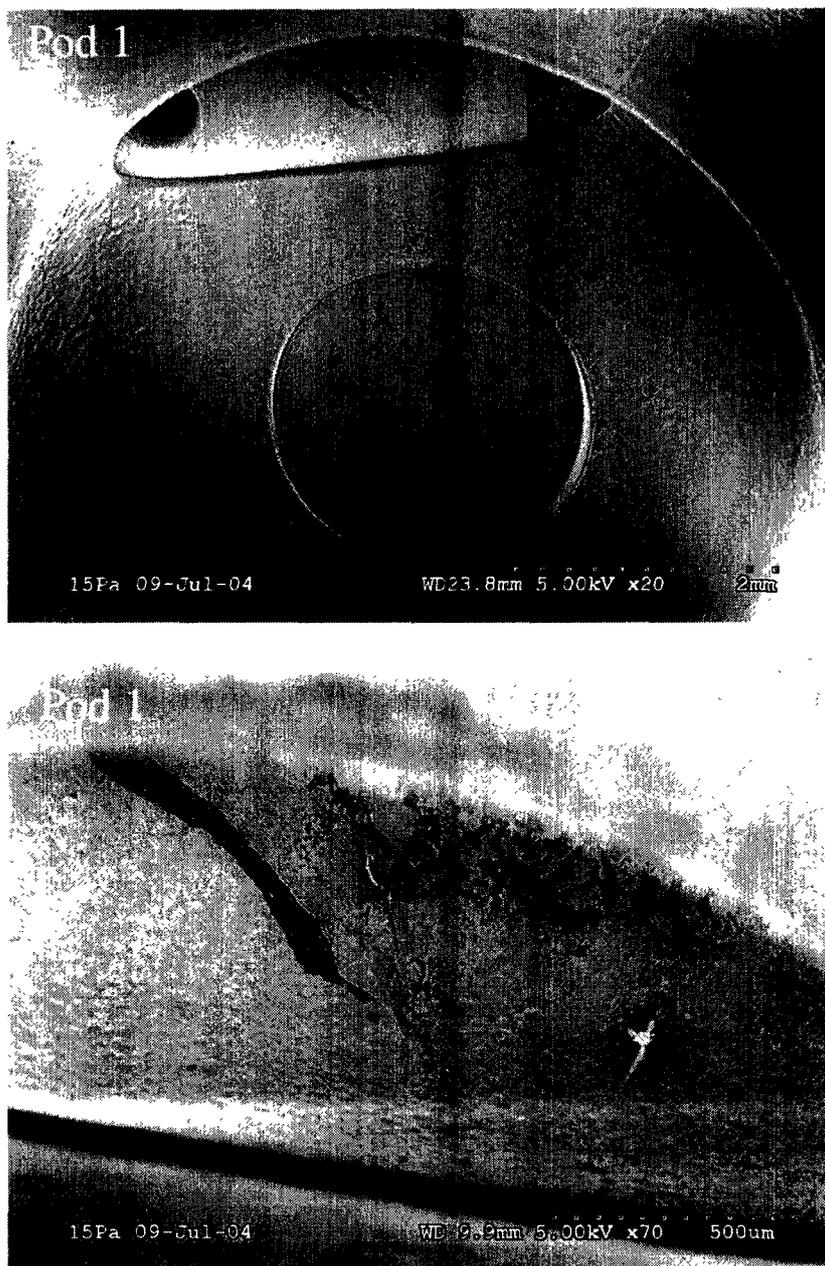
Figure 59. Images collected from Hitachi S3500N variable pressure scanning electron microscope in the areas of pod 1 on the **reprocessed Octopus 4[®] MT-104-13**. The images show contamination on surface of the hypotubing. The number in the upper left indicates the pod # (see Figure 5). Scale bar in each image.

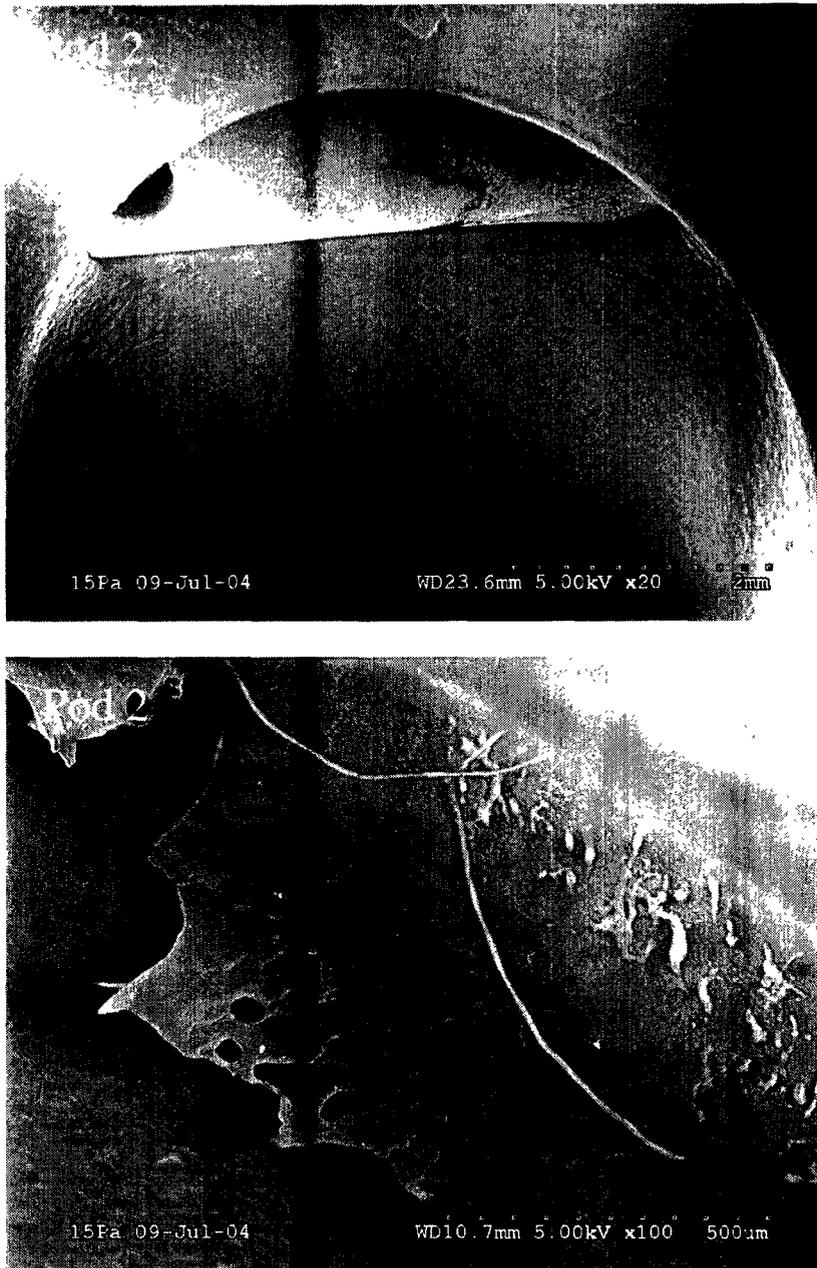
Figure 61. Images collected from Hitachi S3500N variable pressure scanning electron microscope in the areas of pod 2 on the **reprocessed Octopus 4[®] MT-104-13**. The images show contamination on surface of the hypotubing. Note sheet of bioburden and hair-like fiber. The number in the upper left indicates the pod # (see Figure 5). Scale bar in each image.

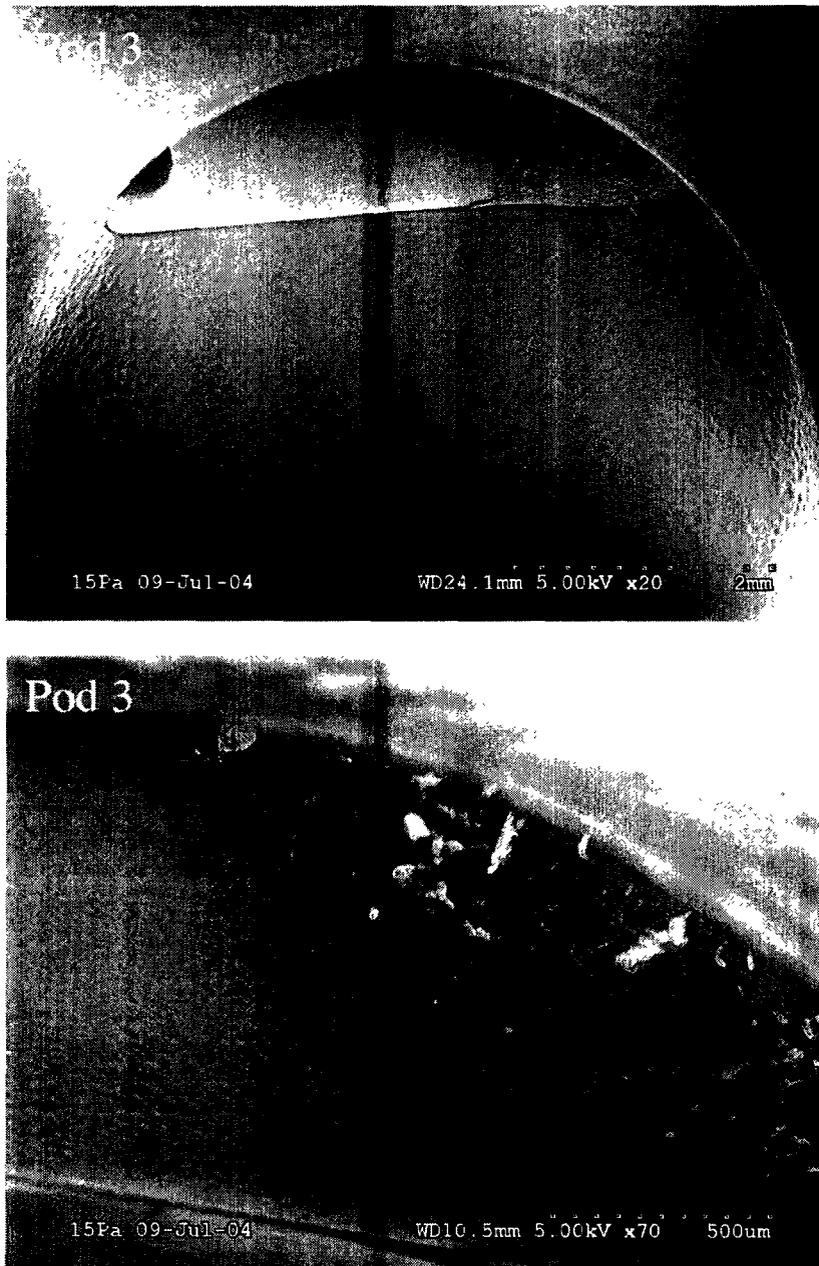
Figure 62. Images collected from Hitachi S3500N variable pressure scanning electron microscope in the areas of pod 3 on the **reprocessed Octopus 4® MT-104-13**. The images show contamination on surface of the hypotubing. Note sheet of bioburden on the hypotube. The number in the upper left indicates the pod # (see Figure 5). Scale bar in each image.

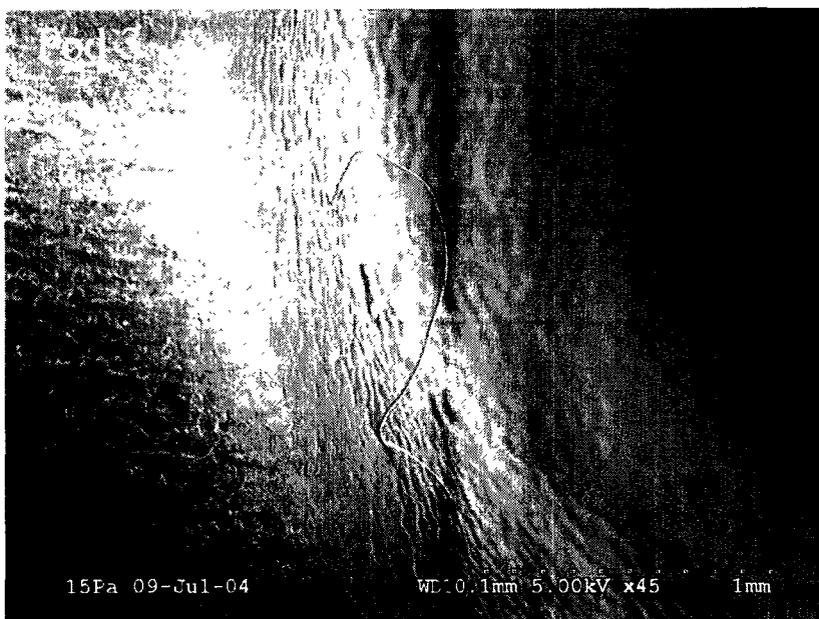
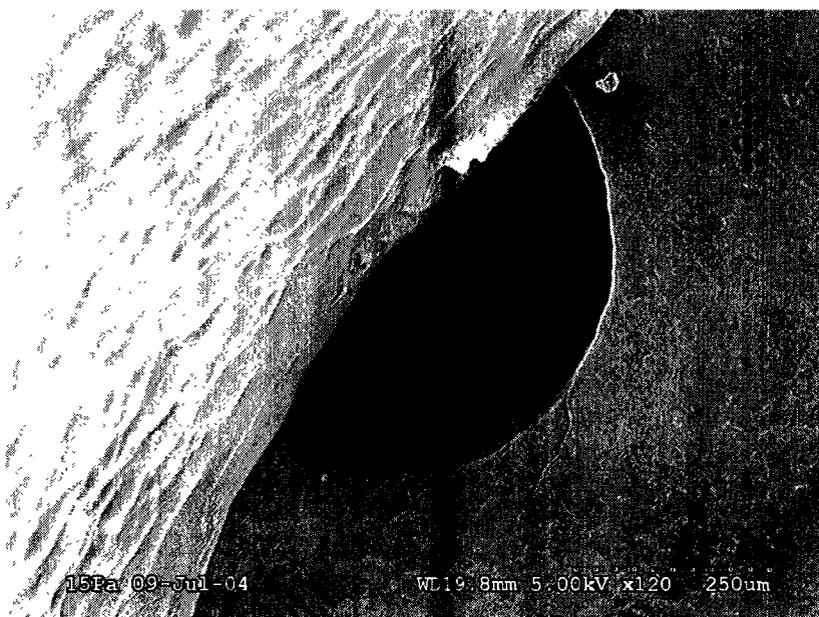
Figure 63. Images collected from Hitachi S3500N variable pressure scanning electron microscope in the areas of pod 3 on the **reprocessed Octopus 4[®] MT-104-13**. The images show hair on the pod surface and partially blocked hypotube opening. The number in the upper left indicates the pod # (see Figure 5). Scale bar in each image.

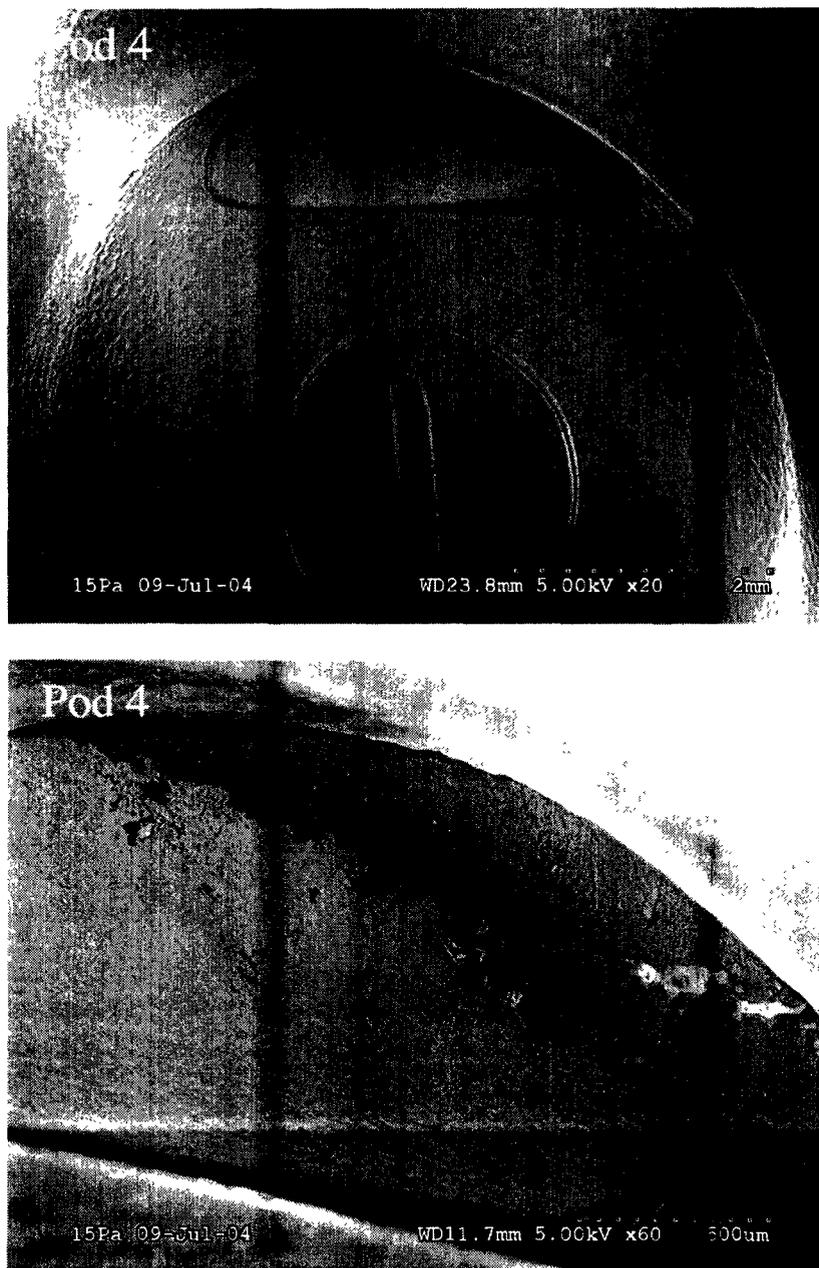
Figure 64. Images collected from Hitachi S3500N variable pressure scanning electron microscope in the areas of pod 4 on the **reprocessed Octopus 4® MT-104-13**. The images show contamination on surface of the hypotubing. The hypotube opening is completely blocked. Note sheet of bioburden and gap between hypotube and pod. The number in the upper left indicates the pod # (see Figure 5). Scale bar in each image.

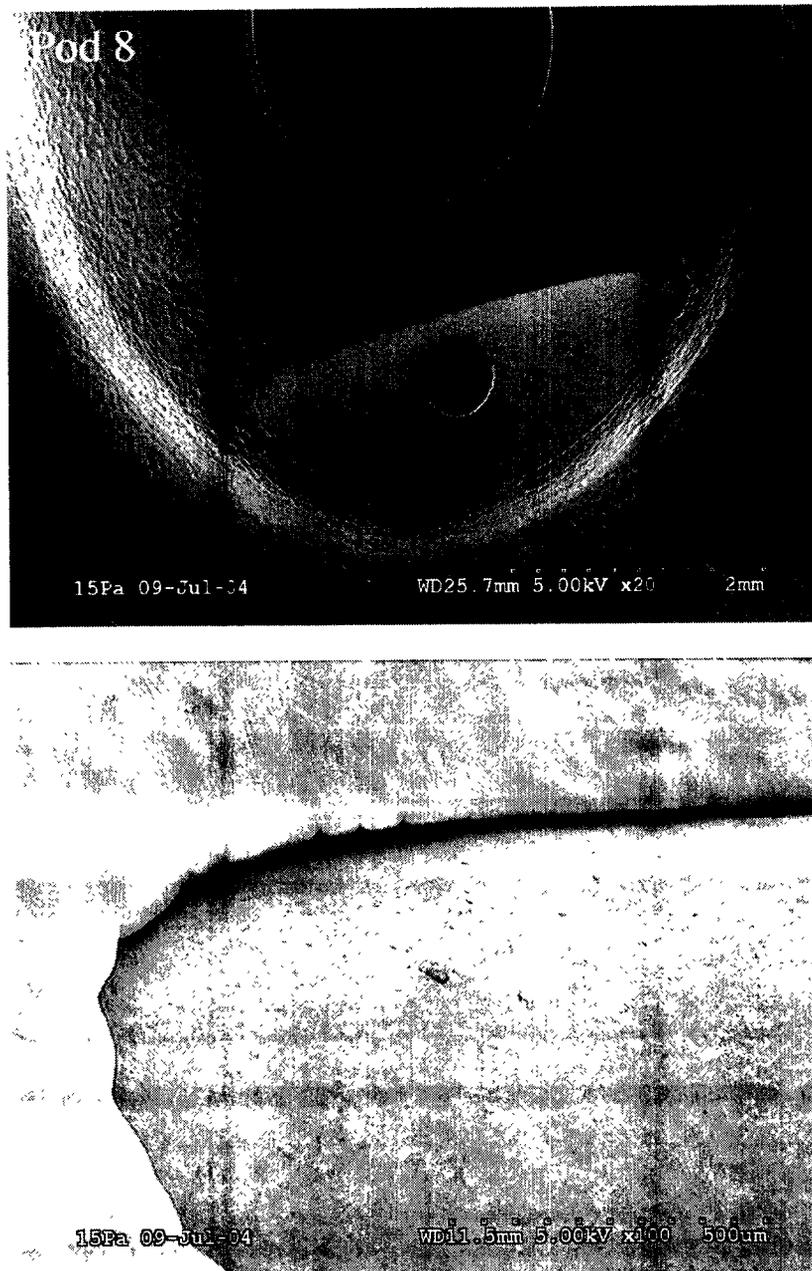
Figure 65. Images collected from Hitachi S3500N variable pressure scanning electron microscope in the areas of pod 8 on the **reprocessed Octopus 4[®] MT-104-13**. The images show little to no contamination on surface of the hypotubing. Note gap between hypotube and pod. The number in the upper left indicates the pod # (see Figure 5). Scale bar in each image.

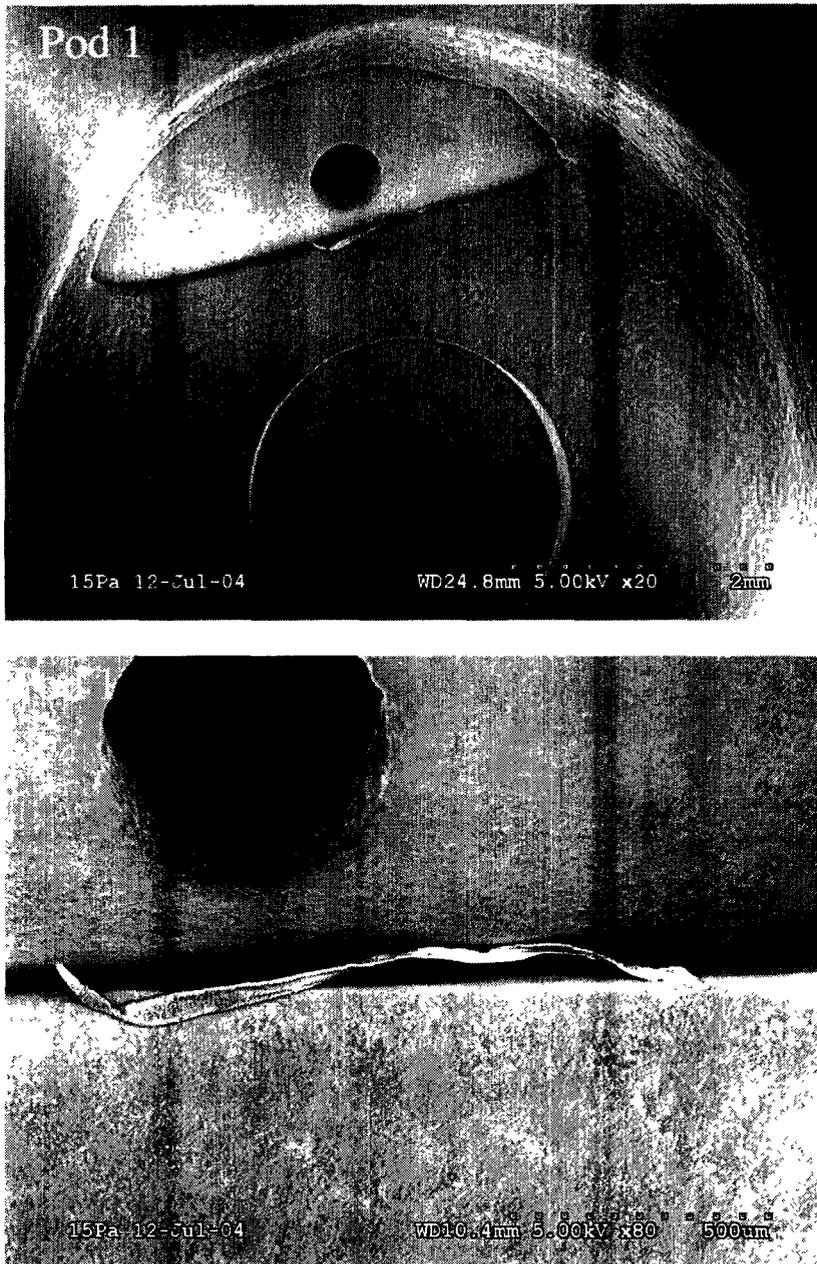
Figure 66. Images collected from Hitachi S3500N variable pressure scanning electron microscope in the areas of pod 1 on the **reprocessed Octopus 4[®] MT-104-16**. The images show gap between hypotube and pod. Note fiber in gap region. The number in the upper left indicates the pod # (see Figure 5). Scale bar in each image.

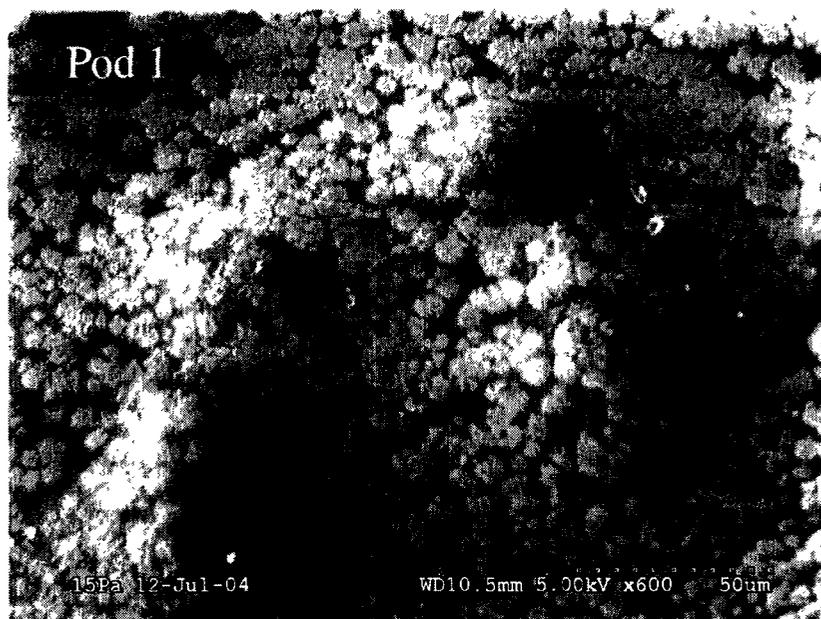
Figure 67. Image collected from Hitachi S3500N variable pressure scanning electron microscope in the area of pod 1 on the **reprocessed Octopus 4[®] MT-104-16**. The images show foreign crystalline substance in pod base. The number in the upper left indicates the pod # (see Figure 5). Scale bar in each image.

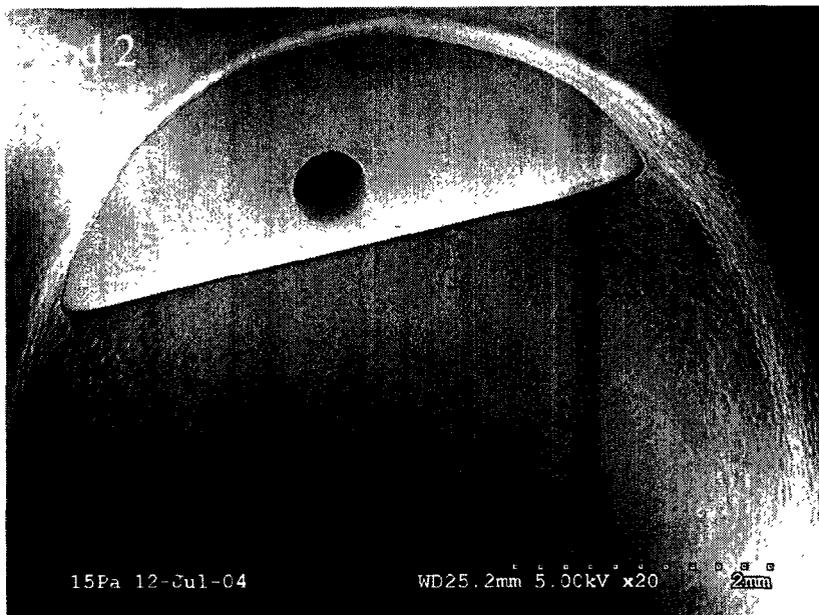
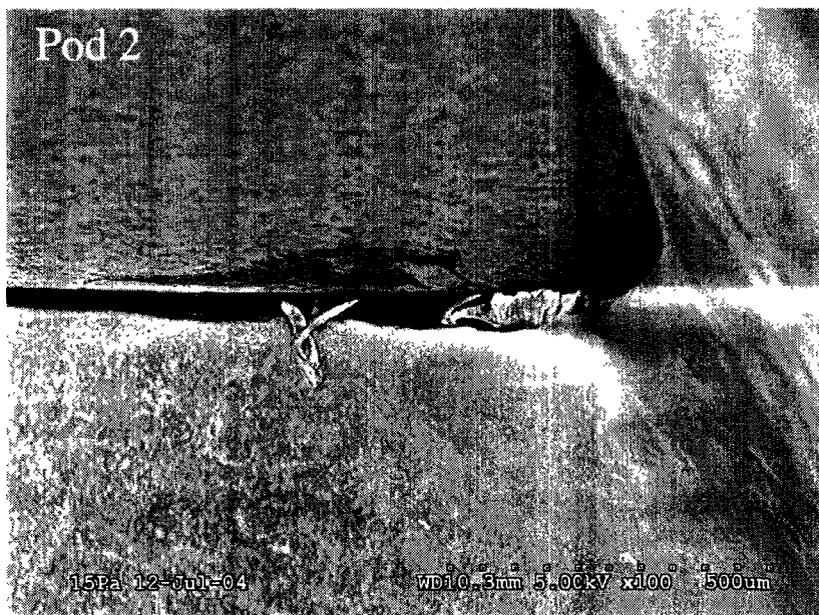
Figure 68. Images collected from Hitachi S3500N variable pressure scanning electron microscope in the areas of pod 2 on the **reprocessed Octopus 4[®] MT-104-16**. The images show gap between hypotube and pod. Note fiber and debris in gap region. The number in the upper left indicates the pod # (see Figure 5). Scale bar in each image.

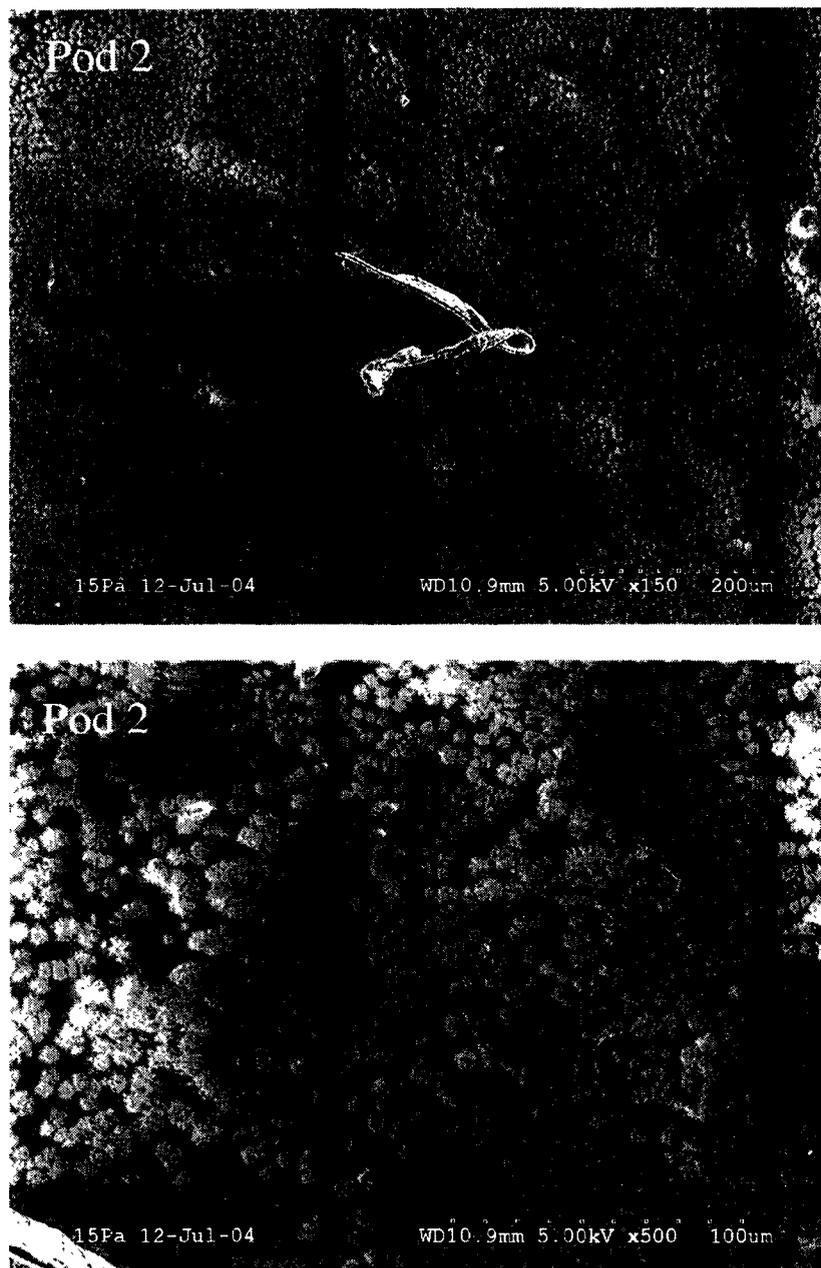
Figure 69. Images collected from Hitachi S3500N variable pressure scanning electron microscope in the area of pod 2 on the **reprocessed Octopus 4[®] MT-104-16**. The images show bioburden and fiber on pod base. The number in the upper left indicates the pod # (see Figure 5). Scale bar in each image.

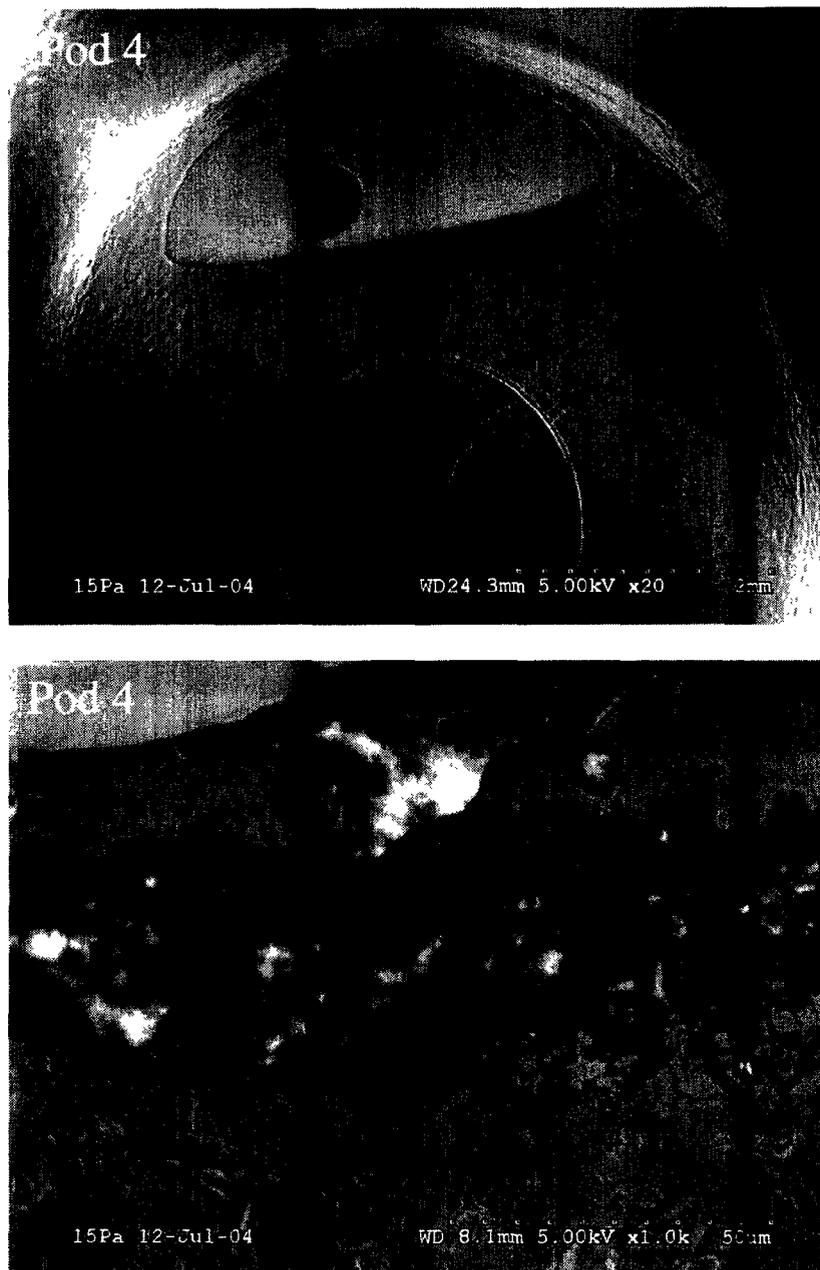
Figure 70. Image collected from Hitachi S3500N variable pressure scanning electron microscope in the area of pod 4 on the **reprocessed Octopus 4[®] MT-104-16**. The images show on hypotube near upper region of tube. The number in the upper left indicates the pod # (see Figure 5). Scale bar in each image.

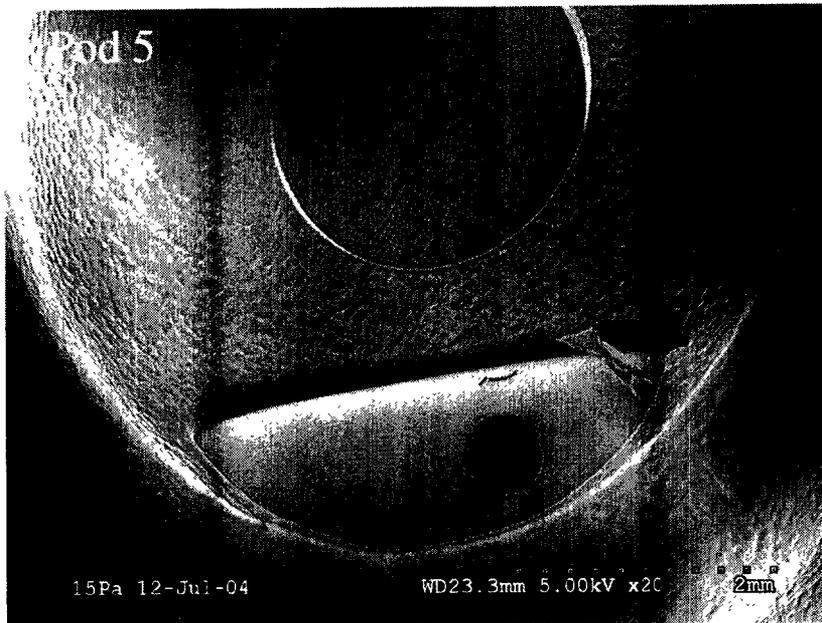
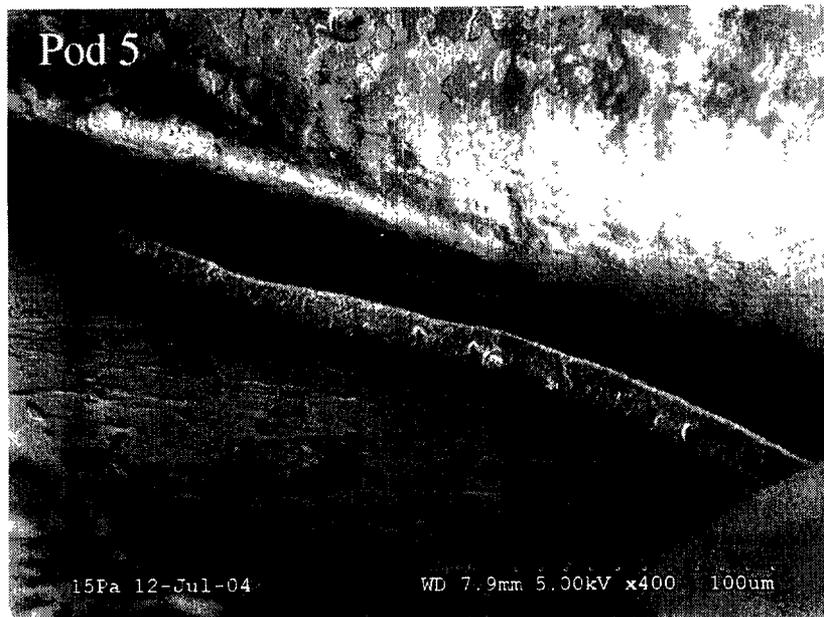
Figure 71. Images collected from Hitachi S3500N variable pressure scanning electron microscope in the areas of pod 5 on the **reprocessed Octopus 4[®] MT-104-16**. The images show gap between hypotube and pod. Note debris in gap region. The number in the upper left indicates the pod # (see Figure 5). Scale bar in each image.

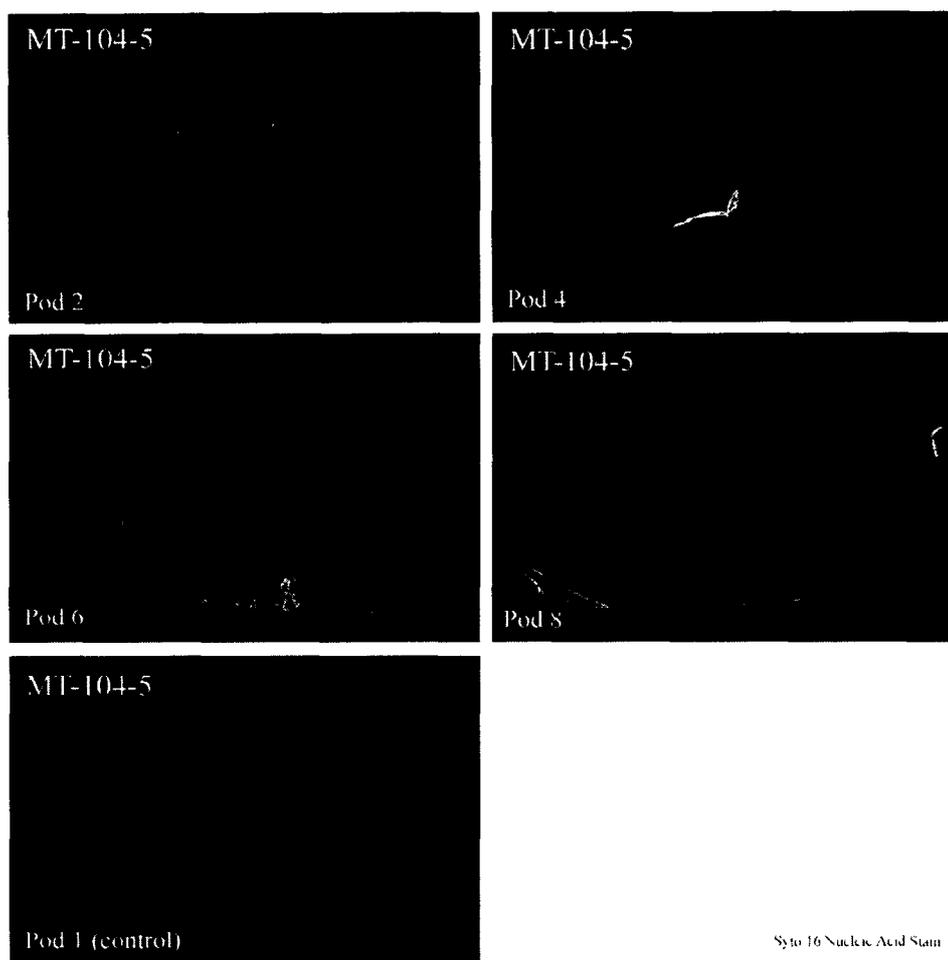
Figure 82. MT-104-5, pod #s 2, 4, 6 and 8 treated with Syto 16 nucleic acid probe. Projections (maximum intensity method) of series of optical sections collected from the laser scanning confocal microscope through the hypotube area of the pod following treatment with 1 μ M of the stain Syto 16. Bright regions indicate positive nucleic acid staining. Pod #1 is an unstained control image through the same area of the hypotube as the other images. The control image shows a low level of autofluorescence.

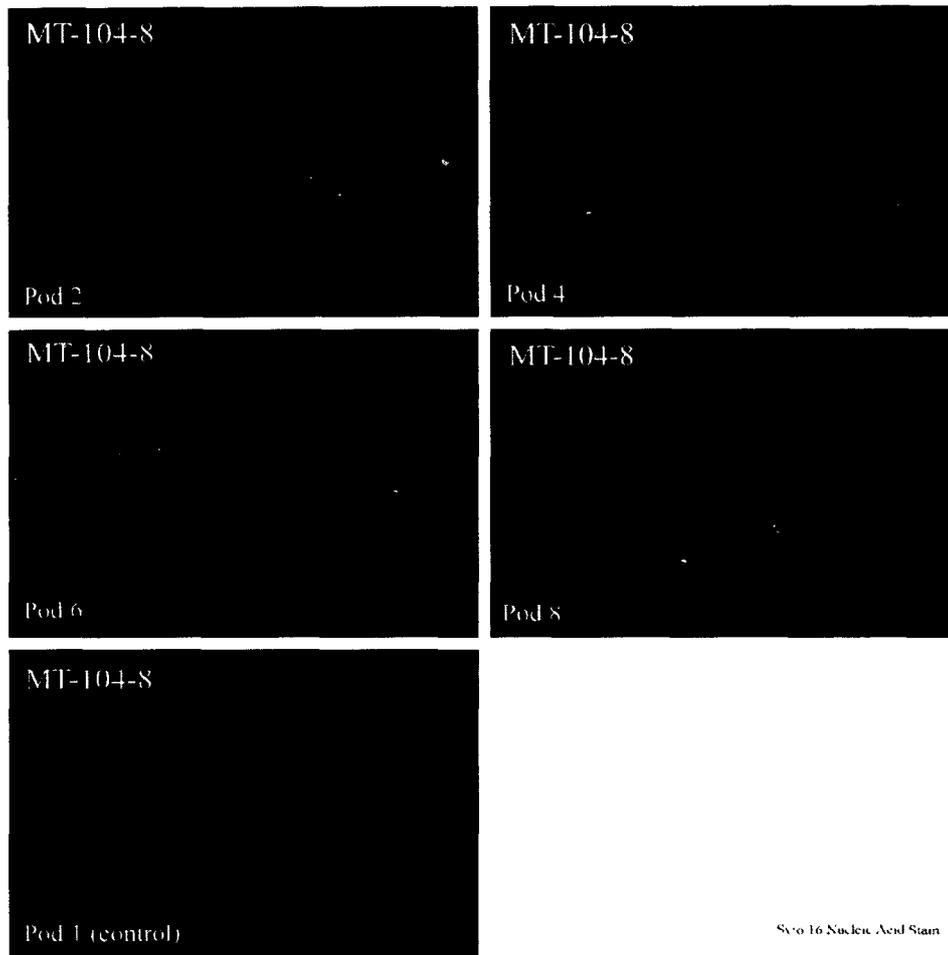
Figure 83. MT-104-8, pod #s 2, 4, 6 and 8 treated with Syto 16 nucleic acid probe. Projections (maximum intensity method) of series of optical sections collected from the laser scanning confocal microscope through the hypotube area of the pod following treatment with 1 μ M of the stain Syto 16. Bright regions indicate positive nucleic acid staining. Pod #1 is an unstained control image through the same area of the hypotube as the other images. The control image shows a low level of autofluorescence.

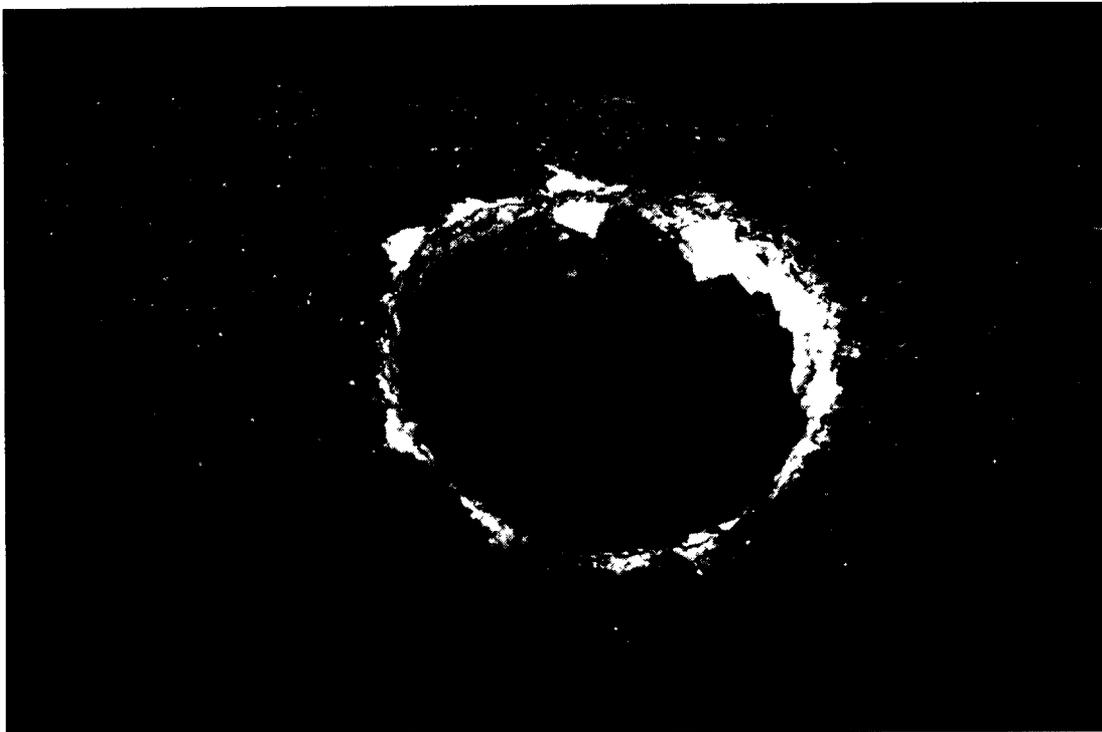
Figure 87. Higher magnification of MT-104-9, pod #6 treated with Syto 16 probe. Projection (maximum intensity method) of a series of optical sections collected from laser scanning confocal microscope through the same area of the tube in figure 86 of **MT-104-9, pod #6 of the reprocessed Octopus 3[®]** following treatment with 1 μ M of the stain Syto 16. The images show significant Syto positive labeling around the orifice and on the surface of the tubing. This correlates to the SEM images collected prior to staining.

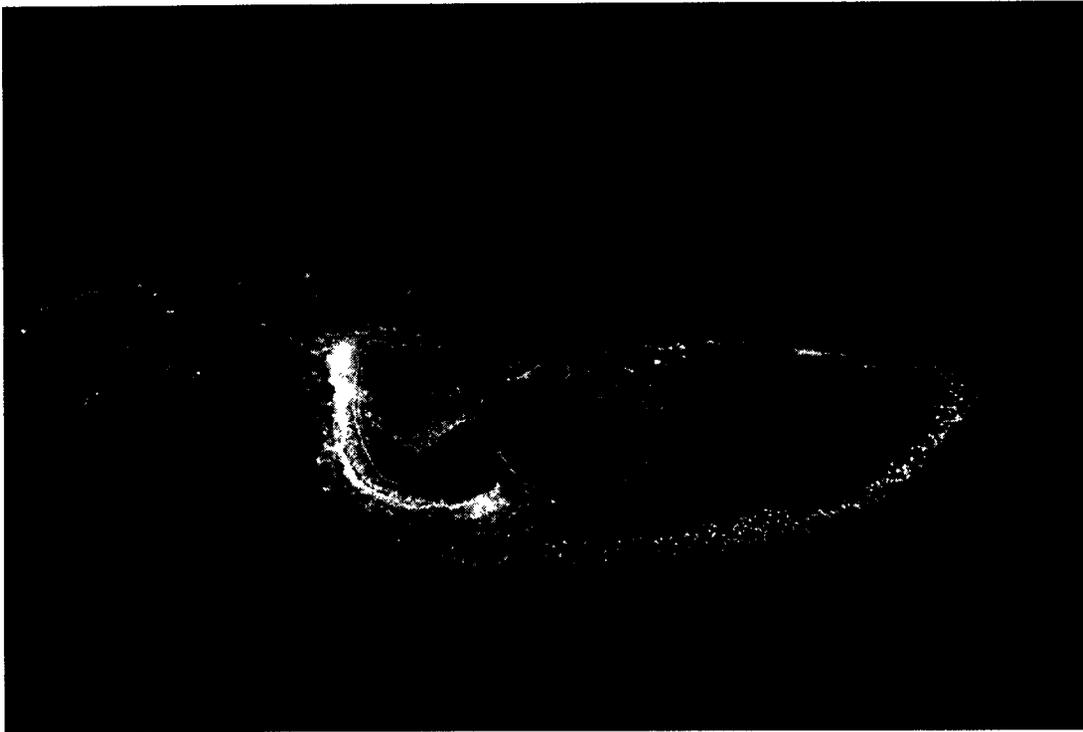
Figure 88. MT-104-9, pod #5 treated with Syto 16 probe. Projection (maximum intensity method) of a series of optical sections collected from laser scanning confocal microscope through the hypotube area of the pod of **MT-104-9, pod #5 of the reprocessed Octopus 3[®]** following treatment with 1 μ M of the stain Syto 16. The images show significant Syto positive labeling around the orifice and on the surface of the tubing. Note positive staining in area of hair-like fiber. This correlates to the foreign material observed in the macro and SEM images collected prior to confocal imaging.

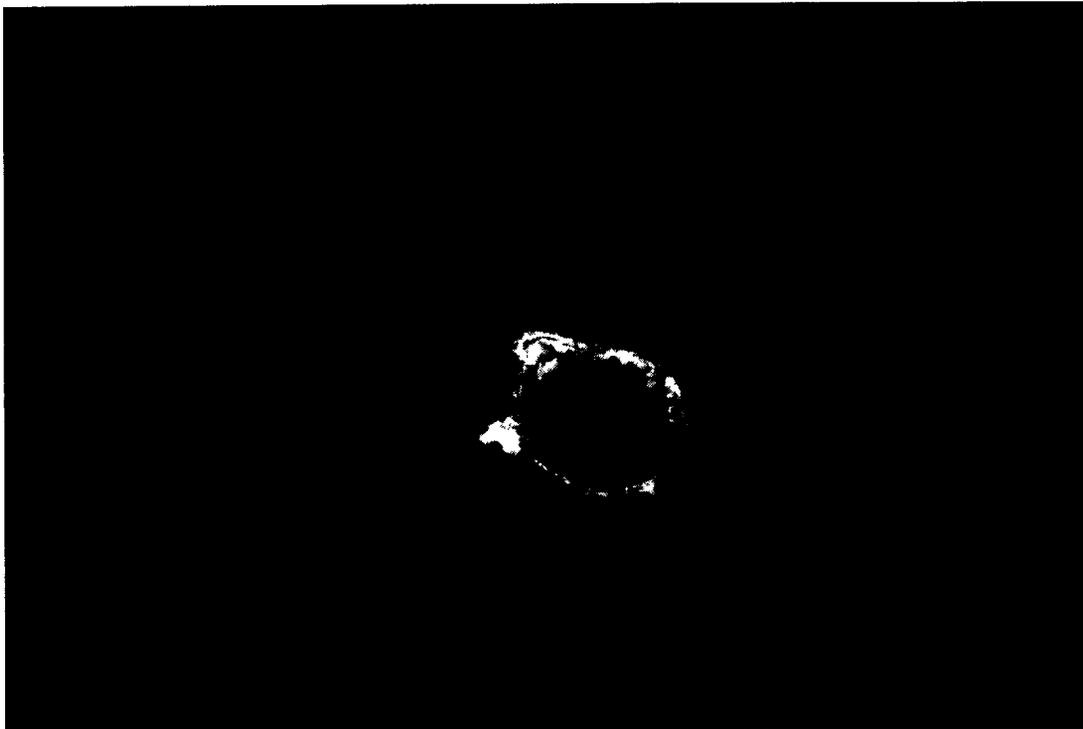
Figure 89. MT-104-9, pod #7 treated with Syto 16 probe. Projection (maximum intensity method) of a series of optical sections collected from laser scanning confocal microscope through the hypotube area of the tube in previous figures of **MT-104-9, pod #7 of the reprocessed Octopus 3[®]** following treatment with 1 μ M of the stain Syto 16. The images show significant positive Syto 16 labeling around the orifice and on the surface of the tubing. This correlates to the foreign material observed in the macro and SEM images collected prior to confocal imaging.

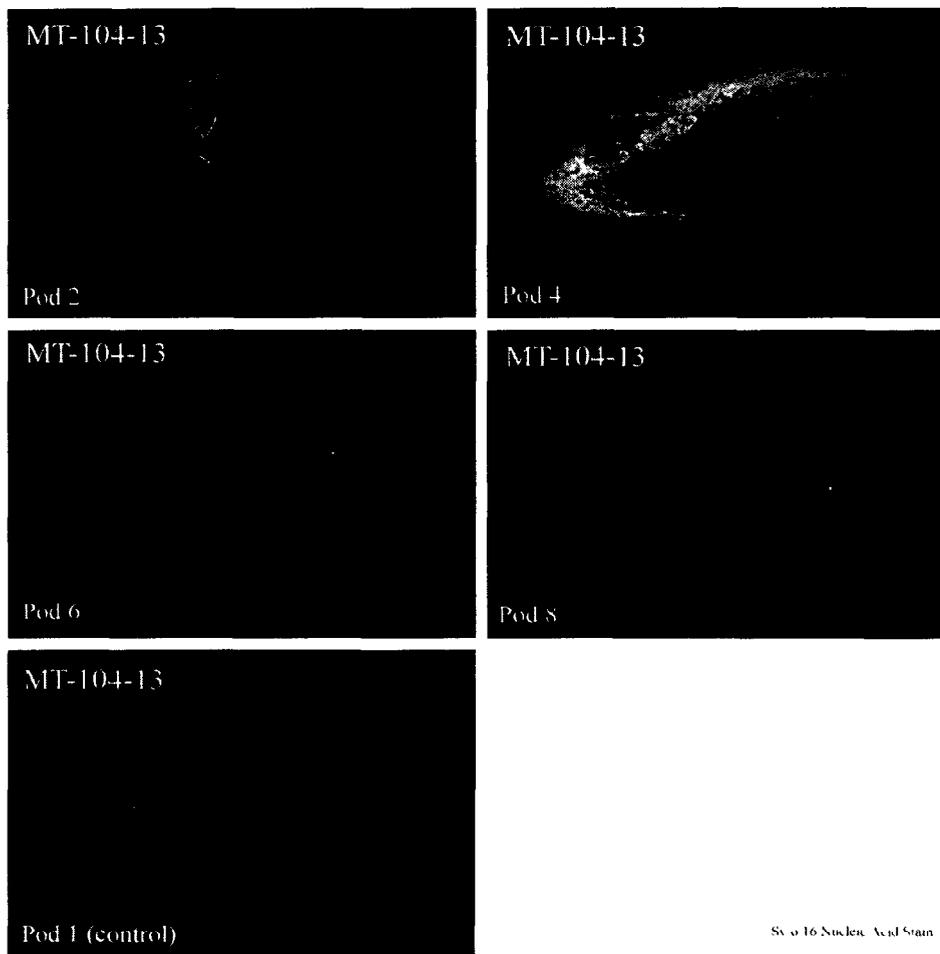
Figure 90. **Reprocessed MT-104-13**, pod #s 2, 4, 6 and 8 treated with Syto 16 nucleic acid probe. Projections (maximum intensity method) of series of optical sections collected from the laser scanning confocal microscope through the hypotube area of the pod following treatment with 1 μ M of the stain Syto 16. Bright regions indicate positive nucleic acid staining. Pod #1 is an unstained control image through the same area of the hypotube as the other images. The control image shows a low level of autofluorescence.
