Subject: The Draft Guidance for Industry and Food and Drug Administration Staff, from the document: **Hospital Bed System Dimensional Guidance to Reduce Entrapment** issued August 30, 2004.

Comments and suggestions regarding the draft guidance for Industry and Food and Drug Administration Staff, from the document: **Hospital Bed System Dimensional Guidance to Reduce Entrapment**.

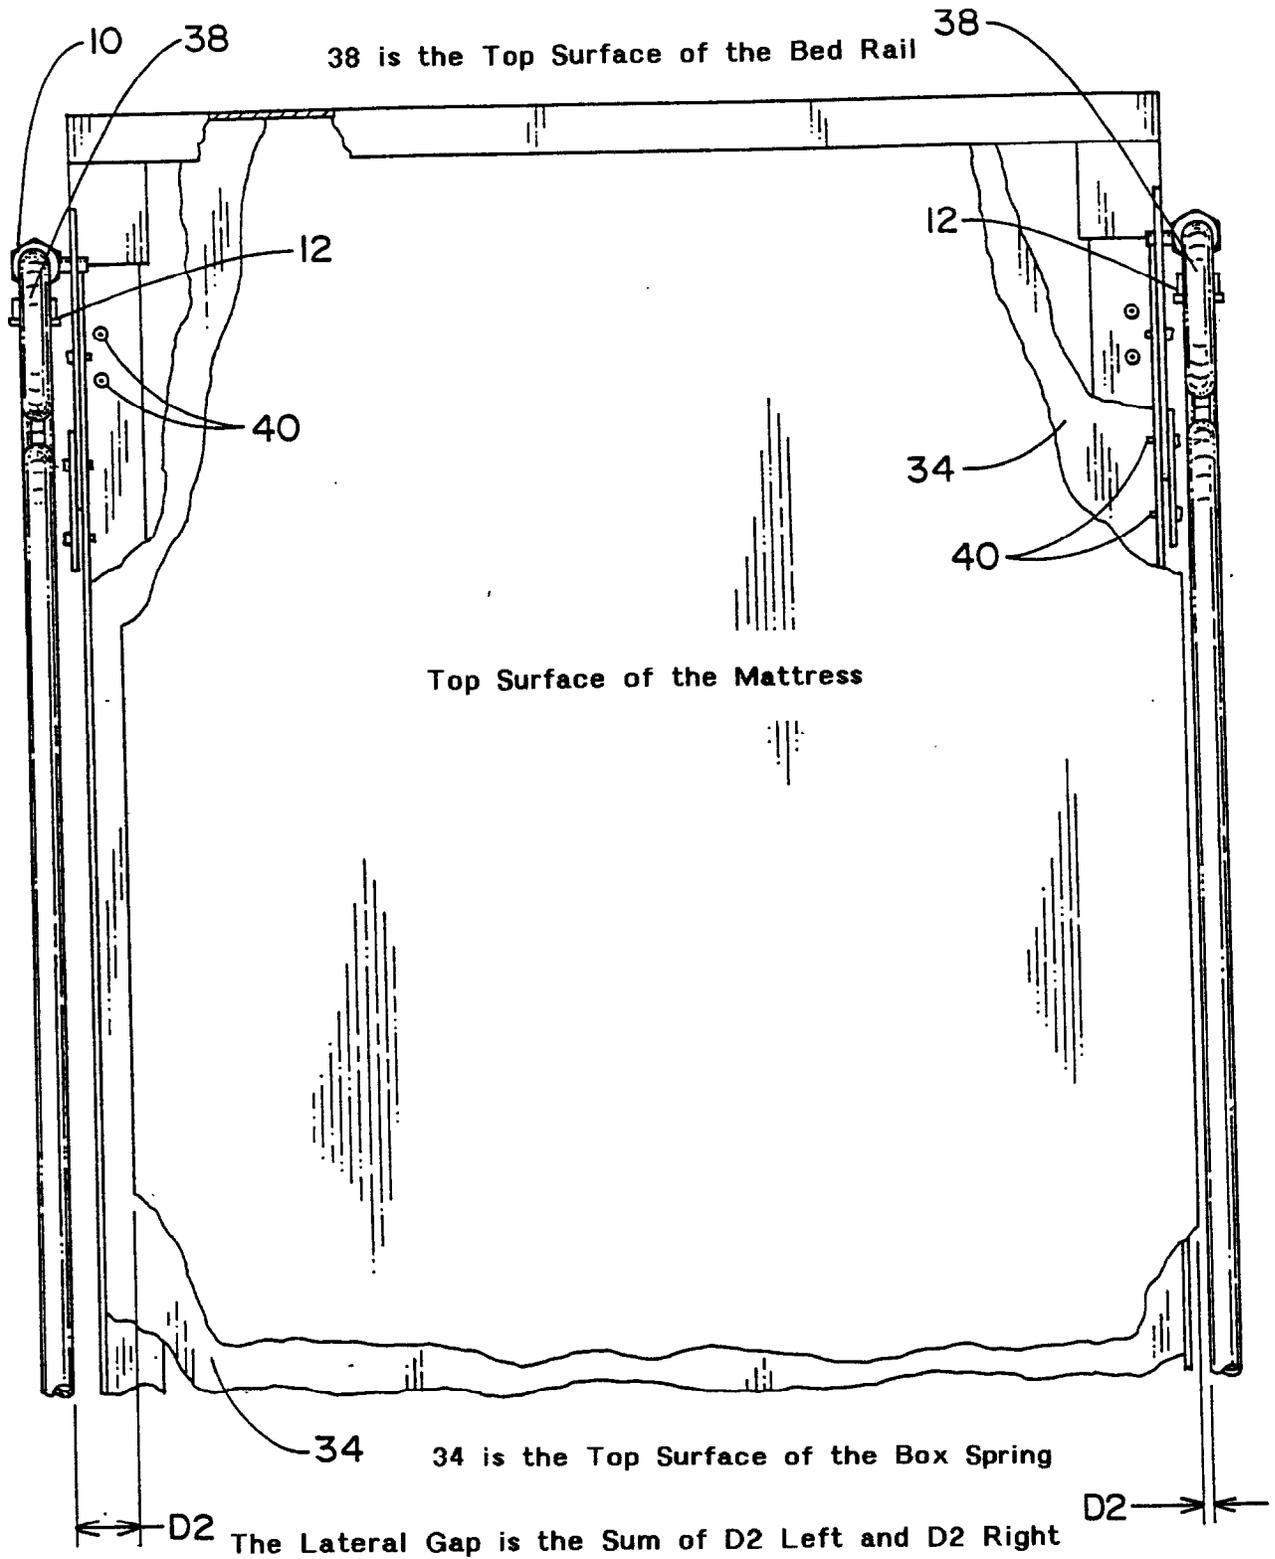
FIGURE 1

An Overhead View of Bed Rails on a Twin Bed

Of greater concern is the fact that the width of mattresses, twin beds with bed rails and attachment hardware have been omitted from this draft Guidance. This State's Checklist, Attachment #1, clearly recognizes the contribution that a mattress of the proper width can make in preventing bed rail entrapments. Checkpoints # 2, #3 and # 18 focus on the width and performance of the mattress. See Figure #1.

Regrettably, only split side rails have been used to exemplify entrapment possibilities. Split side rails fail to demonstrate the full entrapment potential within Zone 3 that is present when full-length side rails are used, see Figure 1. Accordingly, the belief that the head blocks the entry of the neck into this gap is not true. With full length side rails, the legs slide between the side rail and the mattress and the weight of the legs pulls the trunk through the Zone 3 gap until either the chest or the head becomes entrapped.

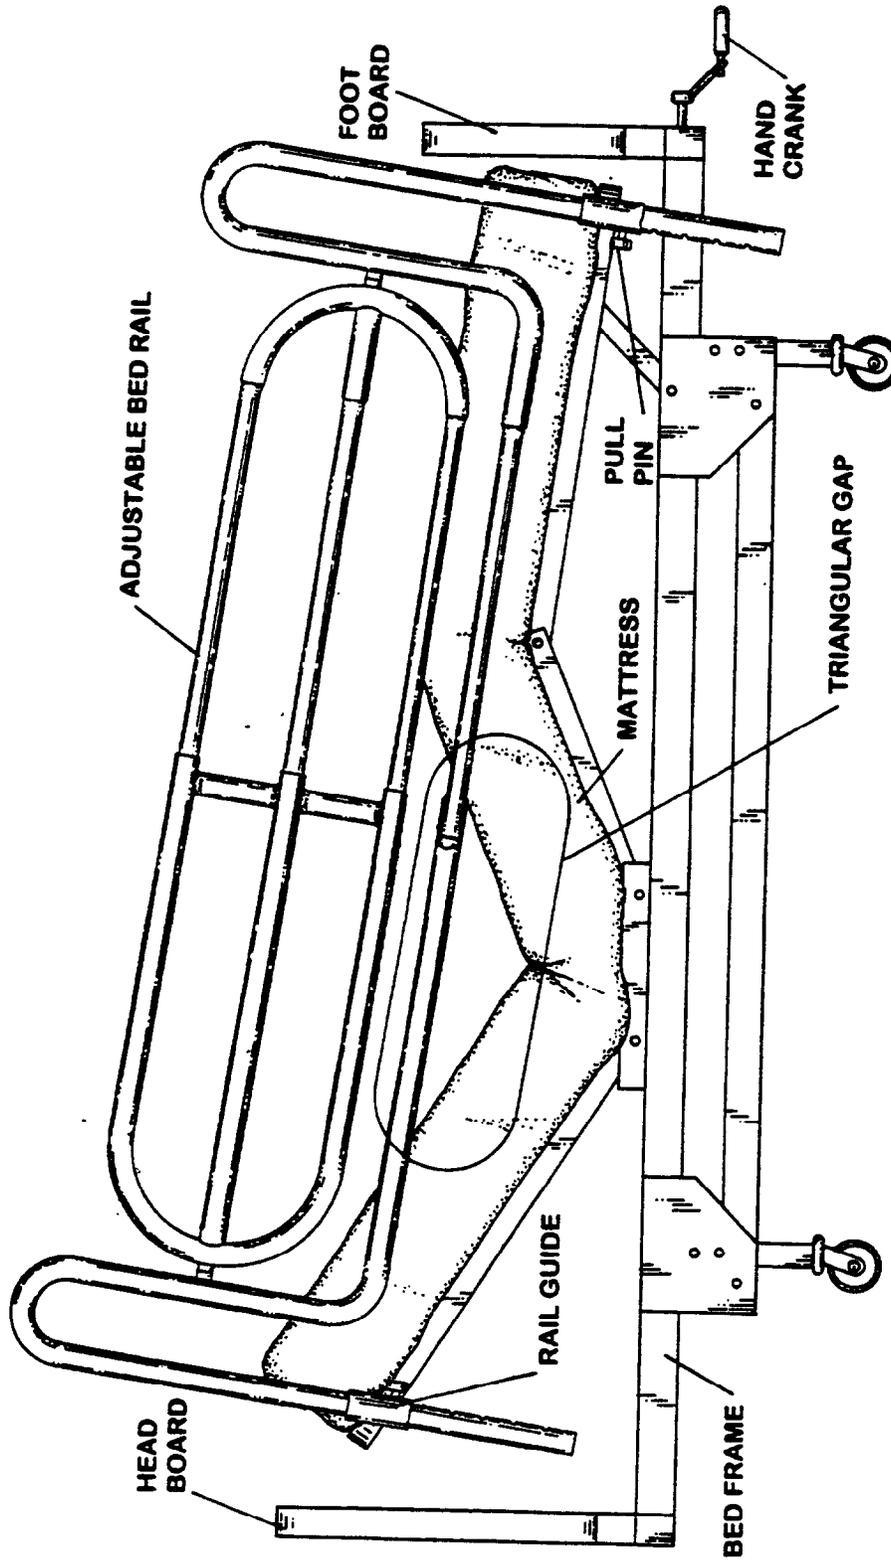
FIGURE 2

The triangular gap created when the head of the hospital bed is raised

Comment #7 relating to articulated bed positions, page 23 of the draft. Most entrapment deaths in hospital beds take place when the head of the bed is elevated. The under bar entrapment potential of Zone 2 is significantly exacerbated when a full length bed rail is being used, see Figure 2. This Figure is taken from the User's Guide for the Bed Safety Checklist to illustrate Checkpoint #20, which states that:

As noted by the obvious entrapment hazard identified in Figure 2, I am strongly suggesting that the FDA include guidance for under bar gaps in articulated beds and particularly for those articulated beds with full length rails.
