CARROLL HEALTHCARE - CARROLL HOSPITAL GROUP
INVACARE CONTINUING CARE GROUP

HBSW COMMENTS

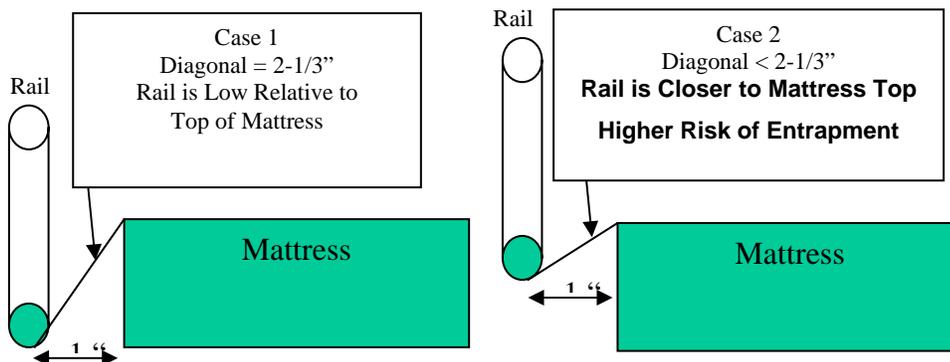
- b. Zone 2 and Zone 4 directs: ...FDA is recommending a diagonal dimensional limit less than 2-1/3" inches in Zone 4 (4-3/4" in Zone 2) ... from the inside bottom edge of the rail... to the top of a compressed mattress... These directions are correct only if the HBSW Assessment Tool is used for the measurement; following the directions as described (without the assessment tool) can actually lead to higher risks of entrapment (see illustration below).

** Case 2 where the Diagonal is less than 2-1/3" has a higher risk of entrapment than Case 1 where the Diagonal = 2-1/3". The desired results would be achieved if the HBSW assessment tool and method were used as illustrated below.*

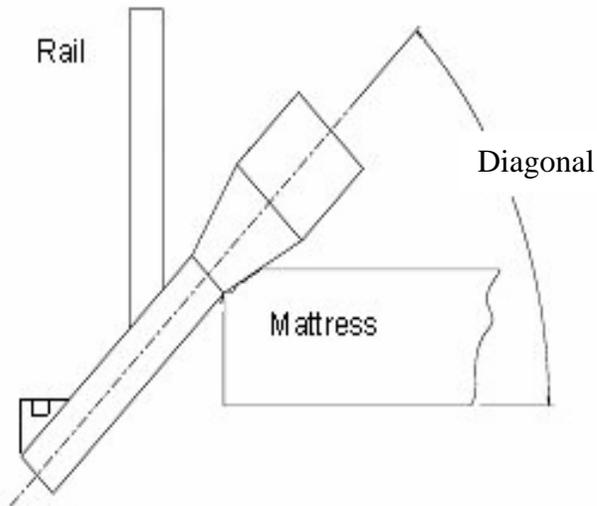
CHC recommends using the HBSW assessment tool and method for diagonal measurements. CHC also recommends that where the HBSW Assessment Methods are specified that the entire HBSW Assessment Method be defined in the Guidance either directly or by reference.
