*Re: Draft Guidance for Industry and Food and Drug Administration Staff: Hospital Bed System Dimensional Guidance to Reduce Entrapment (“the Guidance”) [Docket No. 2004D-0343]*

## SUSPECTED "TOP OF RAIL" INCIDENTS, MAUDE & MDR DATABASES, TO DEC 31, 2002

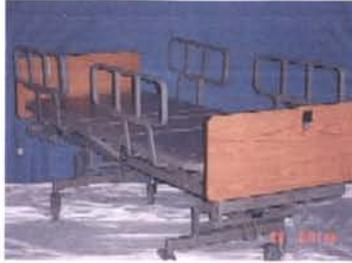
MDR REPORT	DATE RECEIVED	INCIDENT DESCRIPTION	MANUFACTURER NARRATIVE	MFR NAME	MODEL NUMBER	BRAND NAME
M350788	11/19/1992	RESIDENT OF NURSING FACILITY WAS FOUND IN HER BED WITH HER HEAD IN THE SPACE BETWEEN THE HEAD BOARD AND SIDE RAIL OF THE BED. THE SIDE RAIL WAS IN A RAISED POSITION. RESIDENT WAS REPOSITIONED AND LACK OF RESPIRATION WAS NOTED. THERE WAS A LACK OF VITAL SIGNS AND PUPILS WERE NONREACTIVE. THERE WAS A MARK ON THE LEFT SIDE OF NECK WHERE IT WAS LAYING AGAINST SIDE RAIL. BED WAS REMOVED FROM SERVICE AND EVALUATED. IT WAS DETERMINED THAT THE BED OPERATED PROPERLY AND WAS USED BY FACILITY IN PROPER MANNER. THIS TYPE OF BED HAS BEEN IN USE AT FACILITY FOR OVER 10 YEARS WITHOUT INCIDENT. THE SIDERAILS INSTALLED ON THIS BED ARE FULL LENGTH WHICH WILL RESTRICT PT EGRESS FROM THE BED. IN DISCUSSING THE INCIDENT WITH THE FACILITY ADMINISTRATOR, THE ONLY RATIONALE OFFERED LEADING TO THE PT ENTRAPMENT WAS THAT SHE HAD PREVIOUSLY EXHIBITED SIGNS OF AGITATION AND POSSIBLY ATTEMPTED TO CLIMB OVER THE SIDERAIL.

HILL-ROM CO., INC.	723	A.C. POWERED HOSPITAL BED CENTURY SERIES

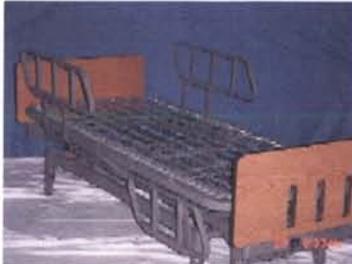
M383656	05/05/1993	NURSE FOUND PT LYING ACCROSS THE BED WITH HER NECK WEDGED BETWEEN THE SIDERAIL AND HEADBOARD. THE RESIDENT WAS WITHOUT PULSE OR RESPIRATION. THE MD WAS NOTIFIED AND THE RESIDENT WAS PRONOUNCED DEAD. DUE TO THE NATURE OF THE INCIDENT AND PT STATISTICS THE FACILITY WAS UNABLE TO DETERMINE WITH CERTAINTY ANY CAUSAL RELATIONSHIP BETWEEN THE DEVICE AND THE INCIDENT.

HILL-ROM CO., INC.	425	MANUAL HILO BED
5098	05/17/1993	AT 0200 HRS ON 4/18/93 WHEN THE PMA WENT TO THE RESIDENT'S ROOM TO CHECK ON THE RESIDENT, THE PMA FOUND THE RESIDENT LYING HORIZONTALLY ACROSS THE BED WITH HER NECK WEDGED BETWEEN THE SIDE-RAIL AND THE HEADBOARD. THE RESIDENT WAS WITHOUT PULSE OR RESPIRATION. THE PHYSICIAN WAS NOTIFIED IMMEDIATELY AND THE RESIDENT WAS PRONOUNCED DEAD. THE CORONER WAS NOTIFIED. AN AUTOPSY REPORT IS PENDING DEVICE NOT LABELED FOR SINGLE USE. PATIENT MEDICAL STATUS PRIOR TO EVENT: SATISFACTORY CONDITION. THERE WAS NOT MULTIPLE PATIENT INVOLVEMENT. INVALID DATA - ON DEVICE SERVICE/MAINTENANCE. NO DATA - REGARDING DATE LAST SERVICED. SERVICE PROVIDED BY: INVALID DATA. INVALID DATA - SERVICE RECORDS AVAILABILITY. NO IMMINENT HAZARD TO PUBLIC HEALTH CLAIMED. DEVICE USED AS LABELED/INTENDED. DEVICE WAS EVALUATED AFTER THE EVENT. METHOD OF EVALUATION: ACTUAL DEVICE INVOLVED IN INCIDENT WAS EVALUATED, MECHANICAL TESTS PERFORMED, PERFORMANCE TESTS PERFORMED, VISUAL EXAMINATION. RESULTS OF EVALUATION: DESIGN - HUMAN FACTORS. CONCLUSION: NONE OR UNKNOWN. CERTAINTY OF DEVICE AS CAUSE OF OR CONTRIBUTOR TO EVENT: INVALID DATA. CORRECTIVE ACTIONS: OTHER. INVALID DATA - ON DEVICE DESTROYED/DISPOSED OF STATUS.

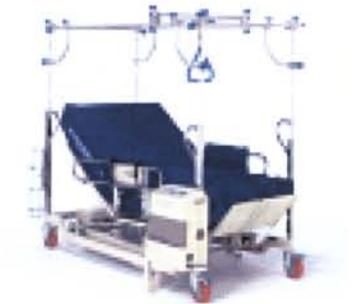
5147	04/27/1993	THE ALLEGED INCIDENT HAPPENED ON 3/13/93 AND INVOLVED A FLEXICAIR BED. PATIENT WAS FOUND BETWEEN UPPER END OF SIDE RAILS AND HEAD OF BED. PATIENT EXPIRED ON 3/15/93. WE BELIEVE A PROBABILITY MAY EXIST THAT THE MEDICAL DEVICE MAY HAVE CONTRIBUTED TO THE DEATH. INVALID DATA - REGARDING SINGLE USE LABELING OF DEVICE. PATIENT MEDICAL STATUS PRIOR TO EVENT: INVALID DATA. INVALID DATA - REGARDING MULTIPLE PATIENT INVOLVEMENT. INVALID DATA - ON DEVICE SERVICE/MAINTENANCE. NO DATA - REGARDING DATE LAST SERVICED. SERVICE PROVIDED BY: INVALID DATA. INVALID DATA - SERVICE RECORDS AVAILABILITY. NO IMMINENT HAZARD TO PUBLIC HEALTH CLAIMED. DEVICE USED AS LABELED/INTENDED. DEVICE WAS NOT EVALUATED AFTER THE EVENT. METHOD OF EVALUATION: NO DATA. RESULTS OF EVALUATION: NO DATA. CONCLUSION: NO DATA. CERTAINTY OF DEVICE AS CAUSE OF OR CONTRIBUTOR TO EVENT: MAYBE. CORRECTIVE ACTIONS: NO DATA. INVALID DATA - ON DEVICE DESTROYED/DISPOSED OF STATUS.

SUPPORTS SYSTEM INTERNATIONAL	FLEXICAIR BED	FLEXICAIR BED

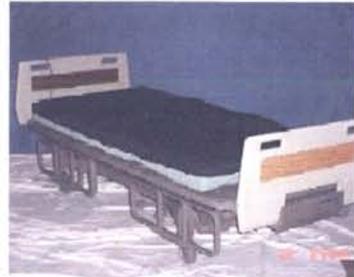
122788	09/23/1997	PT FOUND LYING ON LEFT SIDE WITH LEFT ARM UNDERNEATH HIM AND NECK CAUGHT BETWEEN TWO SIDE RAILS OF THE BED.

HILL-ROM	840	HILL-ROM
139984	12/22/1997	MFR REC'D A REPORT OF A PT FOUND DEAD WITH HER NECK BETWEEN THE BED RAIL AND THE HEAD BOARD. NO ONE WITNESSED THE INCIDENT AND NO MALFUNCTION HAS BEEN IDENTIFIED.		INVACARE CORPORATION	BED, FULL/SEMI ELECTRIC	INVACARE FULL/SEMI ELECTRIC HOME CARE BED
157723	03/19/1998	RESIDENT WAS FOUND TO BE ON HER RIGHT SIDE WITH HER LEFT ARM OVER THE SIDE RAIL AND HER HEAD OVER THE SIDE OF THE BED WITH HER NECK LEANING AGAINST THE SIDE GAIT. RESIDENT WAS PULSELESS AND CYANOTIC.

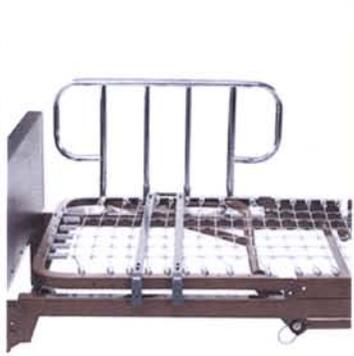
INVACARE	6630	INVACARE
198932	11/25/1998	RPTR WISHES TO REPORT ON AN INCIDENT THAT WAS INVESTIGATED BY HEALTH SERVICES. RESIDENT IN A LONG TERM CARE FACILITY WAS CHANGED AND REPOSITIONED IN BED AT APPROX 2 PM. REPORTEDLY, THE SIDE RAIL ON THE BED WAS BENT, LOOSE AND SHAKEY. AT APPROX 2:30 PM, STAFF FOUND RESIDENT WEDGED BETWEEN THE END OF THE SIDE RAIL AND THE HEAD OF THE BED. HER LEGS WERE ENTANGLED IN THE SIDE RAIL AND BETWEEN THE MATTRESS. RESIDENT WAS PRONOUNCED DEAD AT THE SCENE. THE SIDE RAIL WAS REPLACED PRIOR TO THE INVESTIGATION, SO NO PRODUCT INFO IS AVAILABLE. ALL INFO PERTAINING TO THE ACTUAL EVENT WAS COMPILED THROUGH INTERVIEWS WITH STAFF MEMBERS TO PROVIDE THIS REPORT.		UNK	UNK	UNK

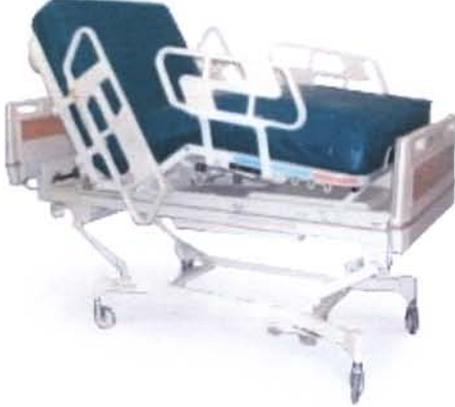
268094	03/06/2000	NURSING STAFF ENTERED PT ROOM AND FOUND PT'S FEET ON THE FLOOR; HEAD AND SHOULDERS ON BED. PT'S BODY WAS WEDGED BETWEEN THE BEDRAILS. ALL FOUR BEDRAILS WERE UP. NO RESPIRATIONS NOTED; PT WARM TO TOUCH. PT WAS LOWERED TO THE FLOOR; RESPIRATIONS RESUMED WITH THIS INTERVENTION. PT PLACED BACK IN THE BED. BRUISE NOTED TO RIGHT UPPER QUADRANT APPROX 2" BELOW RIB CAGE. LEFT HIP ALSO REDDENED. NO BROKEN SKIN NOTED.	INFO RECEIVED FROM THE FIELD INVESTIGATION CONDUCTED BY A HILL-ROM TECH, INDICATED THAT THE UNIT INVOLVED WITH THE ADVERSE EVENT COULD NOT BE LOCATED BY THE FACILITY'S PERSONEL. ADDITIONAL INFO RECEIVED FROM THE FACILITY DURING THE INVESTIGATION SUGGESTS THAT THE UNIT EXHIBITED NO MALFUNCTION. THE FACILITY HAD STATED THAT THERE WAS NOT A PRODUCT PROBLEM, AND HAD PUT THE BED INTO SERVICE ELSEWHERE. THE INFO RECEIVED REASONABLY SUGGESTS A POSSIBLE PT MONITORING ISSUE.	HILL ROM, INC.	ADVANCE 2000	THE ADVANCE 2000 BED

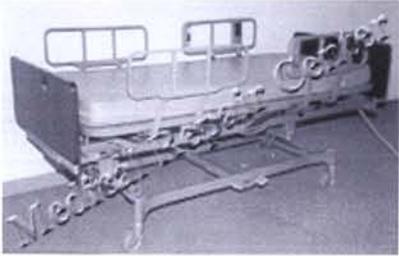
282095	06/12/2000	RESIDENT WEDGED THEMSELV BETWEEN TOP AND BOTTOM SIDE RAILS. RESIDENT WAS FOUND IN RESIDENT ROOM BETWEEN TOP AND BOTTOM SIDE RAILS WITH ARMS HOLDING PT ON BED AND FEET AND BOTTOM HALF OF BODY OFF BED. RESIDENT WAS UNRESPONSIVE AND CYANOTIC WHEN FOUND. FOUR HALF RAILS WERE UP AND RESIDENT TRIED TO GET OUT OF BED BETWEEN TOP HALF RAIL AND BOTTOM HALF RAIL.		SUNRISE MEDICAL, JOERNS-HAYER-PARKER	1401 SERIES	JOERNS
323188	03/28/2001	PT WAS FOUND WEDGED BETWEEN SIDE RAIL. CHEST WAS COMPROMISED AND PT WAS BLUE IN COLOR. PT PLACED BACK IN BED, SUCTIONED AND PT REGAINED COLOR. NO OTHER INFO COULD BE OBTAINED.	INFO RECEIVED FROM THE FIELD INVESTIGATION AND FUNCTIONAL INSPECTION OF THE UNIT CONDUCTED BY THE HILL-ROM TECHNICIAN, INDICATED THE UNIT WAS FUNCTIONING PROPERLY. THE FACILITY DID NOT REPORT A PRODUCT PROBLEM. CORRECTIVE ACTION: FACILITY PLACED SIDE RAIL PADS ON BED TO REDUCE THE OPENING IN THE SIDE RAILS.	HILL-ROM, INC.	837	HILL-ROM
