**March 2019**

**Volume 19, Issue 3**

## HIGHLIGHTED REPORTS

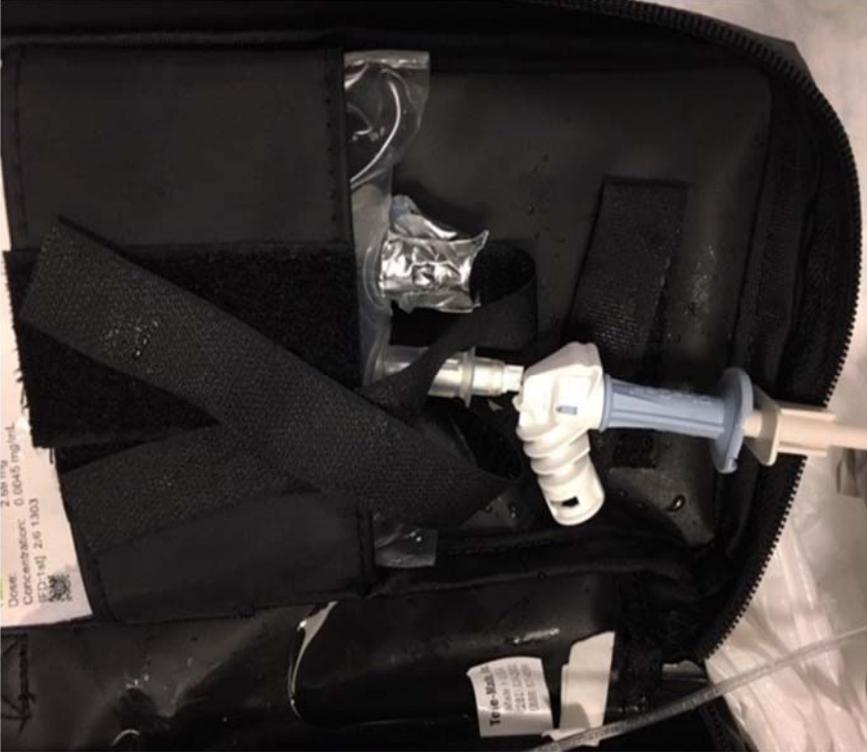
Device	Manufacturer	Problem
<p><b>Close Antineoplastic Transfer System</b></p> <p>Brand: Phaseal</p>	<p>Becton Dickinson</p>	<p>The patient was sent home with a twenty-four hour Yondelis chemo infusion. The patient shared that approximately twelve hours into the infusion she got up to go to the bathroom. When she stood up, she noticed that her feet were wet. The patient noticed the chemo dripping out of the bag. Patient went to local Emergency Room, where they cleaned up, managed the spill, and flushed her port. The patient received about 50% of the dose that is given once every three weeks.</p> <p>The patient was unable to complete her therapy, as it is unclear exactly how much drug she got and how much was spilled. This was very disappointing for pt, who had traveled home, which is about one hundred miles from our hospital. The patient reported that the spike broke on the chemo. She took pictures of the Phaseal spike that broke (attached). The break in the Phaseal can be seen by enlarging the top picture (the spike is completely broken off hub). Reassurance provided to the patient. The carrier bag was replaced with an extra large carrier bag for use with the next infusion of chemotherapy. We do not have the exact lot number of the faulty Phaseal spike.</p> <p>Please see pictures below:</p>
